**LPI, Inc. Consulting Engineers**

*Advanced Analysis & Fitness for Service  
Failure & Materials Evaluation  
Nondestructive Engineering*

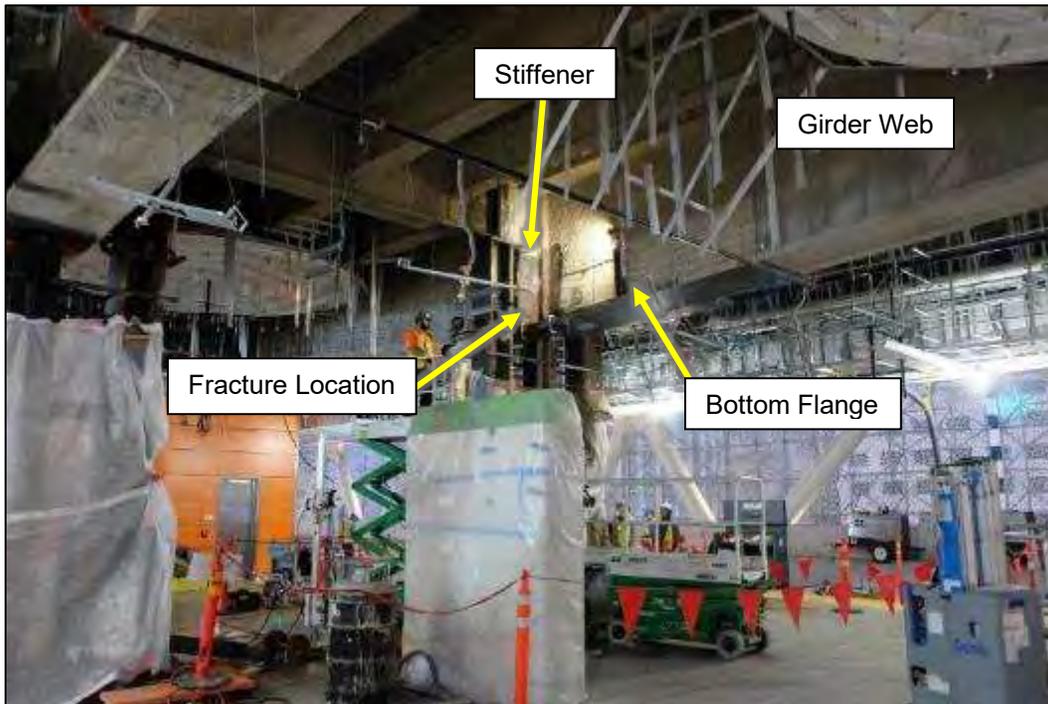
**Fig. 1. Fractured girders above Fremont Street**

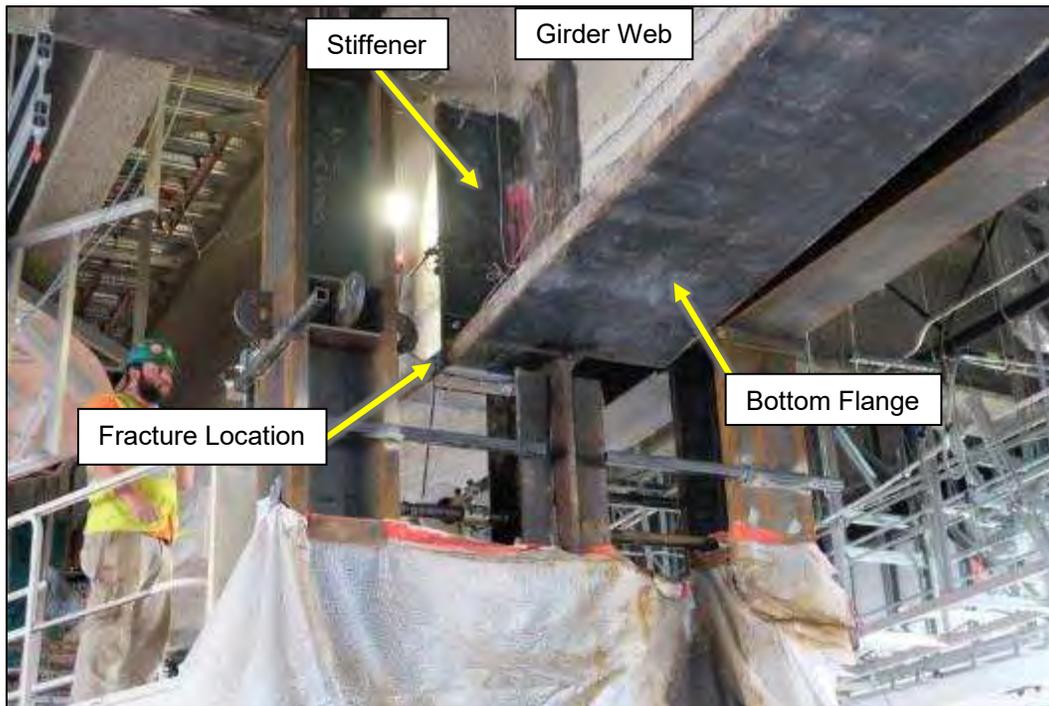
**Fig. 2. North side girder flange fracture location above Fremont Street.**

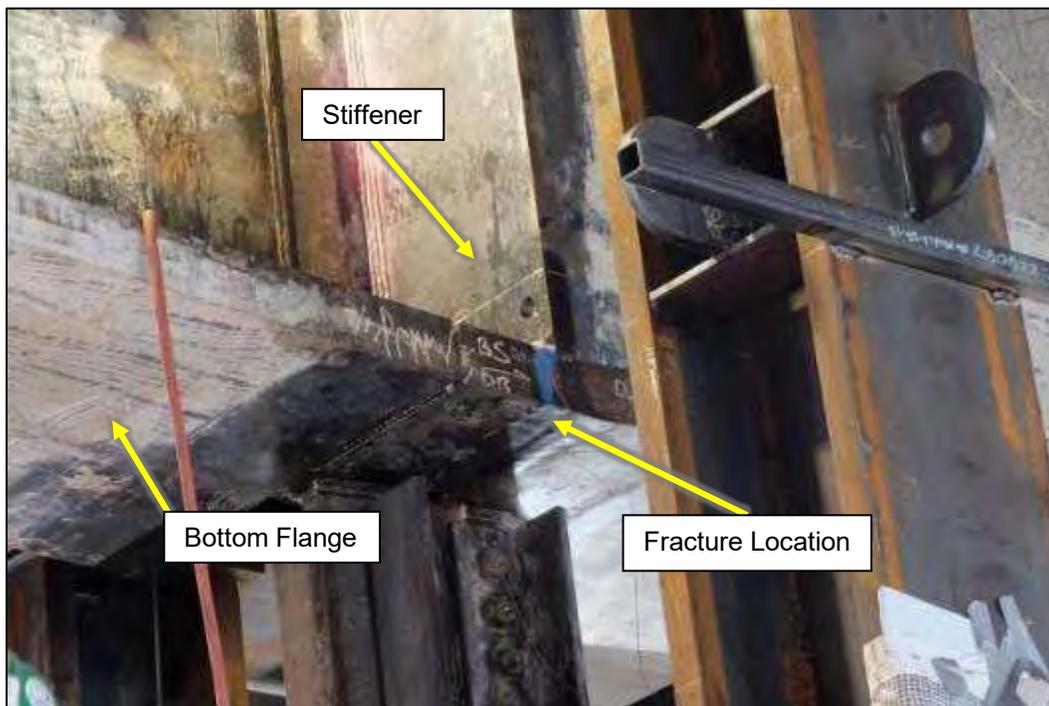
**Fig. 3. Typical location of north side girder fracture, where the fracture was protected with silicone prior to flange sample removal.**

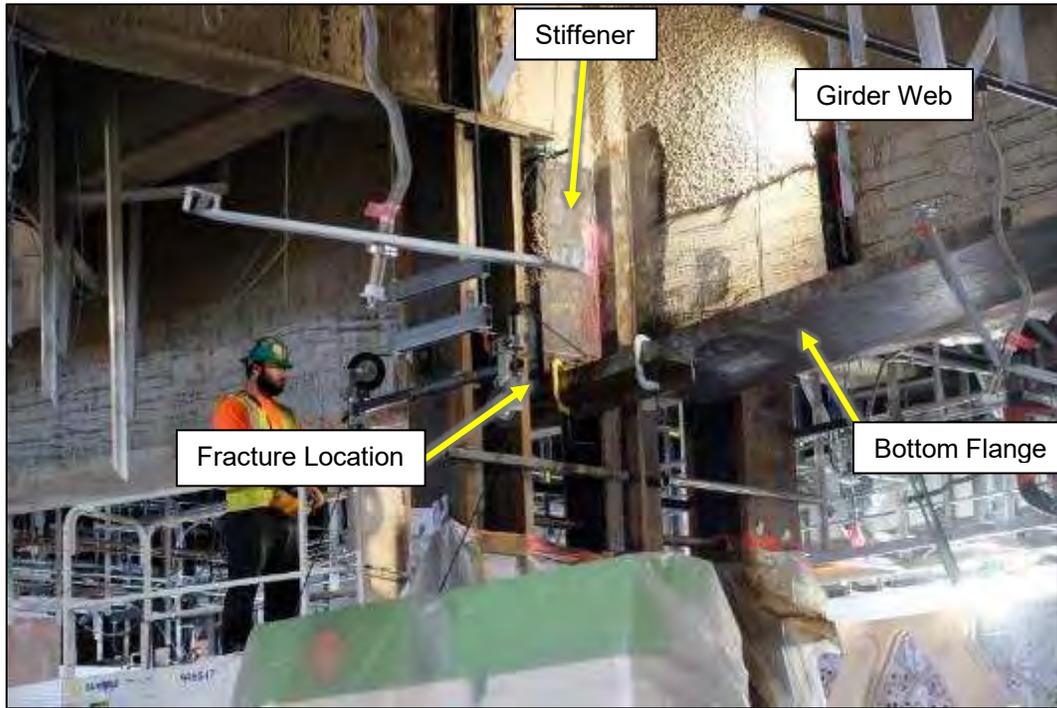
**Fig. 4. Flange sample removal of the north side girder by wire cutting.**

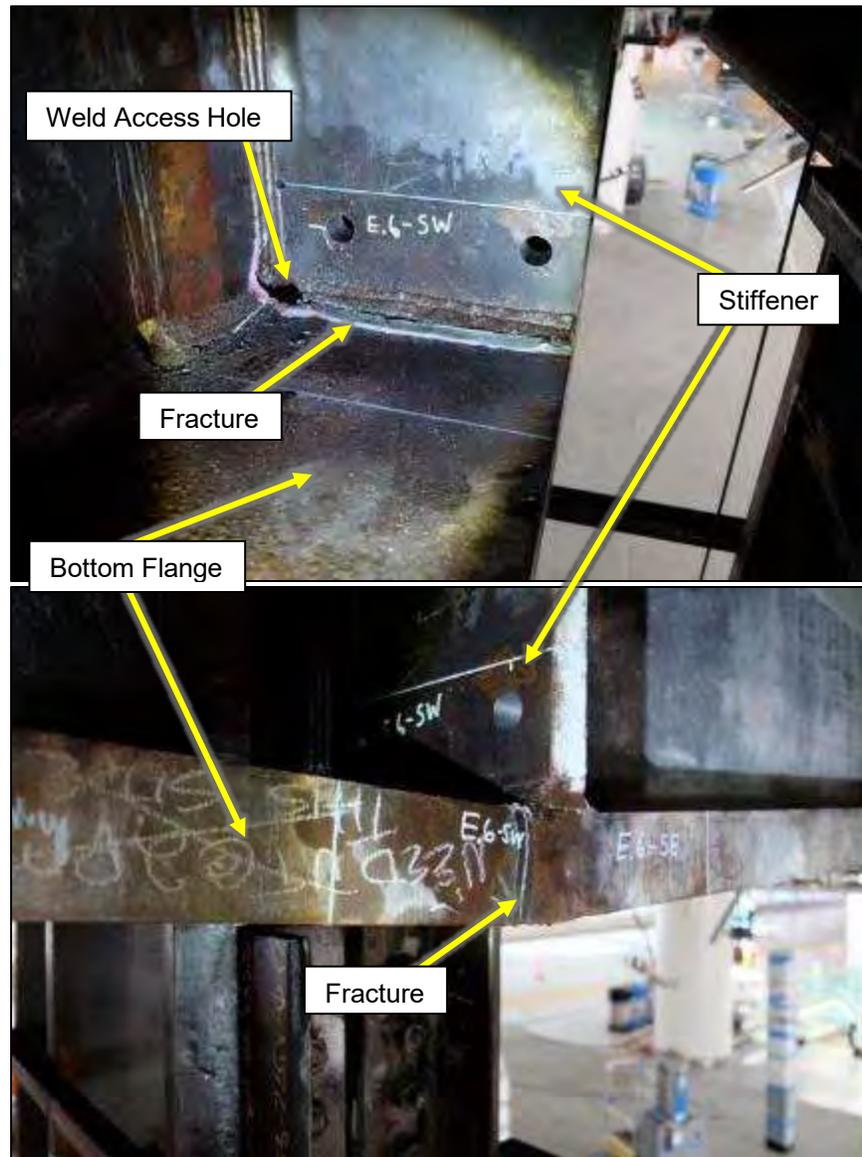
**Fig. 5. South side girder fracture, where the fracture was protected with silicone prior to flange sample removal.**

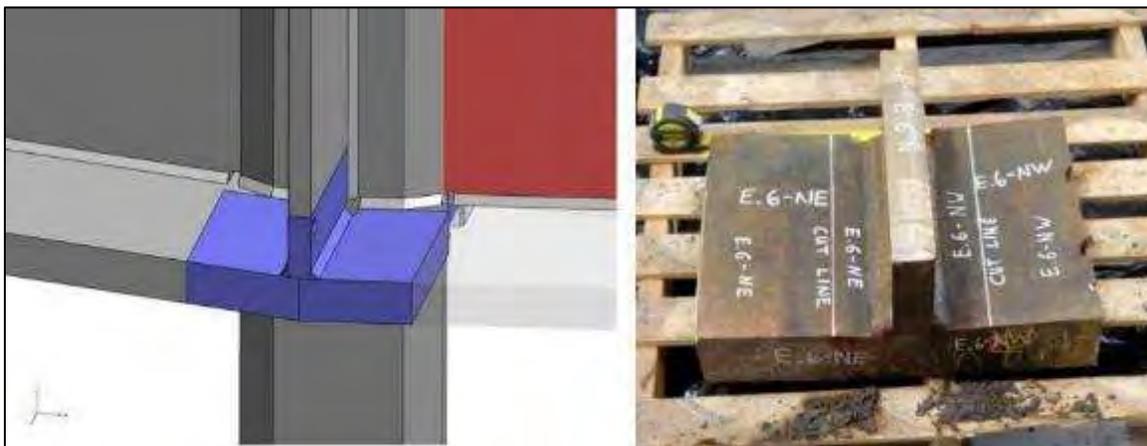
**Fig. 6. Girder model (left) showing girder sample geometry and location. Typical girder sample after removal (right).**

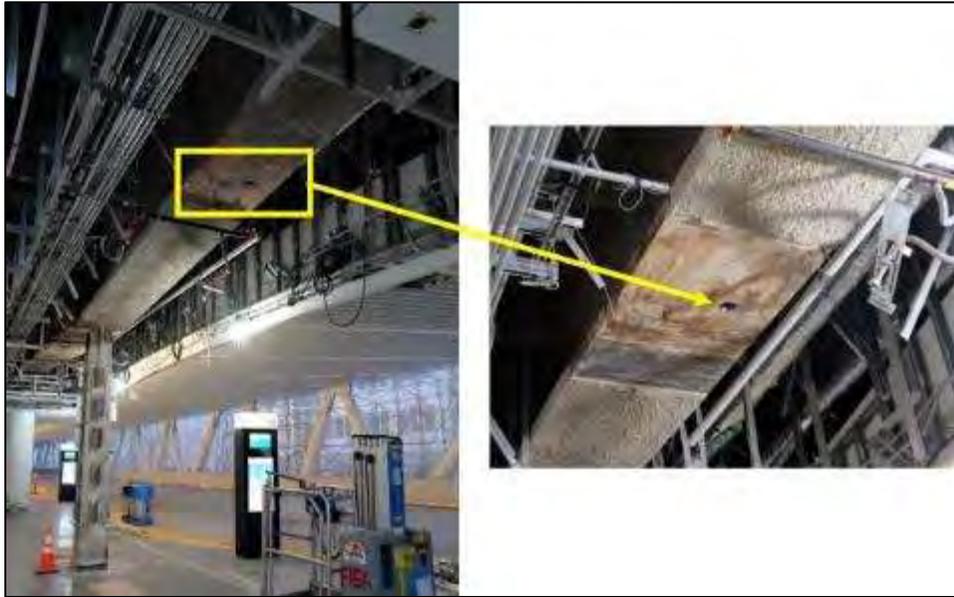
**Fig. 7. Typical location of the 3-in. diameter core samples removed from girder flanges above First Street.**

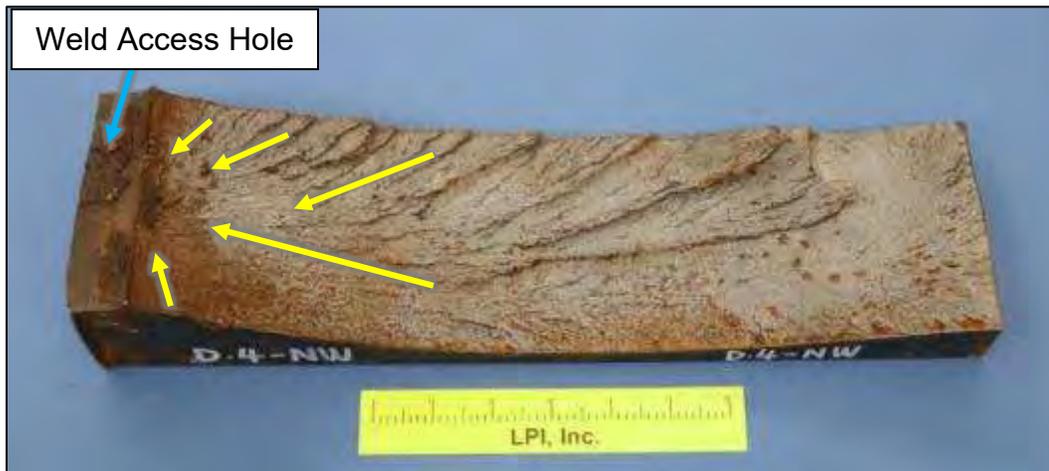
**Fig. 9. Chevron marks (yellow arrows) on the fracture surface of girder sample D.4-NW reveal the fracture origin to be adjacent to the weld access hole.**

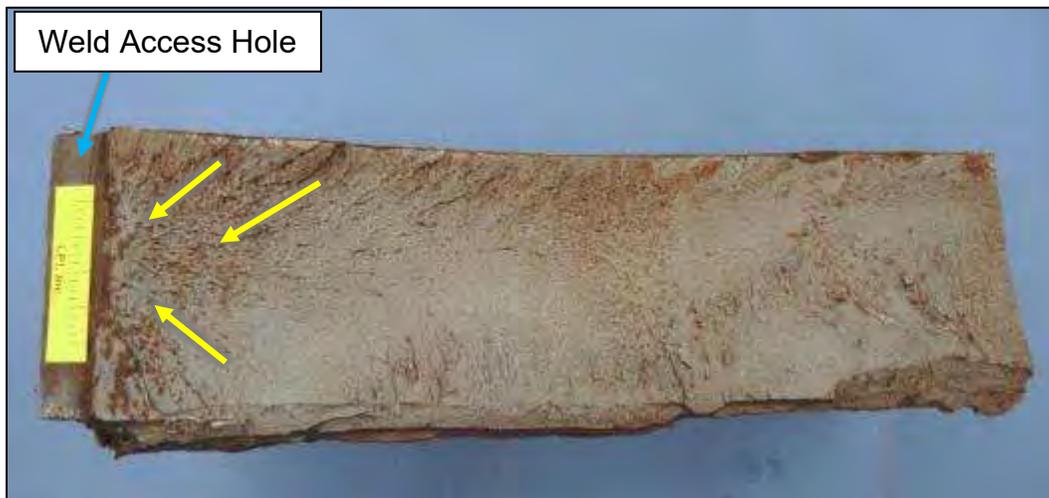
**Fig. 10. Chevron marks (yellow arrows) on the fracture surface of girder sample D.4-SW pointing towards the origin at the edge of the weld access hole.**

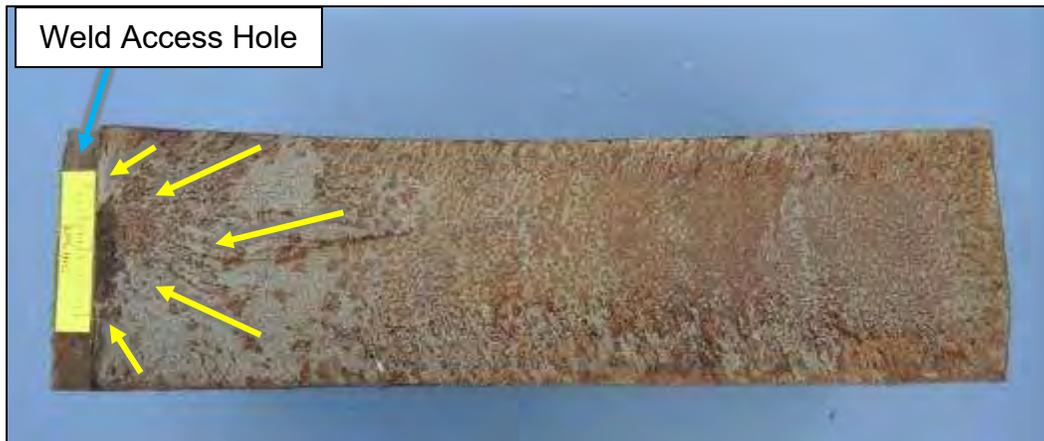
**Fig. 11. Chevron marks (yellow arrows) on the fracture surface of girder sample E.6-SW pointing towards the origin at the edge of the weld access hole.**

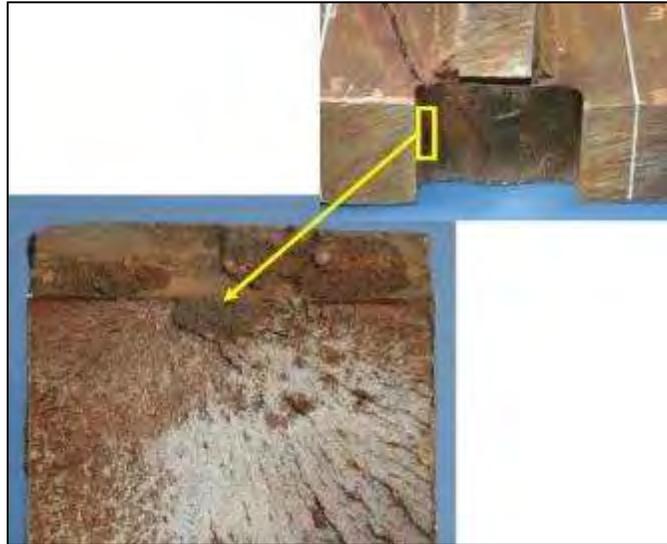
**Fig. 12. Dark oxide covered elliptical pop-in crack fracture origin at the weld access hole (top) of girder sample D.4-NW.**

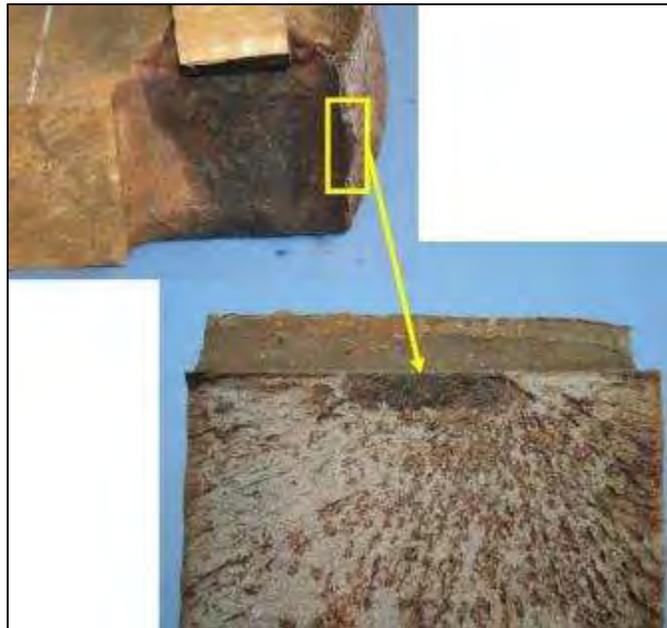
**Fig. 13. Dark oxide covered elliptical pop-in crack fracture origin at the weld access hole (top) of girder sample E.6-SW.**

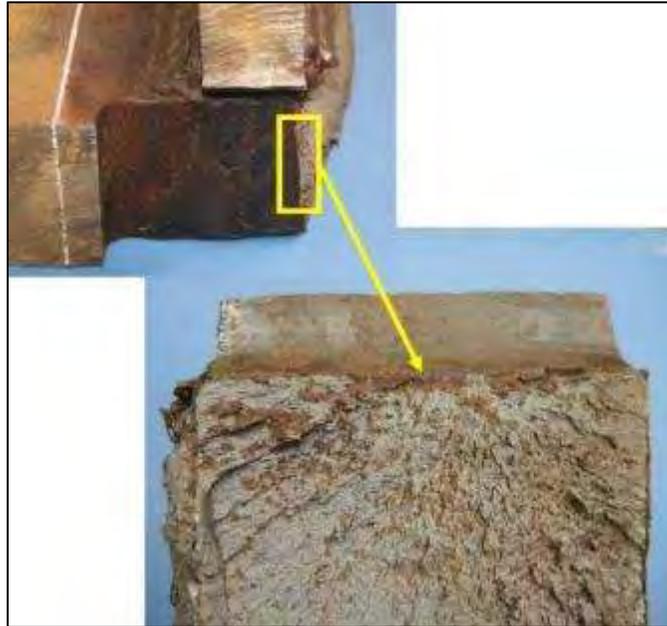
**Fig. 14. Dark oxide covered narrow band microcrack fracture origin at the weld access hole (top) of girder sample D.4-SW.**

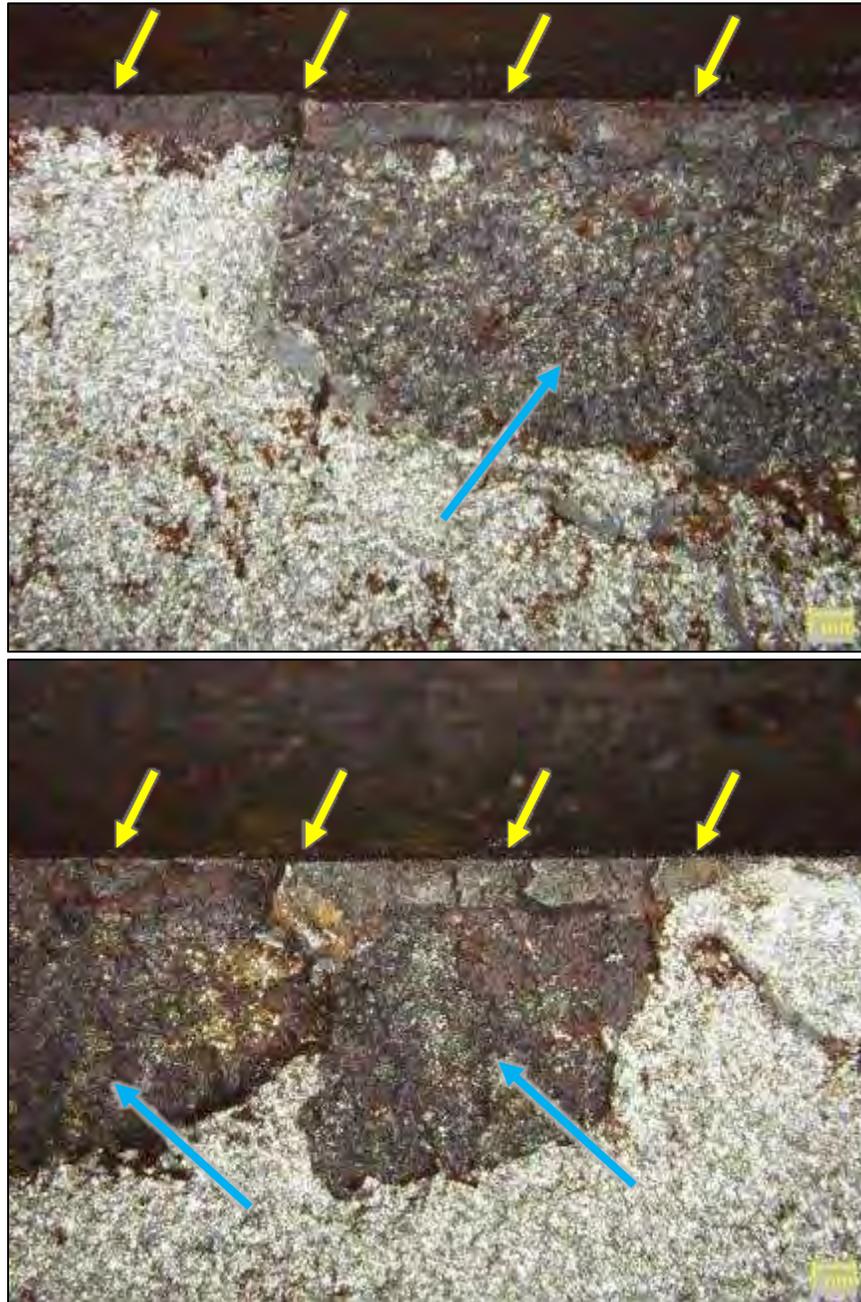
**Fig. 15.** Origin of D.4-NW exhibited narrow band microcracks (yellow arrows) at the edge to the weld access hole with a tenacious dark oxide layer. The elliptical crack (blue arrows) “popped-in” from the microcracks and exhibited a dark oxide layer that was partially removed after cleaning.

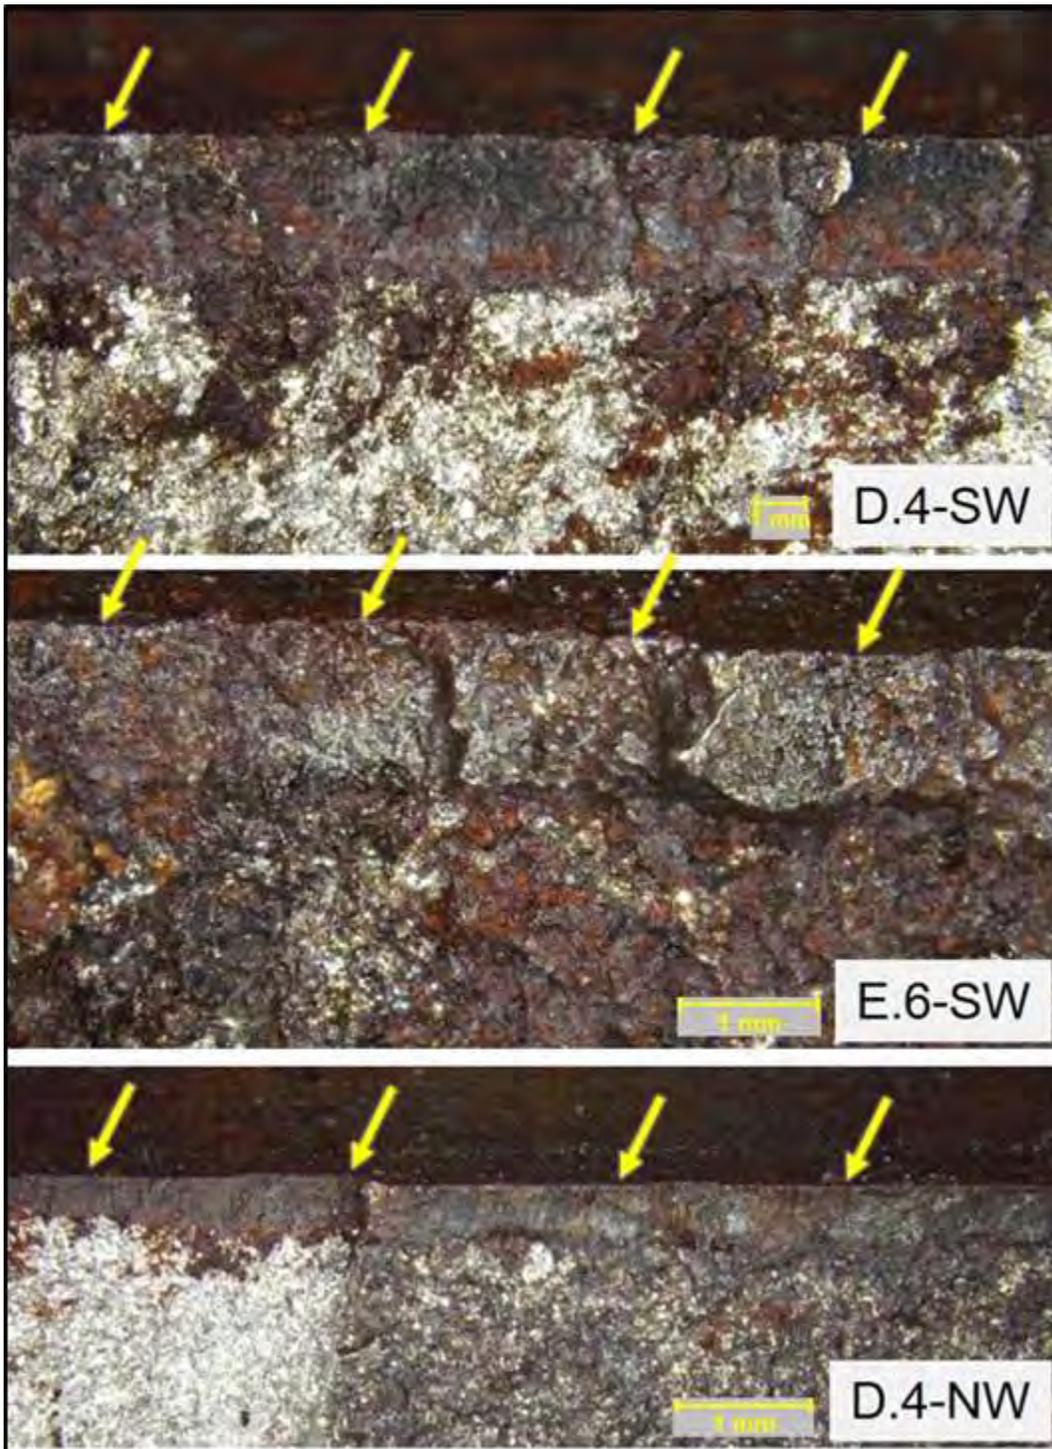
Fig. 16. Fracture origins of samples D.4-SW (top), E.6-SW (center) and D.4-NW (bottom) showing microcracks that initiated during thermal cutting of the access holes.

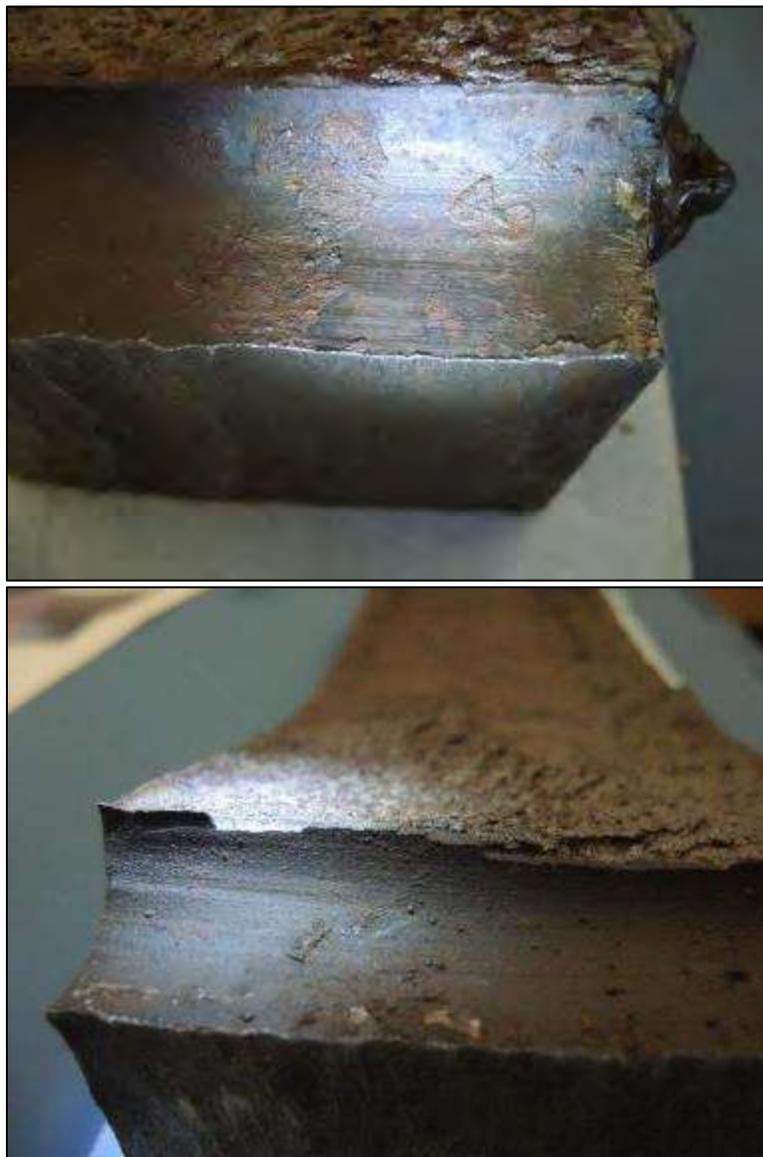
**Fig. 17. Weld access hole surfaces in samples D.4-SW (top) and E.6-SW (bottom).**

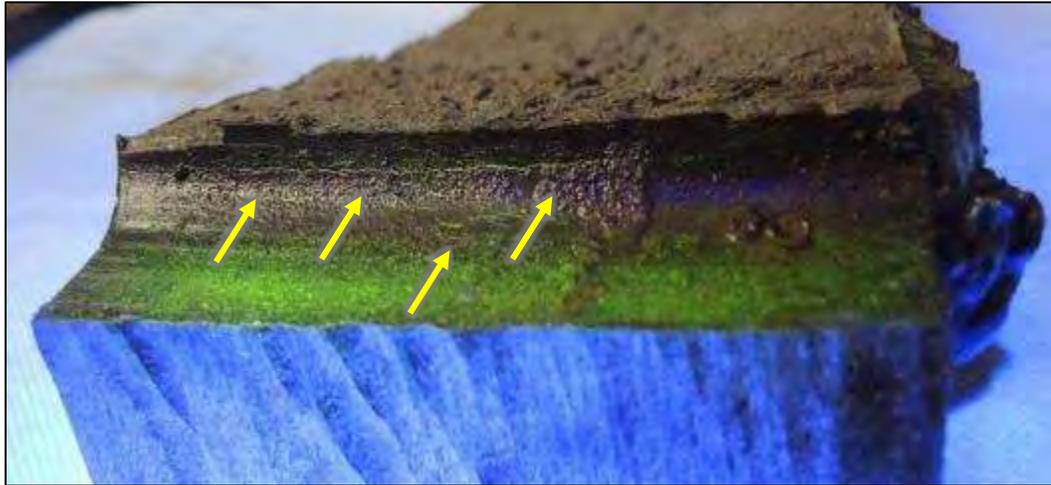
**Fig. 18. Cracking in the radius of the thermally cut access hole surface of sample D.4-SW, as identified by fluorescent magnetic particle testing.**

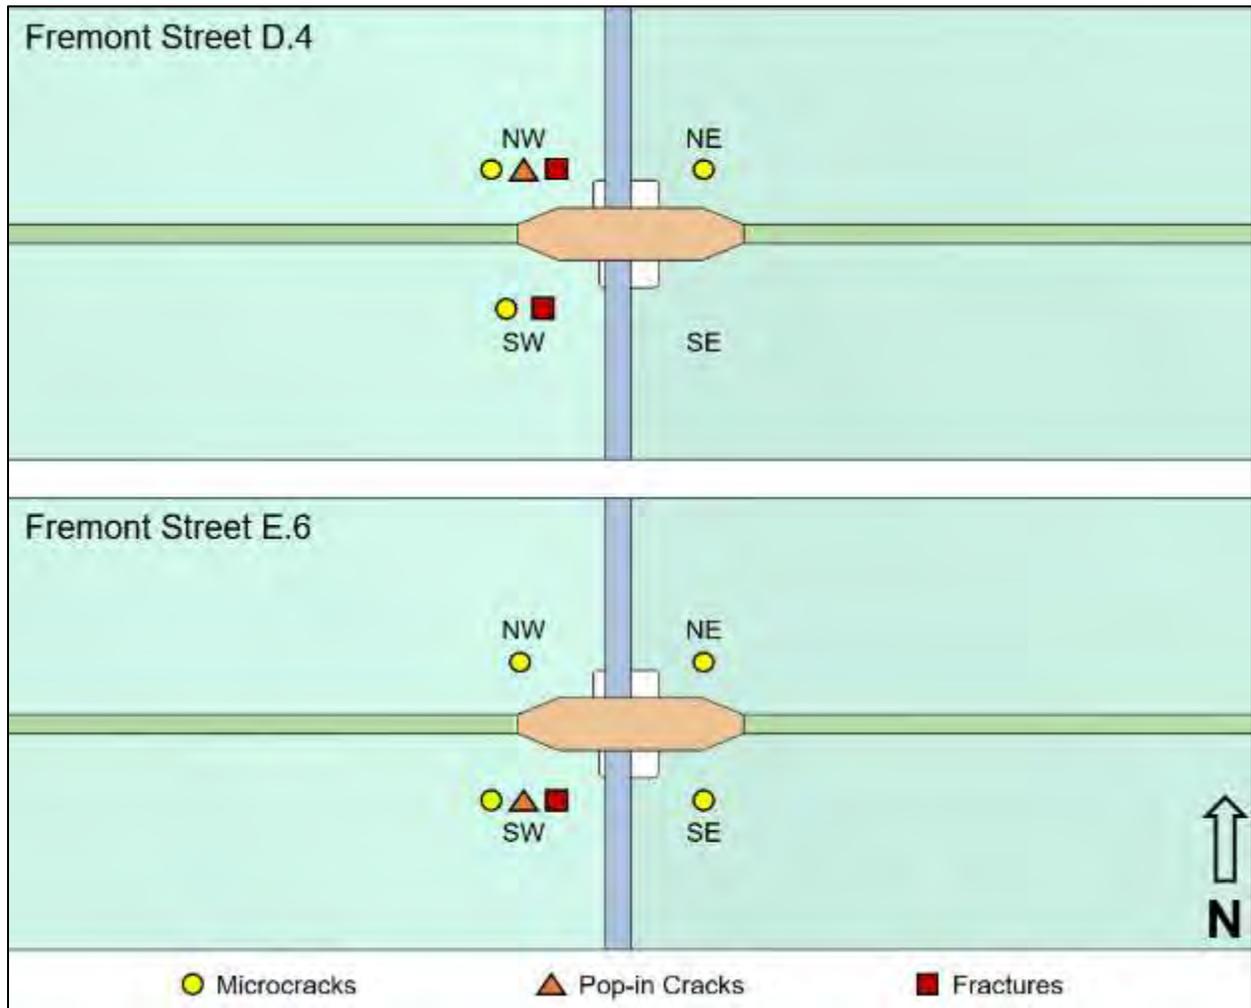
Fig. 19. Summary of observed cracking and fractures. Diagram is generic and not representative of actual weld access hole dimensions. The thin, blue rectangles perpendicular to the orange hangers are the centerline stiffeners.

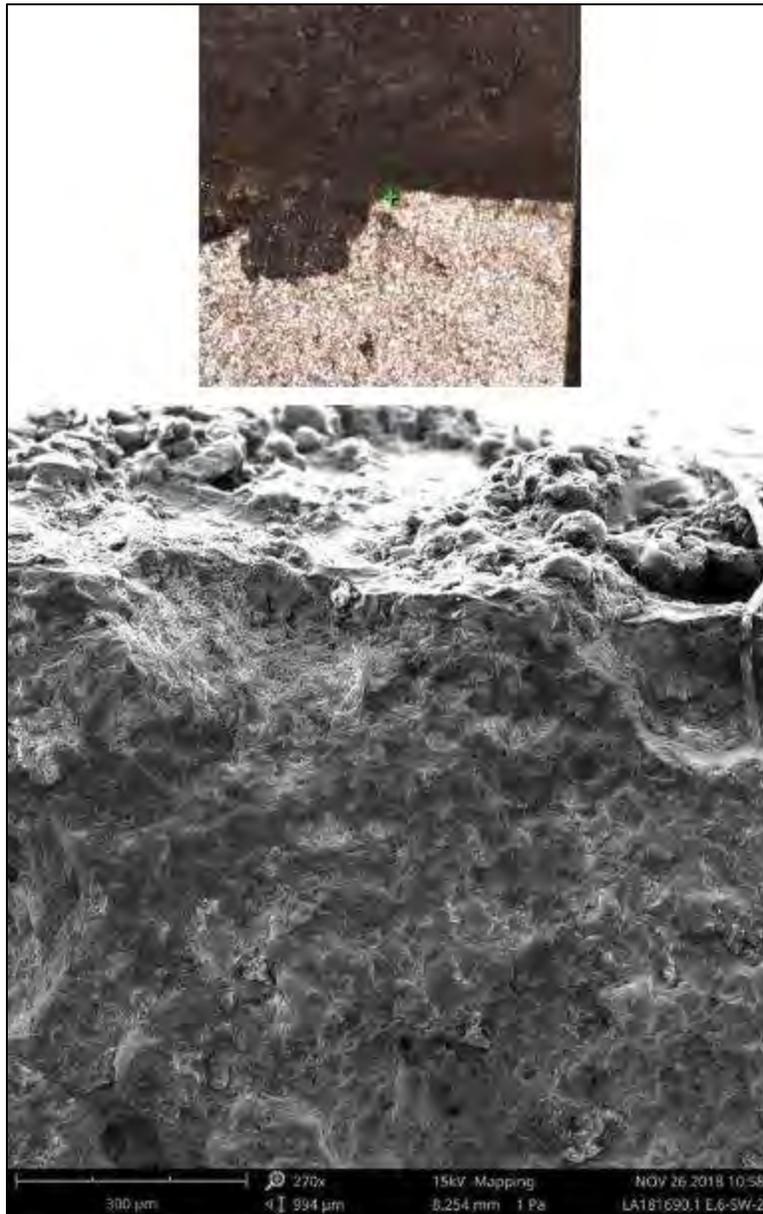
**Fig. 20. Oxide covered microcrack fracture origin after cleaning of sample E.6-SW.**

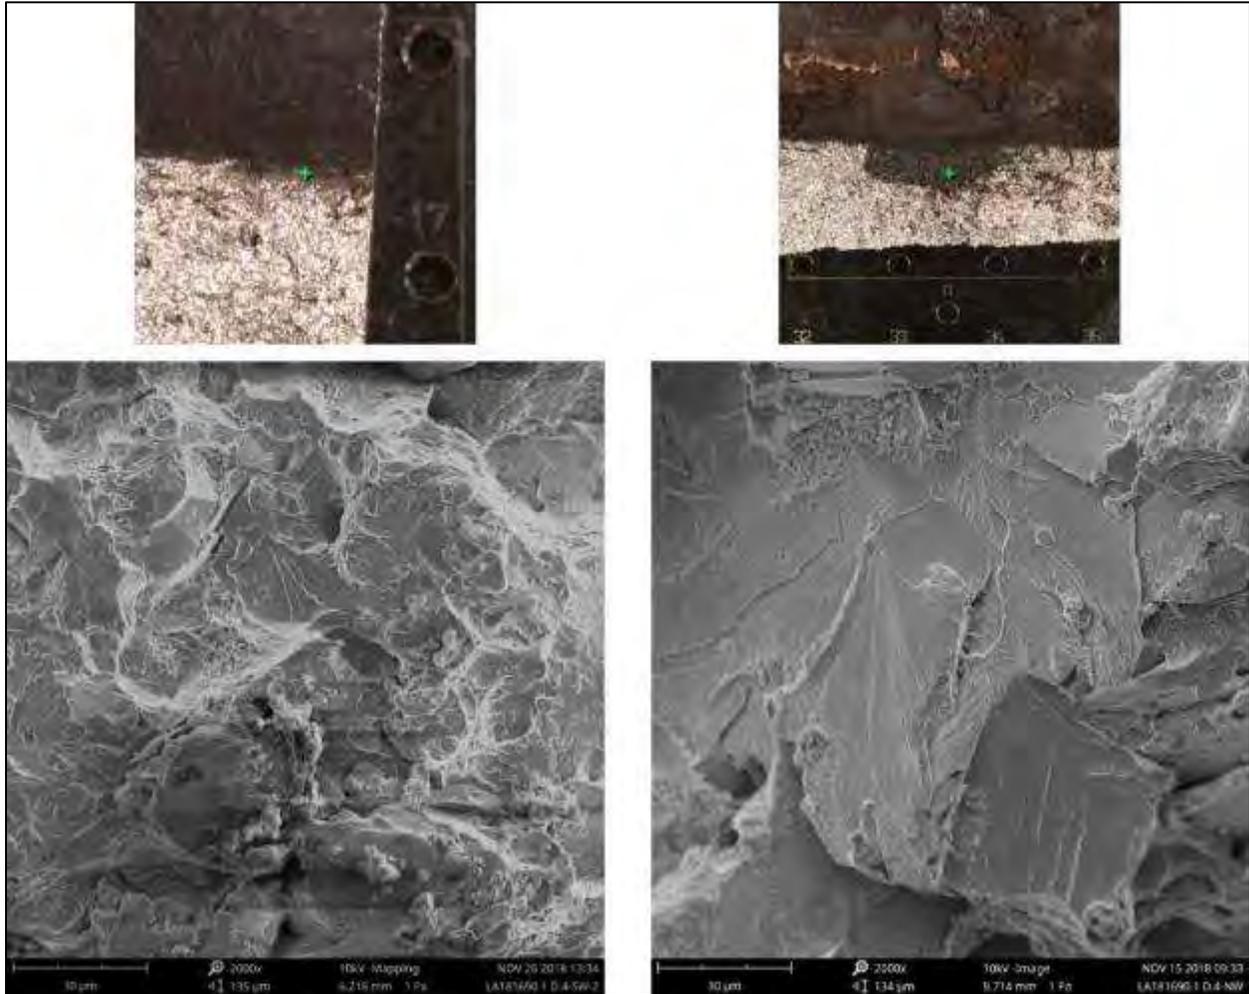
**Fig. 21. (Left) Typical SEM image of microcrack fracture after cleaning in sample D.4-SW exhibiting a low-energy cleavage fracture morphology. (Right) Typical SEM image of elliptical pop-in crack fracture in sample D.4-NW exhibiting a low-energy cleavage fracture morphology.**

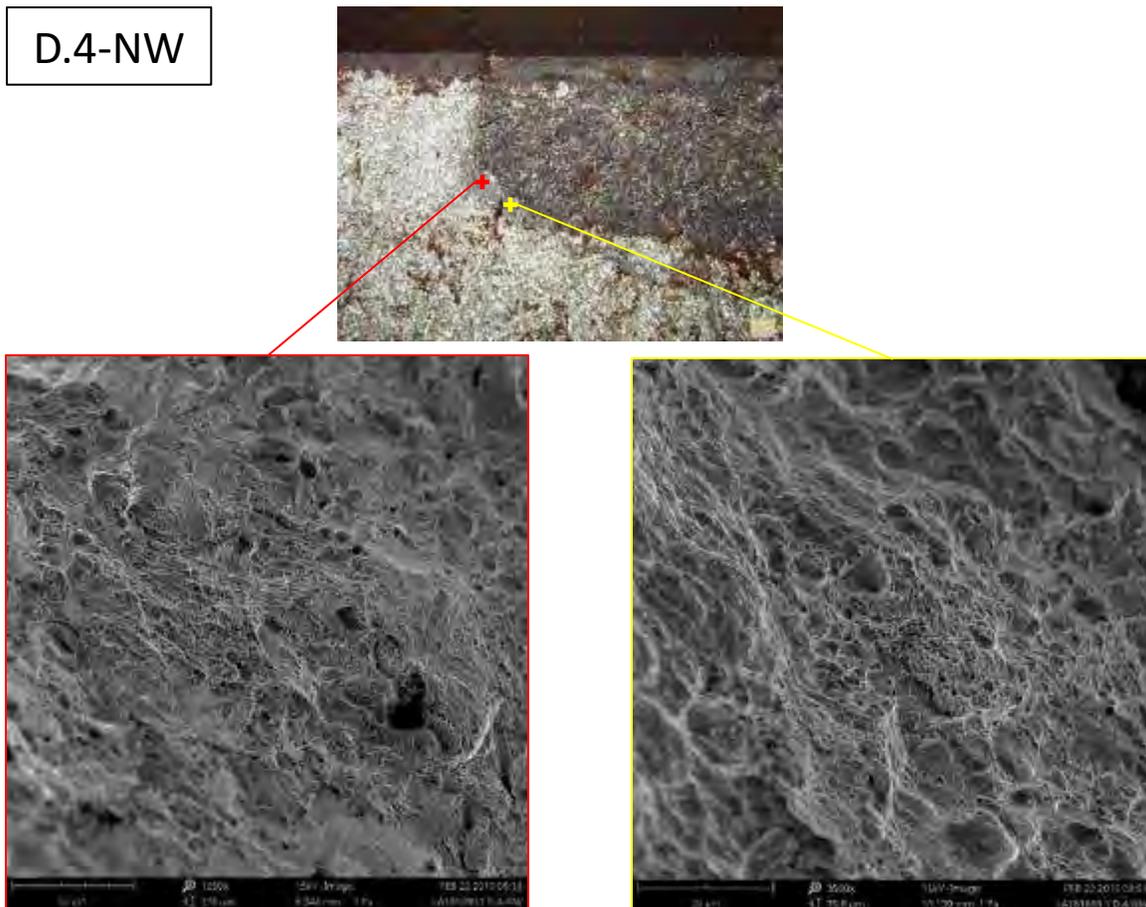
**Fig. 22. SEM images at the leading edge of oxidized elliptical crack in girder sample D.4-NW showing a narrow band of microvoid coalescence.**

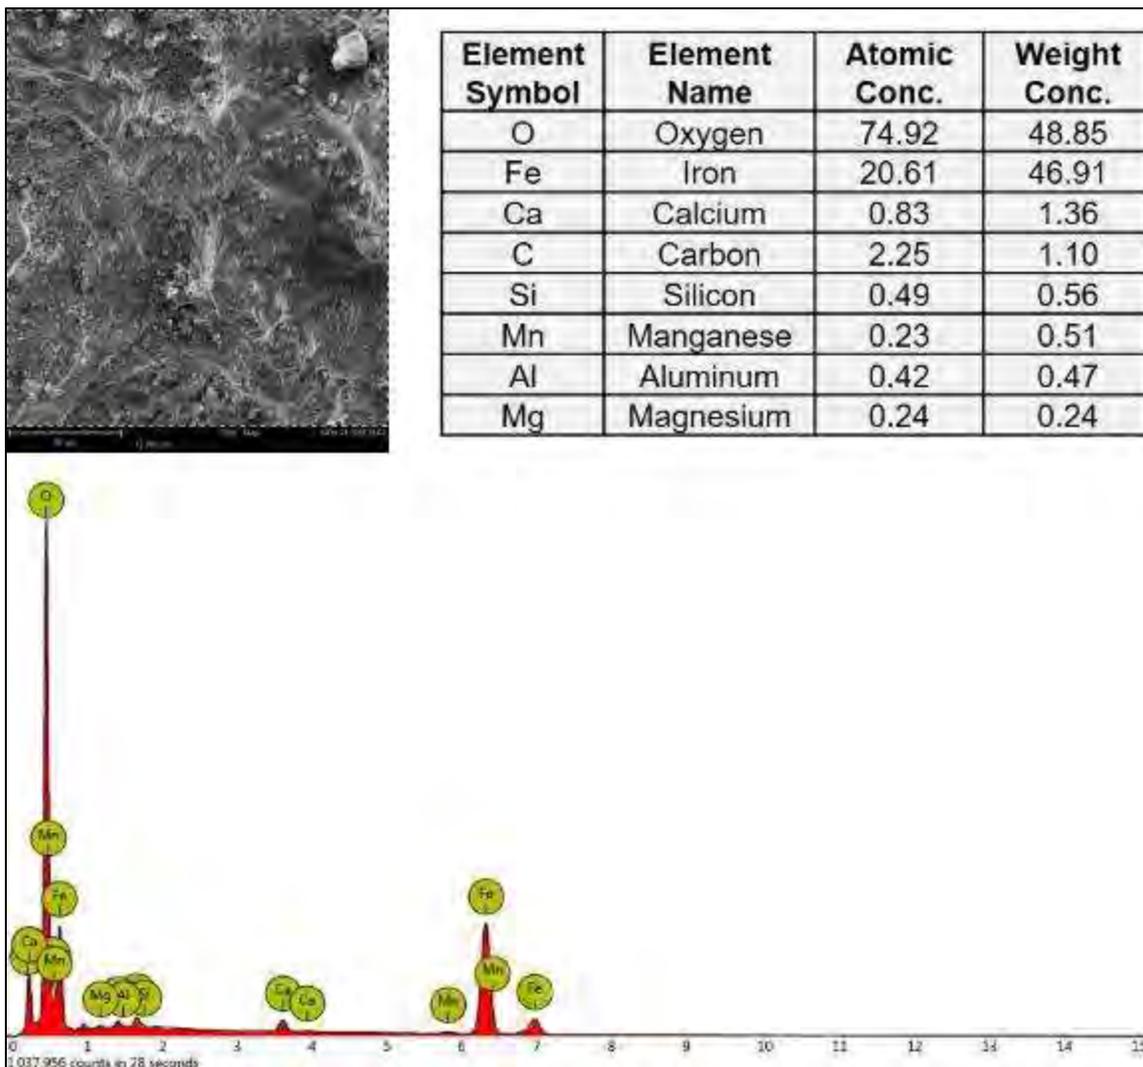
Fig. 23. EDS results from the fracture origin of sample E.6-SW.

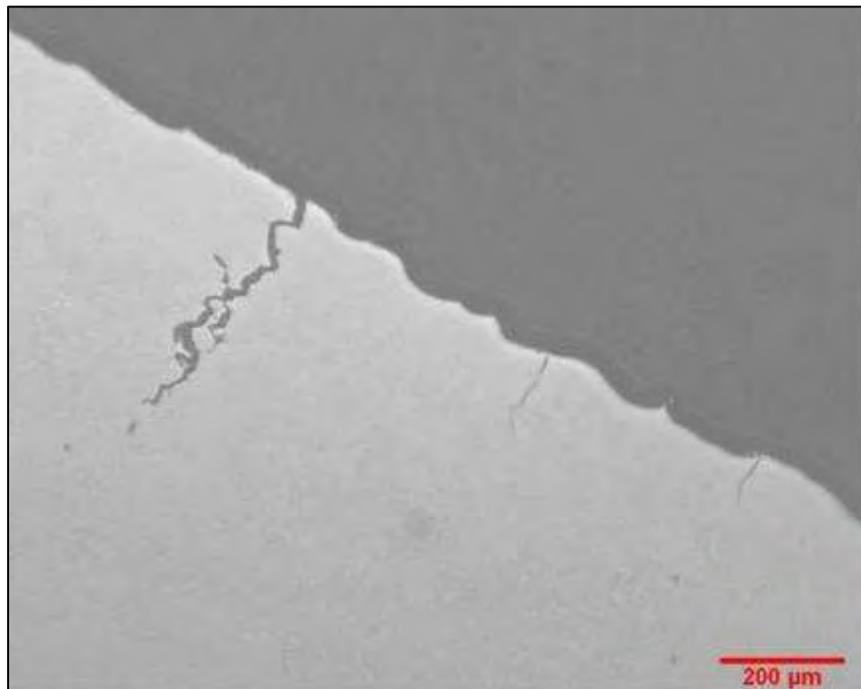
**Fig. 24. Multiple secondary, oxide-filled microcracks in the weld access radius of sample D.4-SW.**

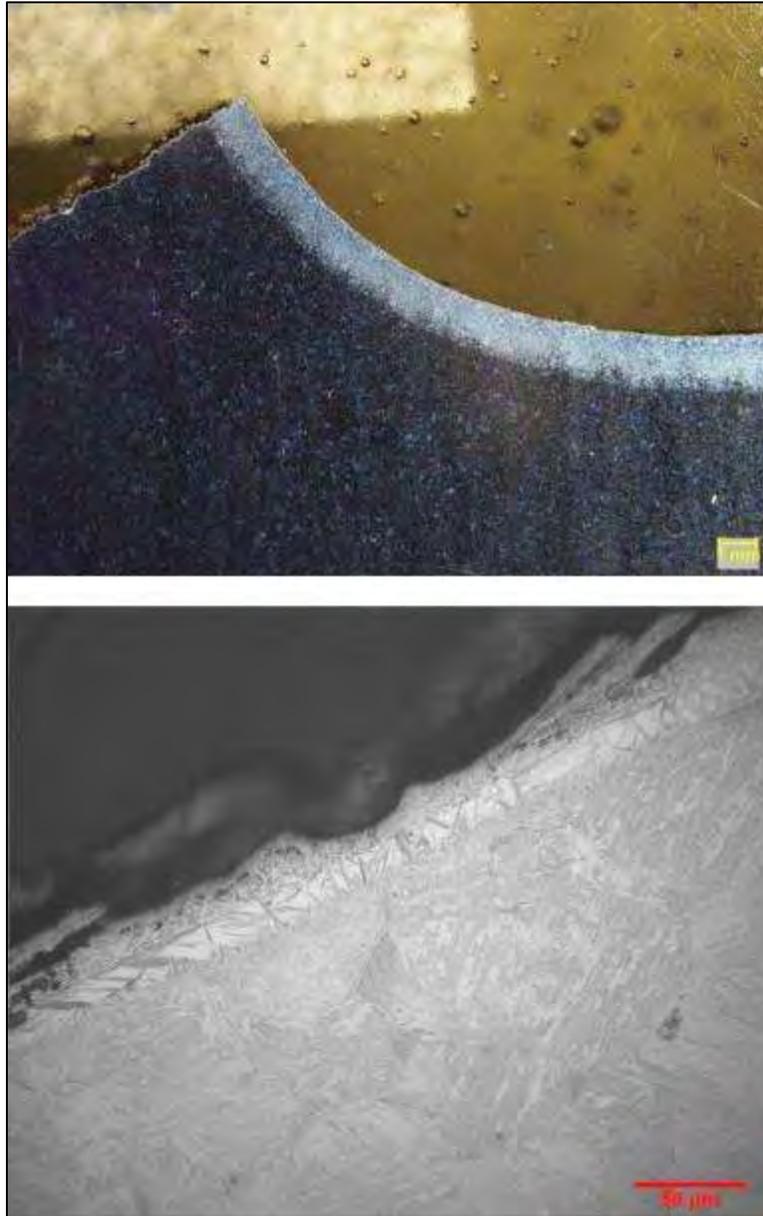
**Fig. 26. Martensitic layer at the weld access hole radius of sample E.6-SW (fractured side). The martensitic layer appears as the lighter-etching band in the stereomicroscopic image at the top. The bottom metallographic image shows the martensitic structure within the white band.**

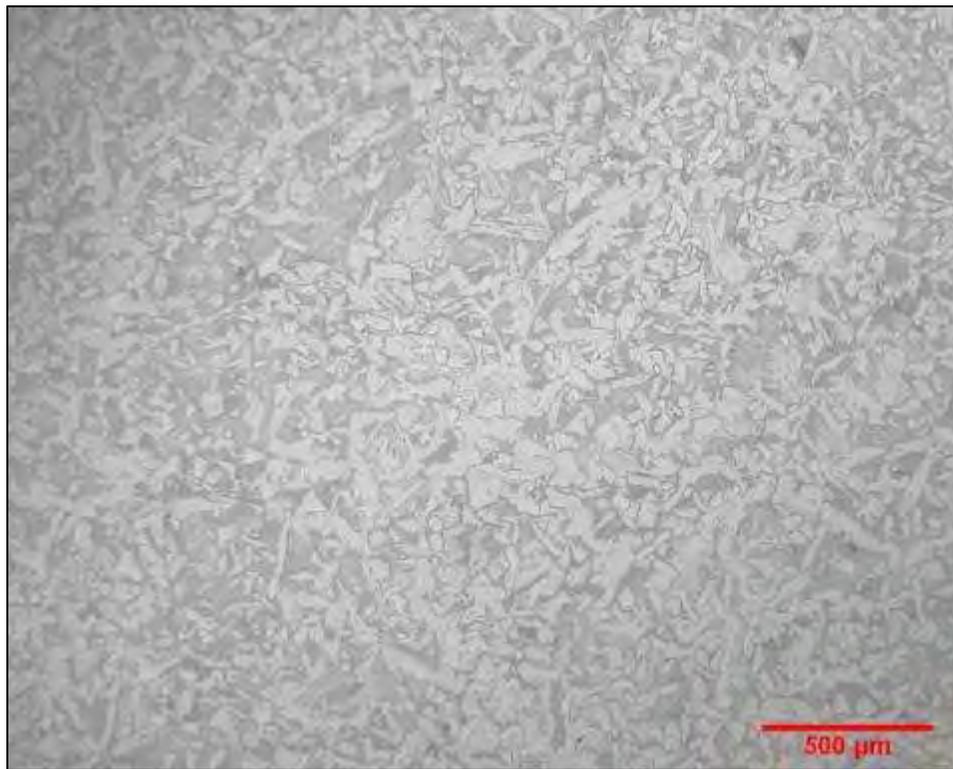
**Fig. 27. Fine grained ferrite (bright) and pearlite (dark) grain structure for the flange steel plate of sample D.4-SW.**

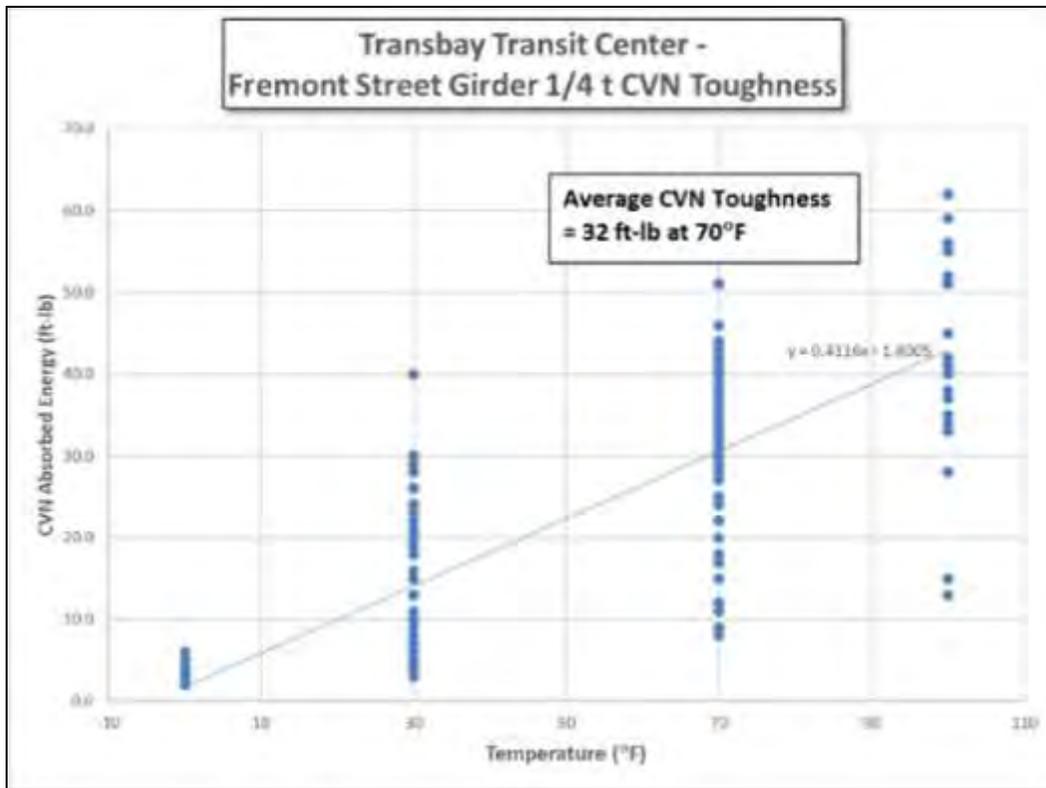
Fig. 29 Fremont Street CVN absorbed energy results for the 1/4 - 3/4 t location as a function of temperature.

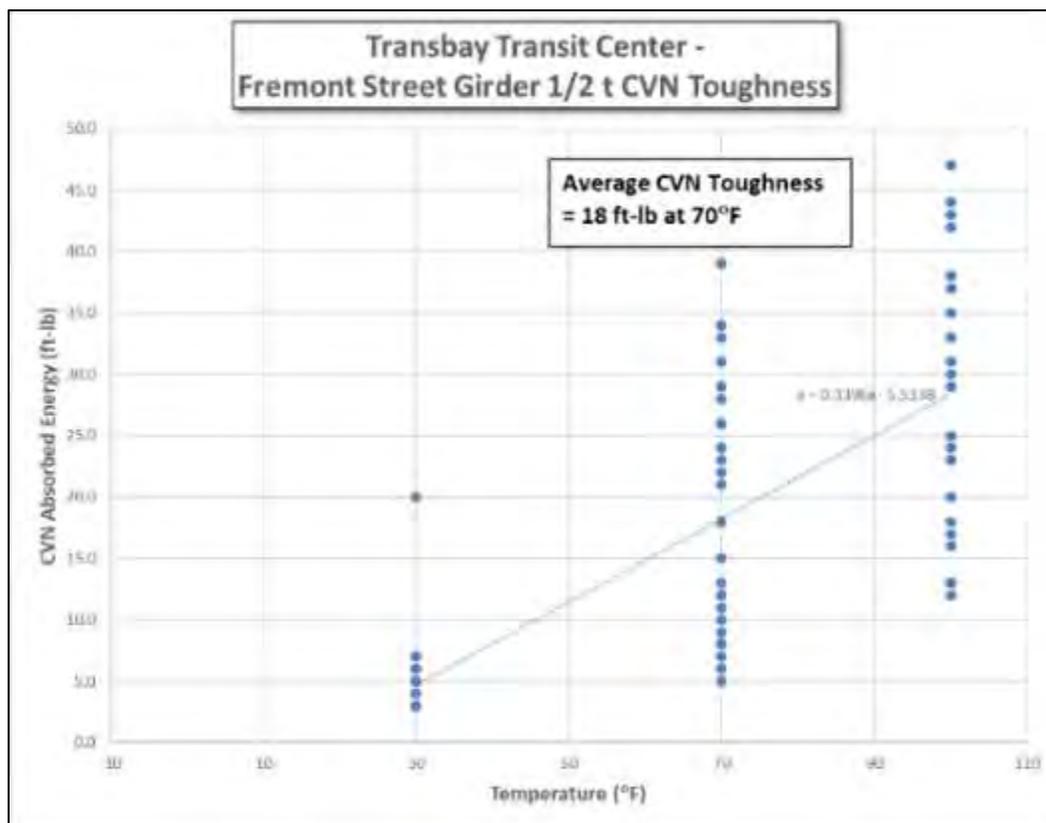
**Fig. 30** Fremont Street CVN absorbed energy results for the  $\frac{1}{2}$  t location as a function of temperature.

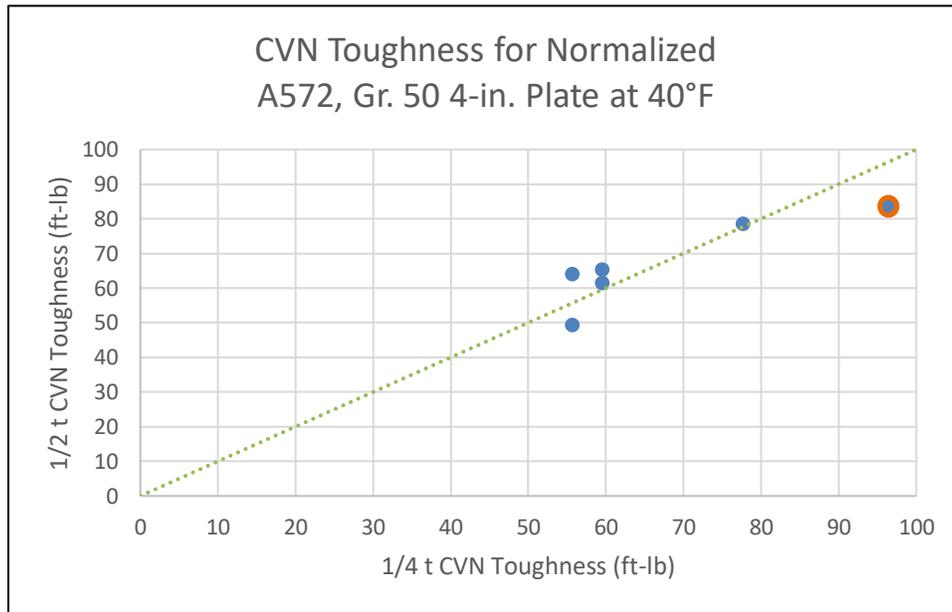
**Fig. 31. Relationship between 1/4 t and 1/2 t CVN toughness levels for normalized A572, Gr. 50, structural steel.**
