**LPI, Inc. Consulting Engineers**

*Advanced Analysis & Fitness for Service  
Failure & Materials Evaluation  
Nondestructive Engineering*

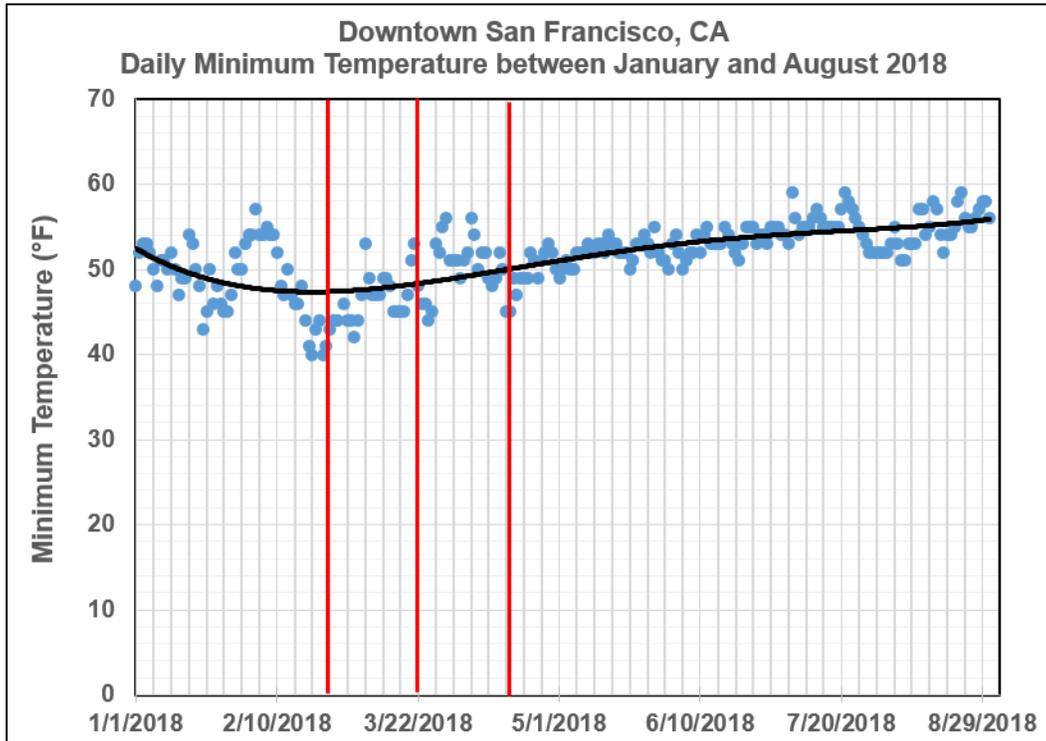
**Fig. 32. Daily minimum temperatures in San Francisco, CA, between January and August 2018. A fourth-order polynomial regression is shown with the black line, and the red lines indicate clusters of low-temperature days.**

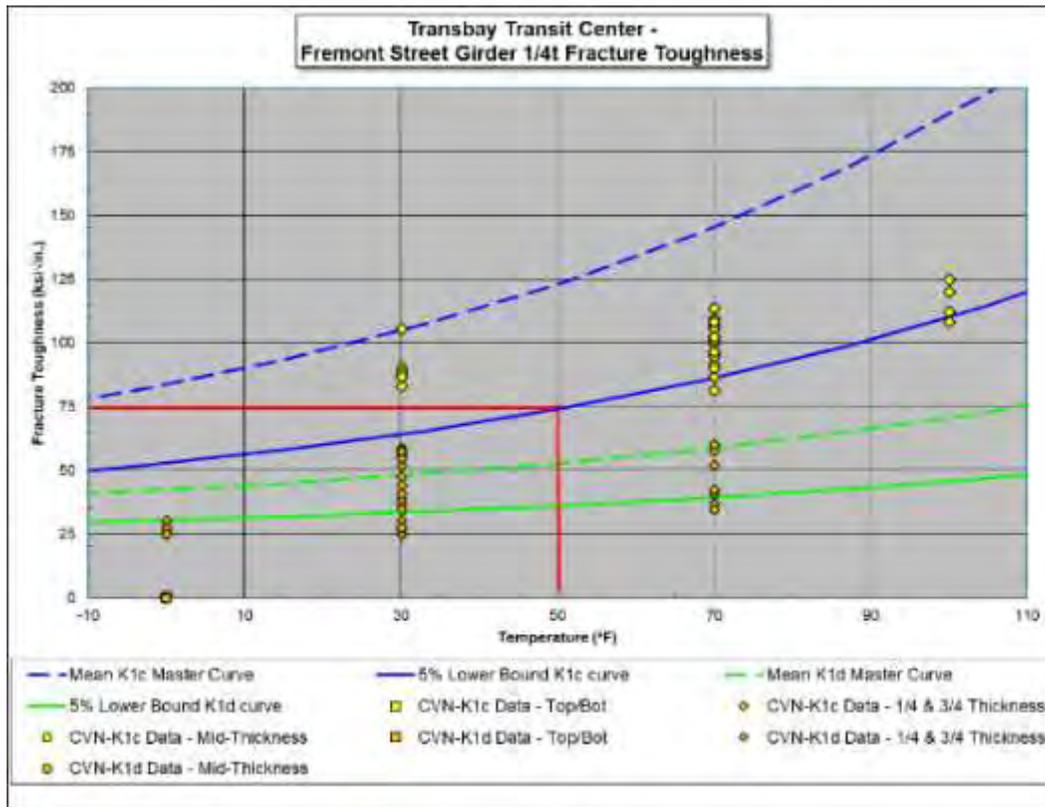
Fig. 33 Flange fracture toughness at the  $\frac{1}{4}$  t location.

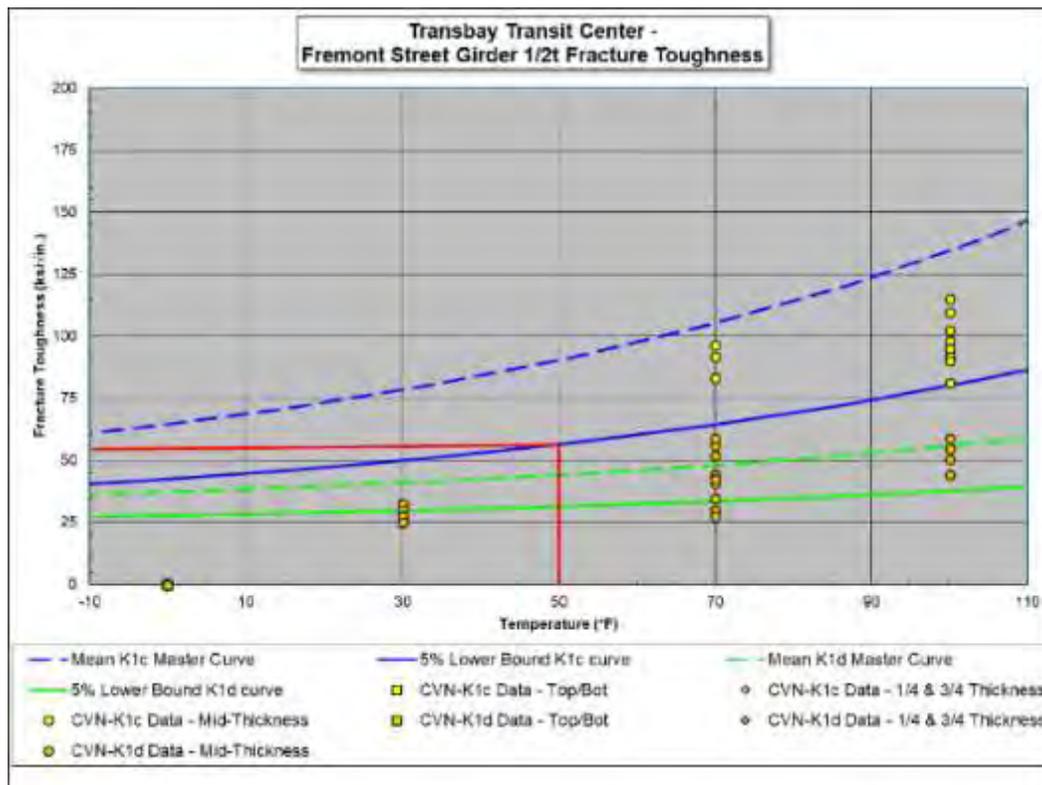
Fig. 34 Flange fracture toughness at the 1/2 t location.

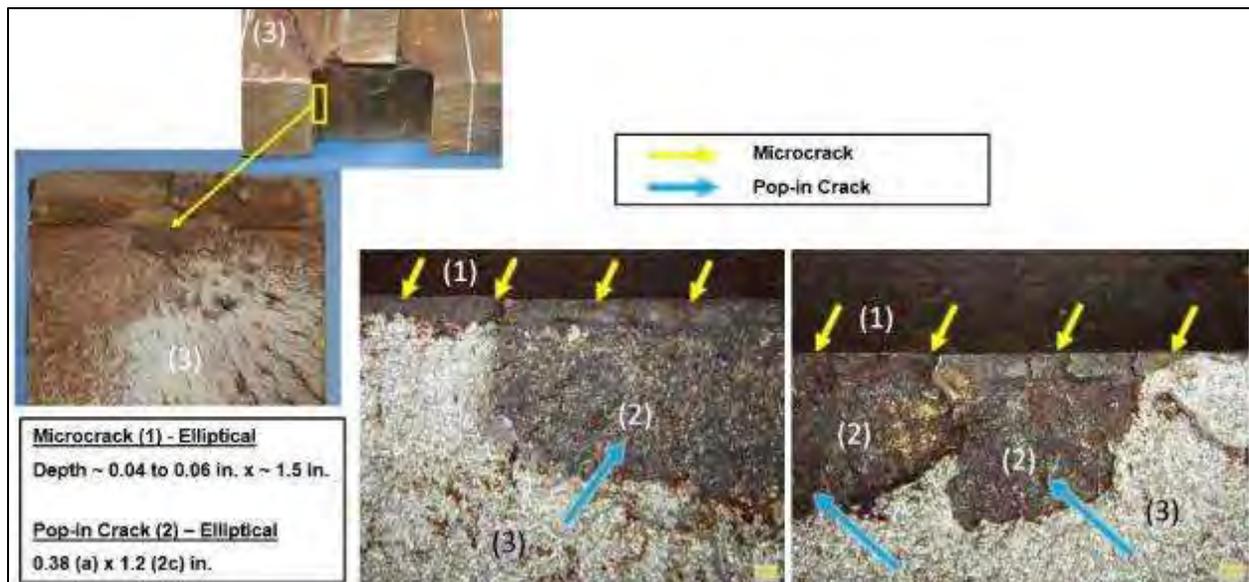
**Fig. 35. Fremont Street D.4 girder fracture features: (1) microcracks, (2) pop-in crack, and (3) bottom flange fracture.**

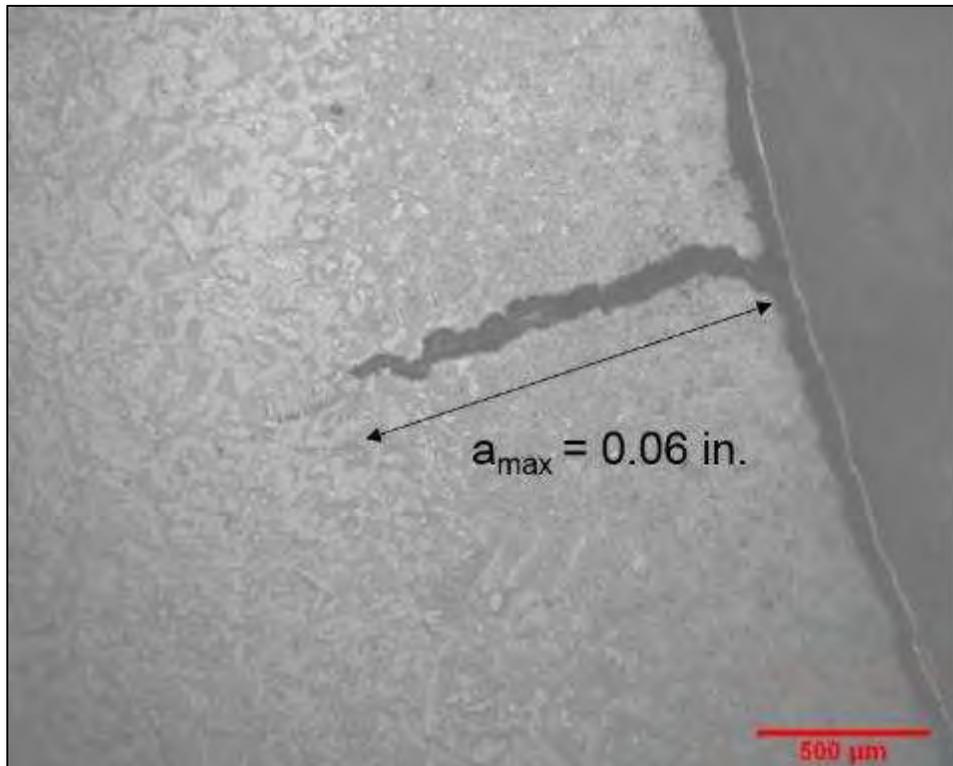
**Fig. 36. Cross-sectional view of a weld access hole microcrack with the maximum depth shown for reference.**

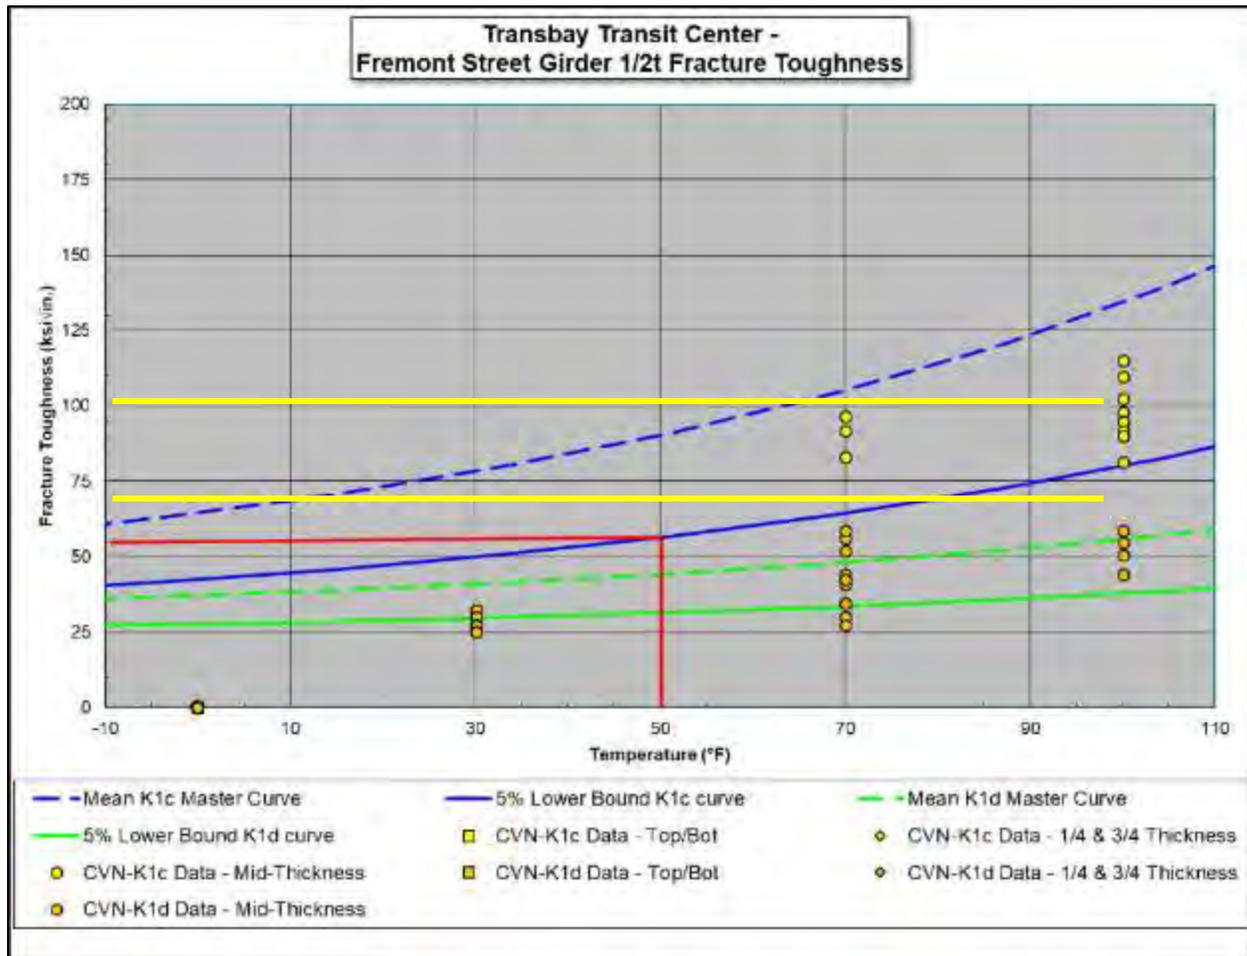
Fig. 37. Fracture toughness data at 1/2 t. The toughness at 50°F is approximately 55 to 60 ksivin. (red lines) and the upper shelf fracture toughness is in the range of 70 to 100 ksivin. (yellow lines).

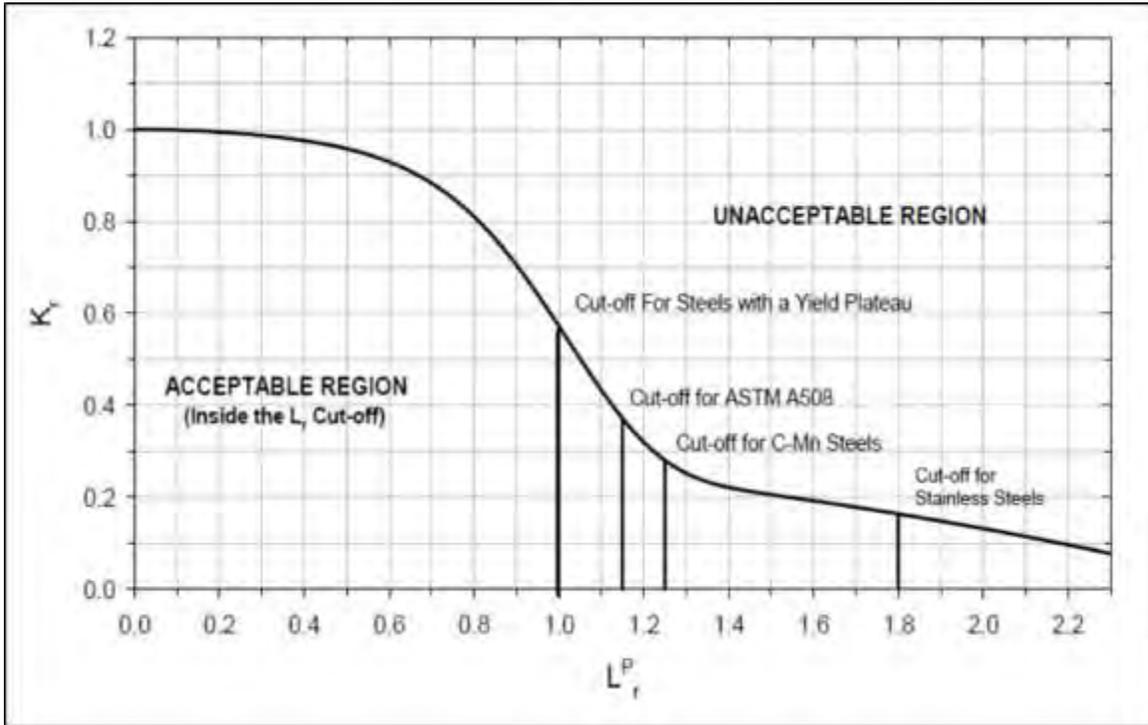
Fig. 38 Failure Assessment Diagram (FAD) from API 579-1/ASME FFS-1 [10]

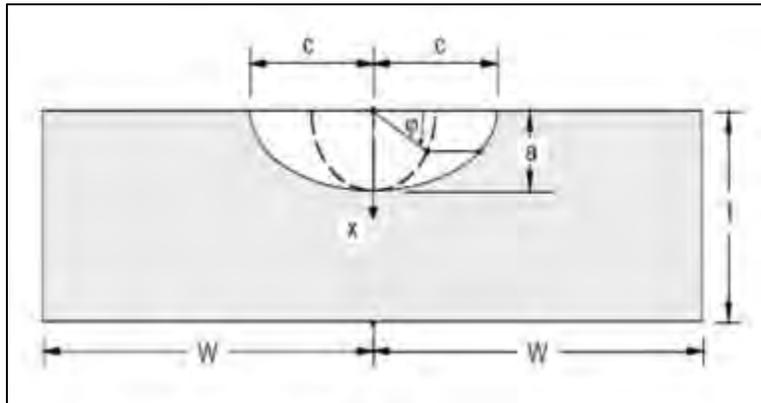
**Fig. 39 Geometric representation of a surface-breaking elliptical crack in a plate. In this case, 2W corresponds to the flange thickness and t to the flange width.**

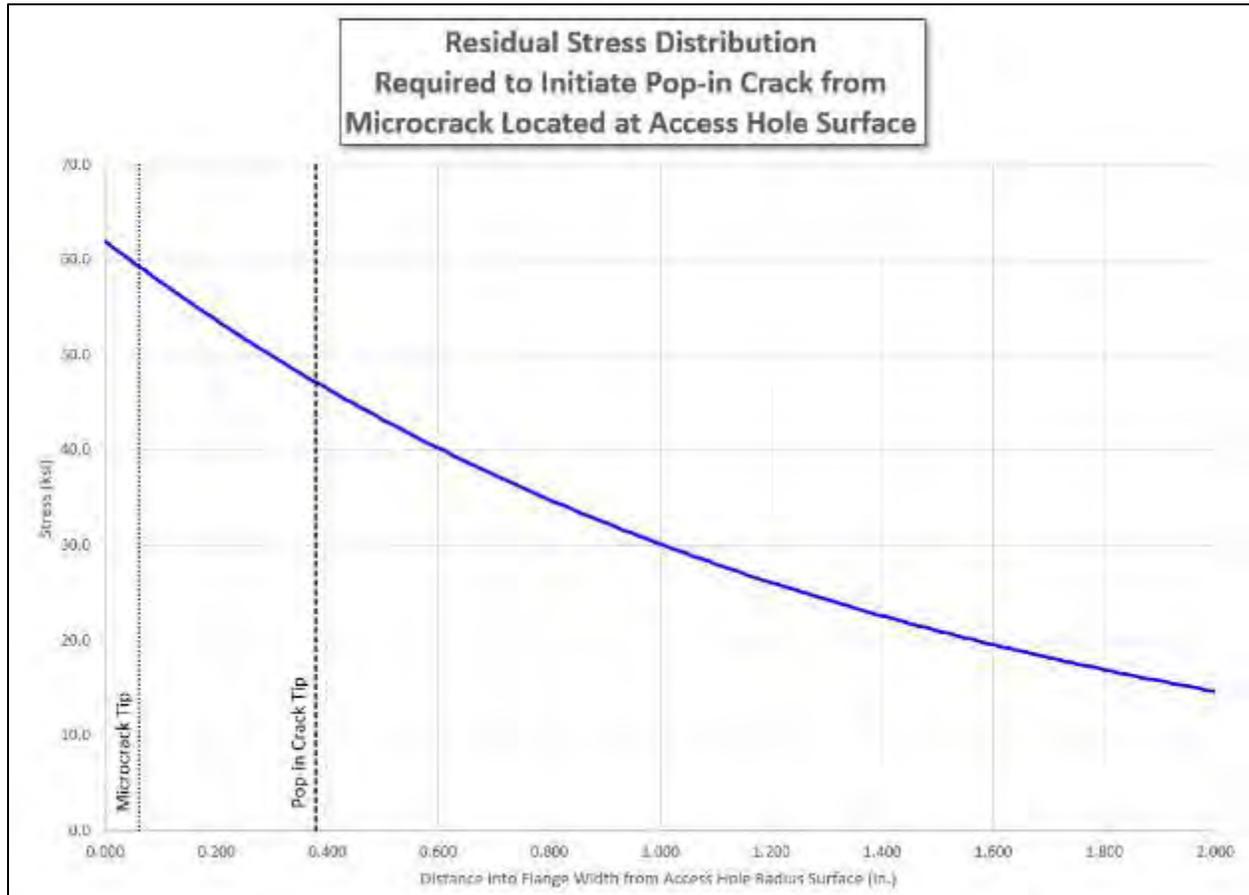
**Fig. 40. Approximate residual stress distribution necessary to cause pop-in crack initiation at a fracture toughness of approximately 30 ksi/in.**

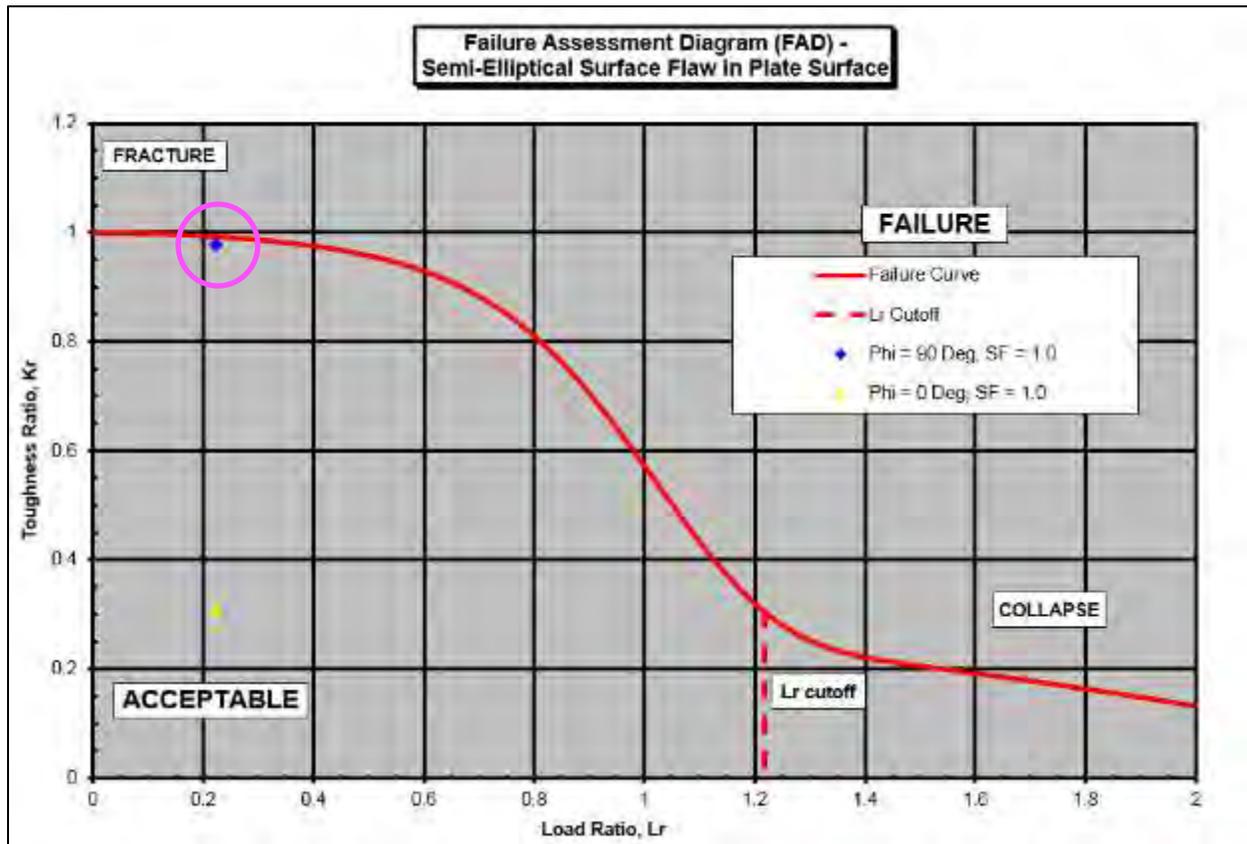
Fig. 41. Failure assessment diagram (FAD) showing pop-in crack initiation at the Fig. 40 residual stresses with a lower bound fracture toughness of approximately 30 ksi/in. See Fig. 39 for definition of Phi ( $\phi$ ). SF = Safety Factor.

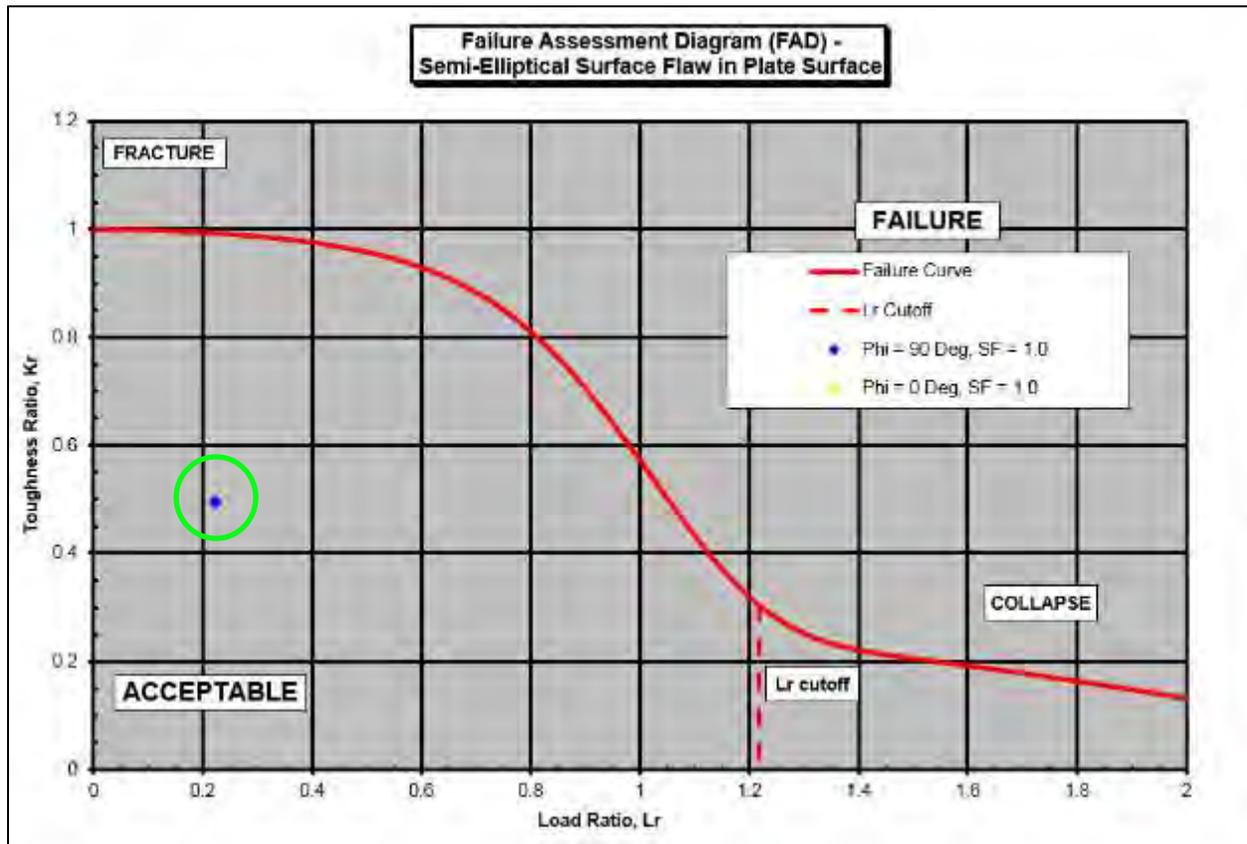
Fig. 42. Failure assessment diagram (FAD) demonstrating that pop-in crack initiation would not have occurred at the Fig. 40 residual stresses with an upper bound fracture toughness of approximately 55 to 60 ksi√in.

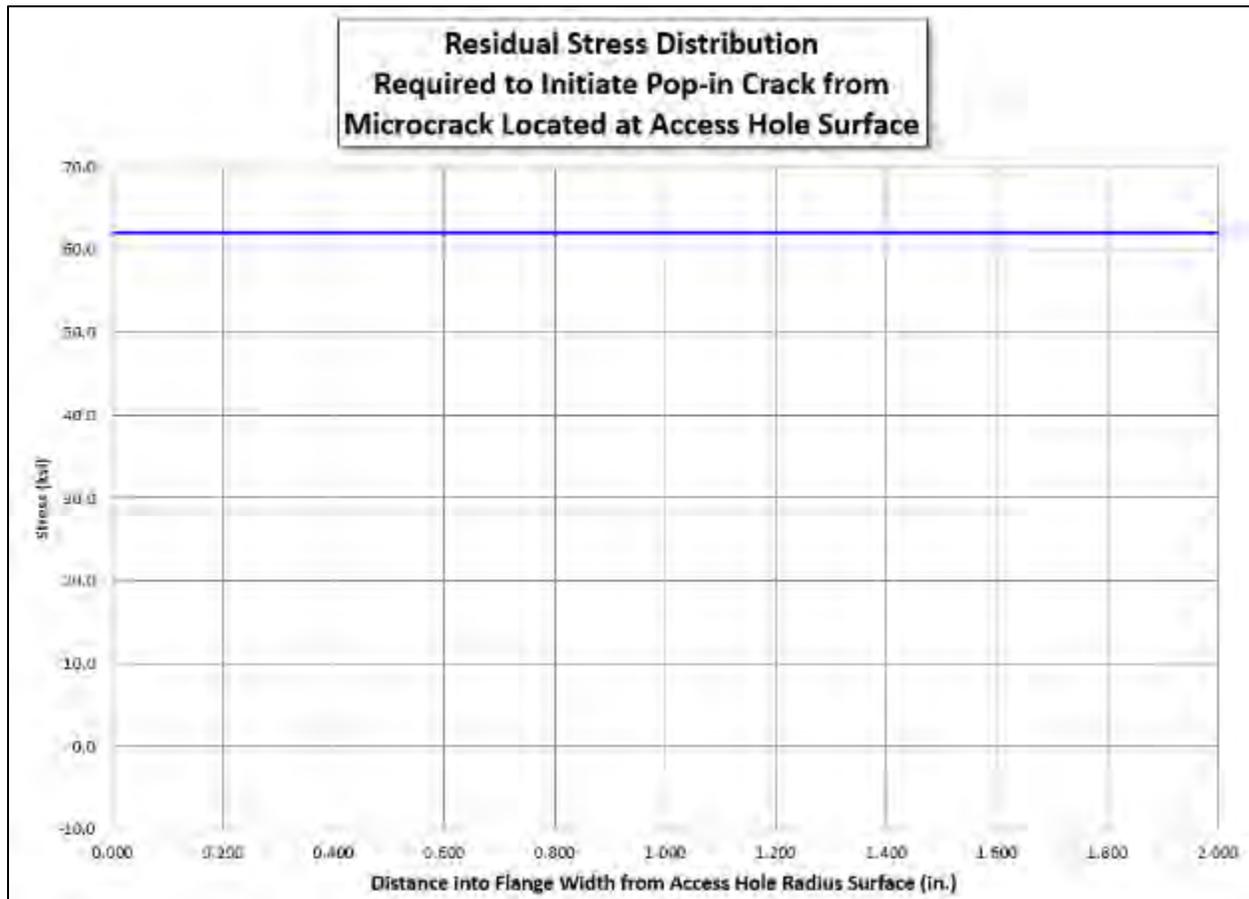
**Fig. 43. Residual stress distribution necessary to cause pop-in crack initiation at a fracture toughness of approximately 55 to 60 ksi/in.**

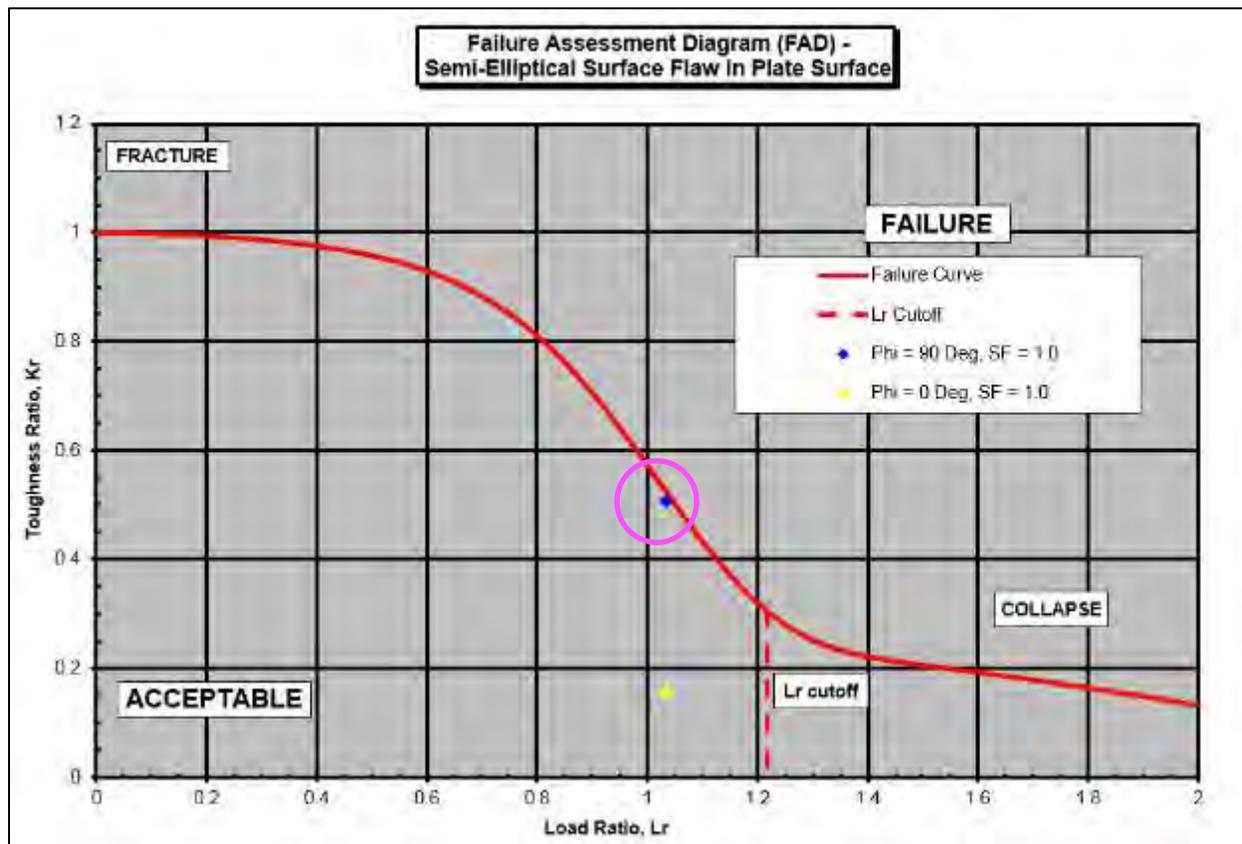
Fig. 44. Failure assessment diagram (FAD) demonstrating that pop-in crack initiation would have been ductile in nature under the Fig. 43 residual stresses with an upper bound fracture toughness of approximately 55 to 60 ksi/in.

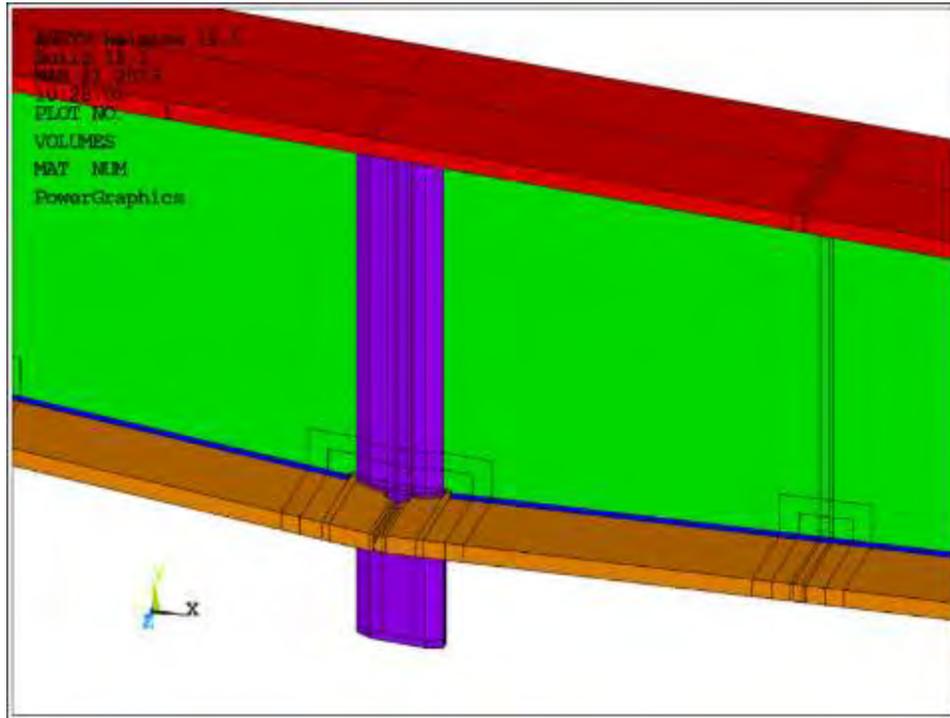
**Fig. 48. Girder solid model prior to groove welding the bottom flange plates together. Configuration is based on welding sequence provided to LPI. Note the absence of vertical stiffeners and welds between bottom flange and tapered hanger.**

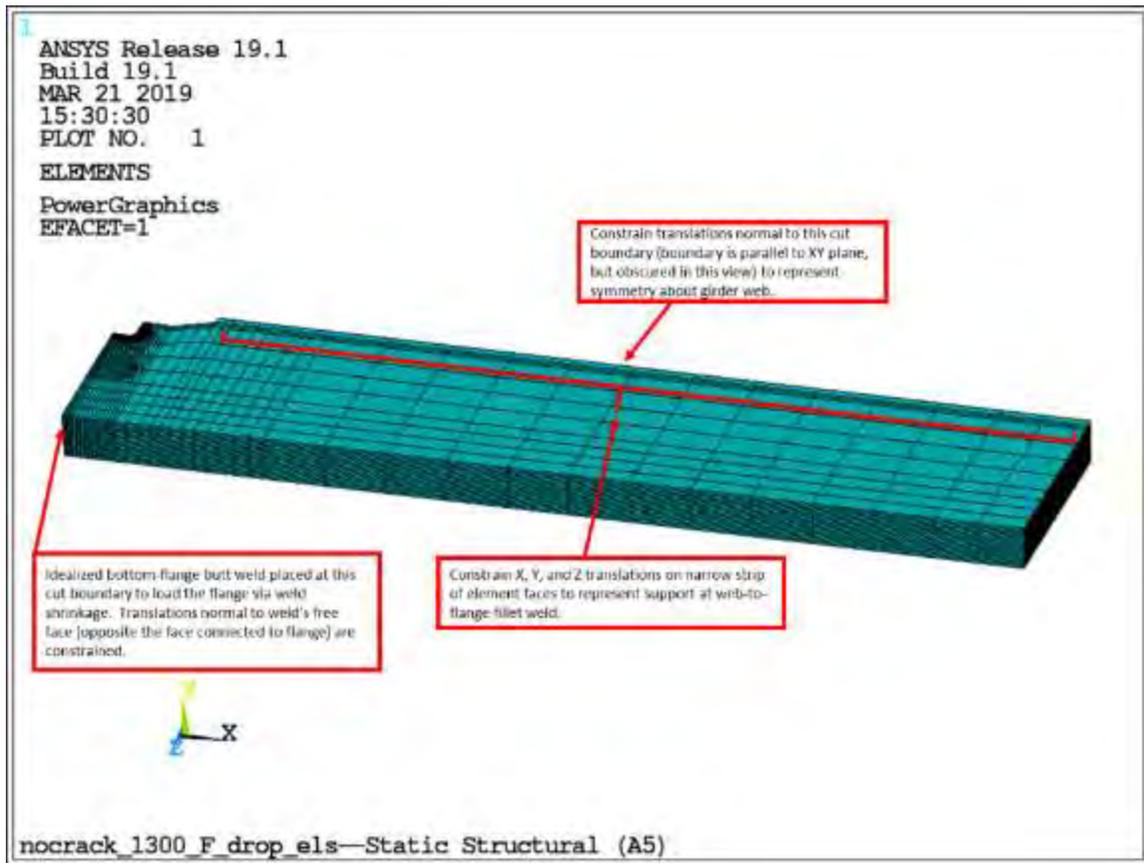
**Fig. 49. Boundary conditions for bottom-flange FE model. Boundary conditions represent the effect of support from neighboring structure.**

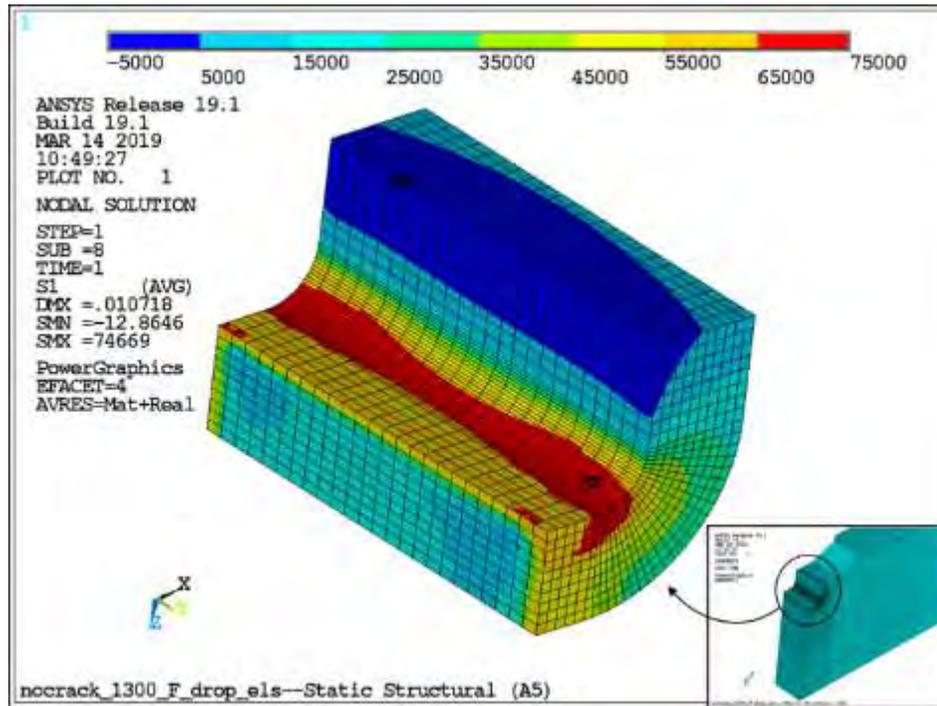
**Fig. 53. Distribution of maximum principal stress local to the weld access hole radius the in Fremont Street girder. Stress exceeds 65 ksi across the 4-in. thickness of bottom flange.**

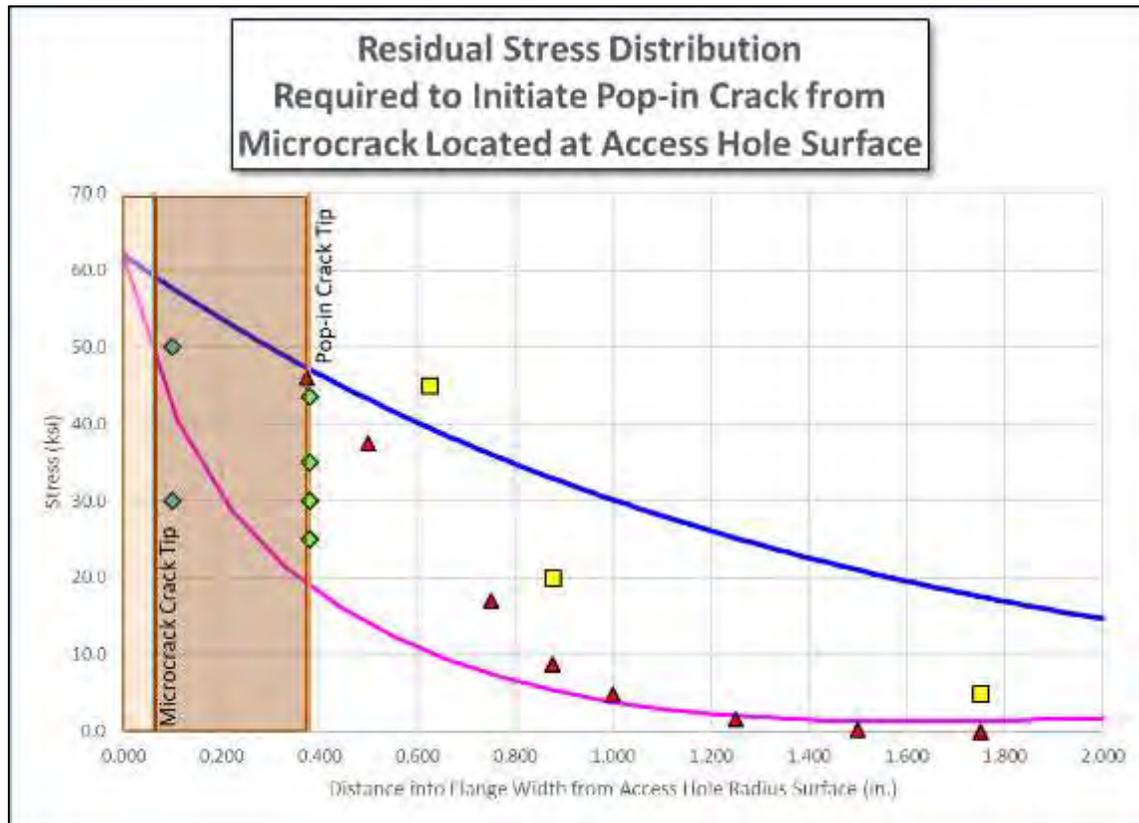
**Fig. 55. Residual stress distributions (curves) necessary to initiate pop-in cracking from the pre-existing microcracks. The blue curve is the upper bound, derived distribution and the purple curve is the thermal FE calculated distribution. These curves bound USACE experimental (yellow squares [18] and green diamonds [19]) and FE calculated (red triangles [18] and blue diamonds [19]) residual stress results.**

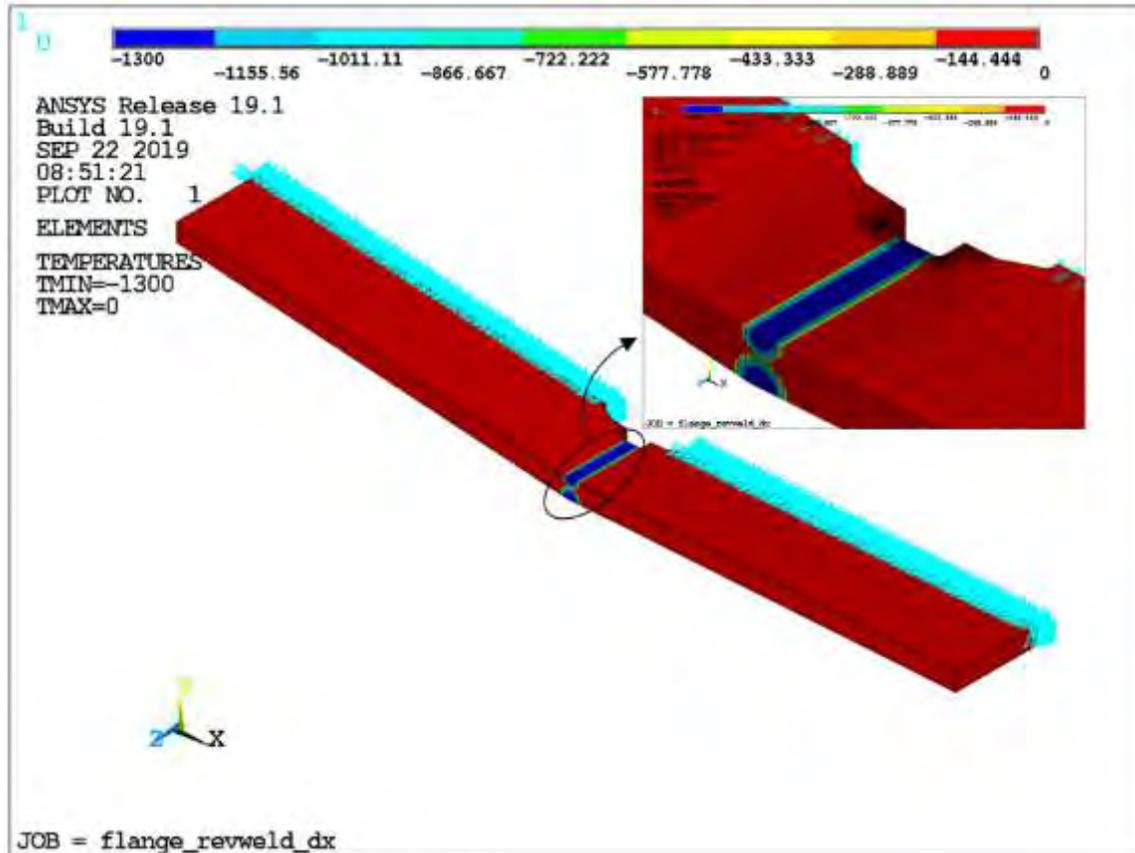
**Fig. 56. Local finite-element model of Fremont Street lower flange showing temperature-distribution contour. Boundary conditions are indicated by aqua-colored symbols and are as described in Section 4.1.3.1.**

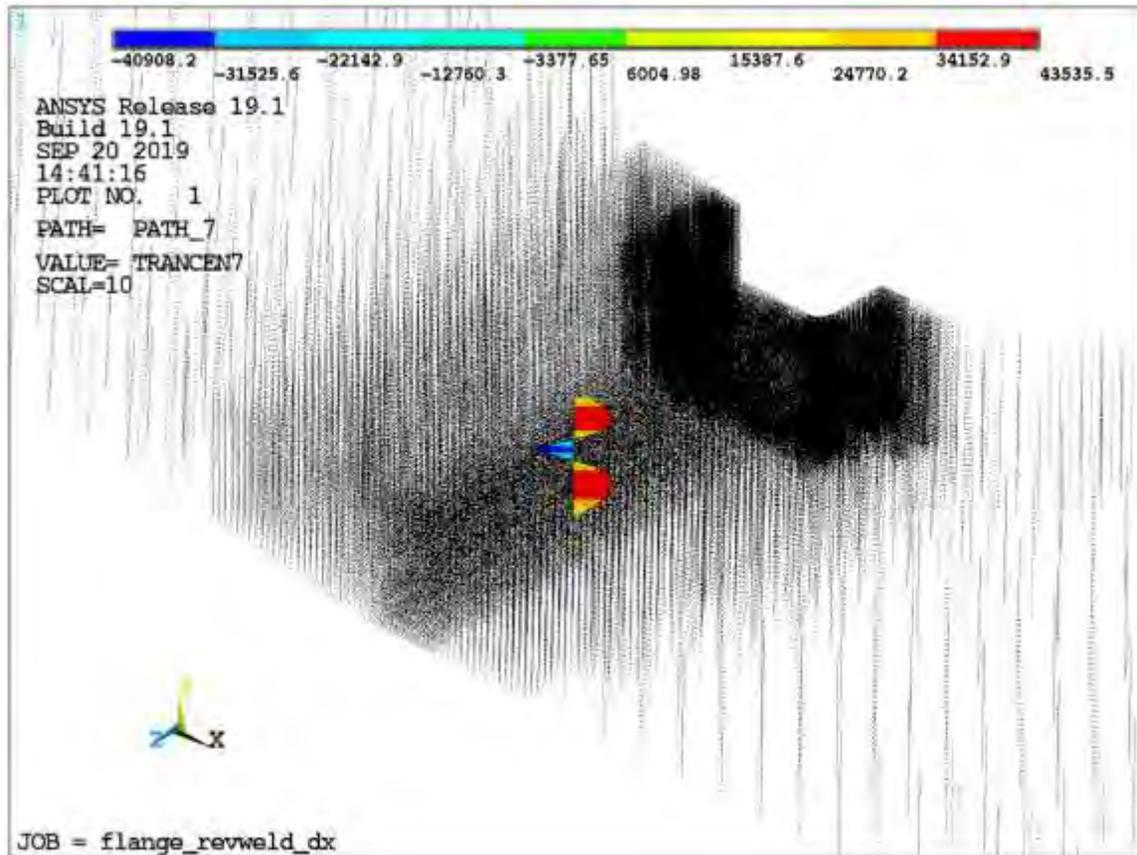
**Fig. 60.** Through-thickness distribution of calculated transverse residual stress at center of flange groove weld. Note similarity of distribution compared to transverse-stress plot shown in Fig. 58.

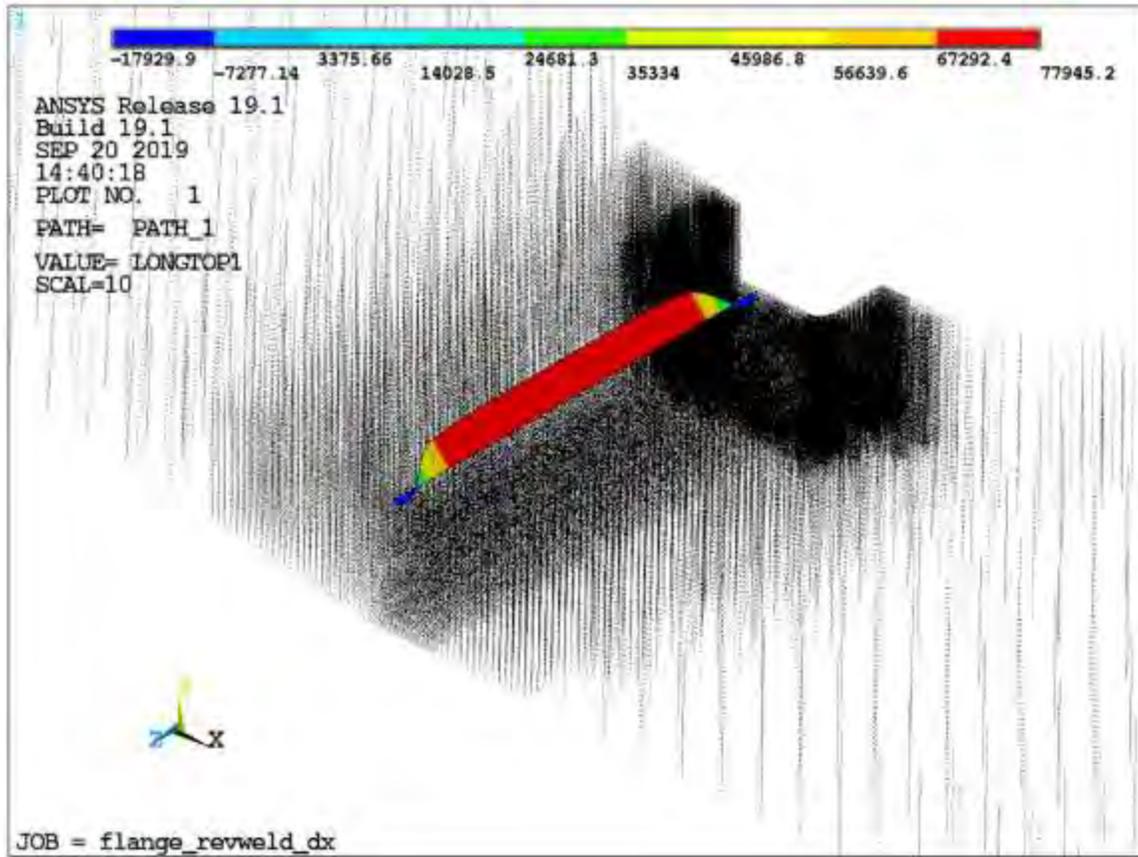
Fig. 61. Longitudinal distribution of longitudinal residual stress, outer surface of Fremont Street lower flange, at groove weld.

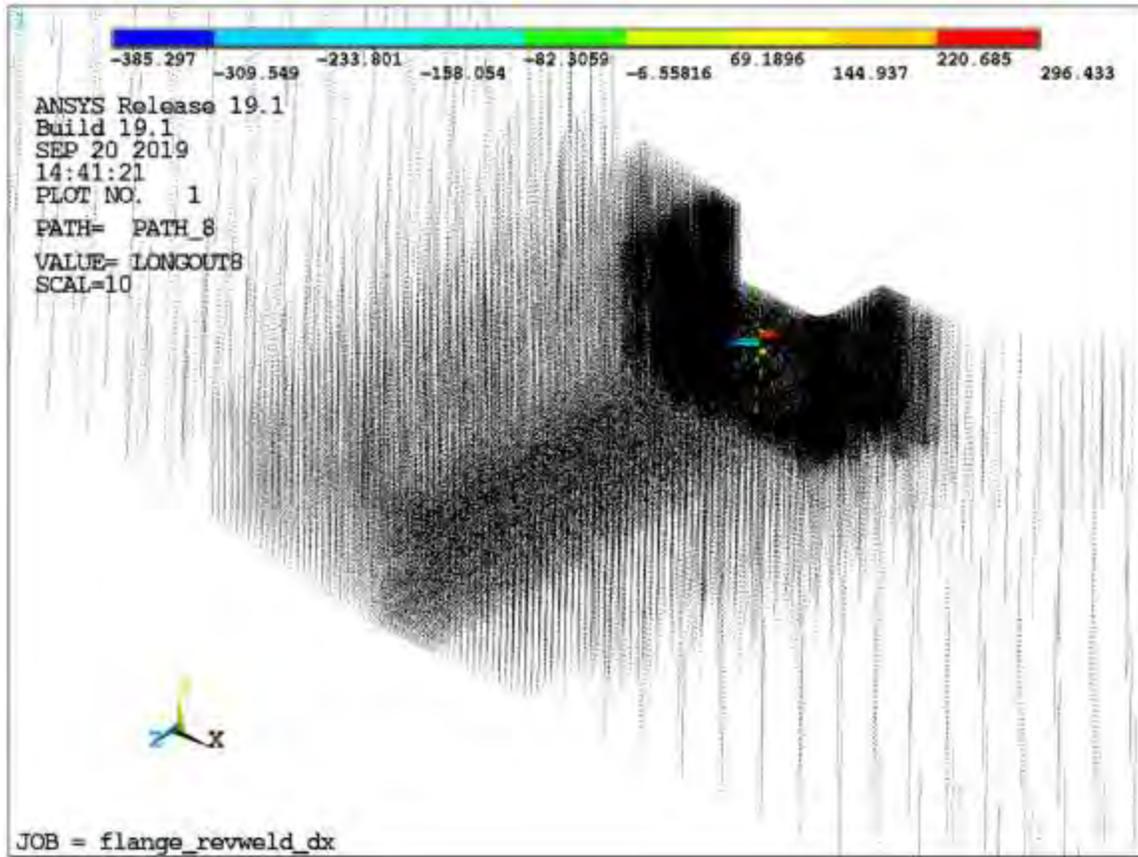
**Fig. 64.** Through-thickness distribution of longitudinal residual stress at end of groove weld nearest access-hole radii. Near-zero magnitudes consistent with the free-surface condition.

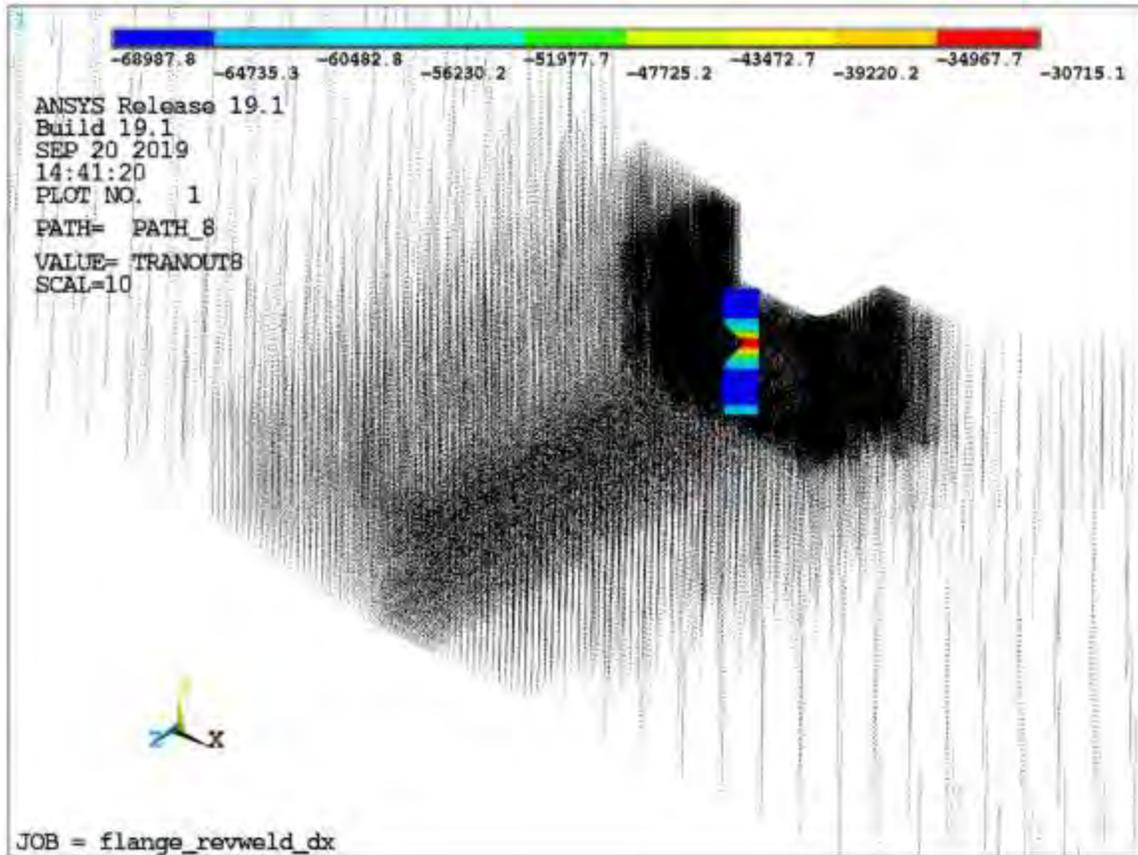
**Fig. 65. Through-thickness distribution of transverse residual stress at end of groove weld nearest access-hole radii. Stresses are compressive, though of variable magnitude.**

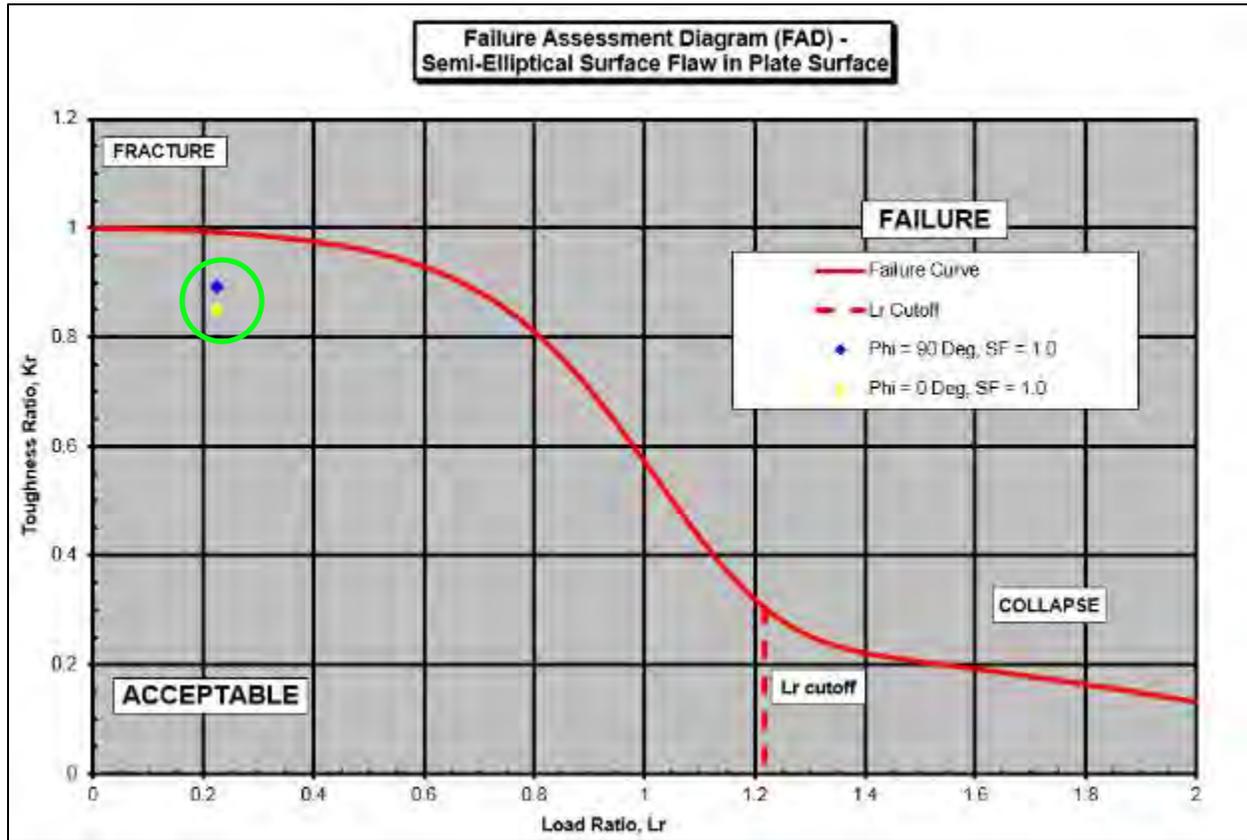
Fig. 68. Failure assessment diagram (FAD) demonstrating that pop-in crack propagation would arrest at a depth of 0.38 in. under the Fig. 40 residual stresses with a crack arrest fracture toughness of approximately 55 to 60 ksi/in.

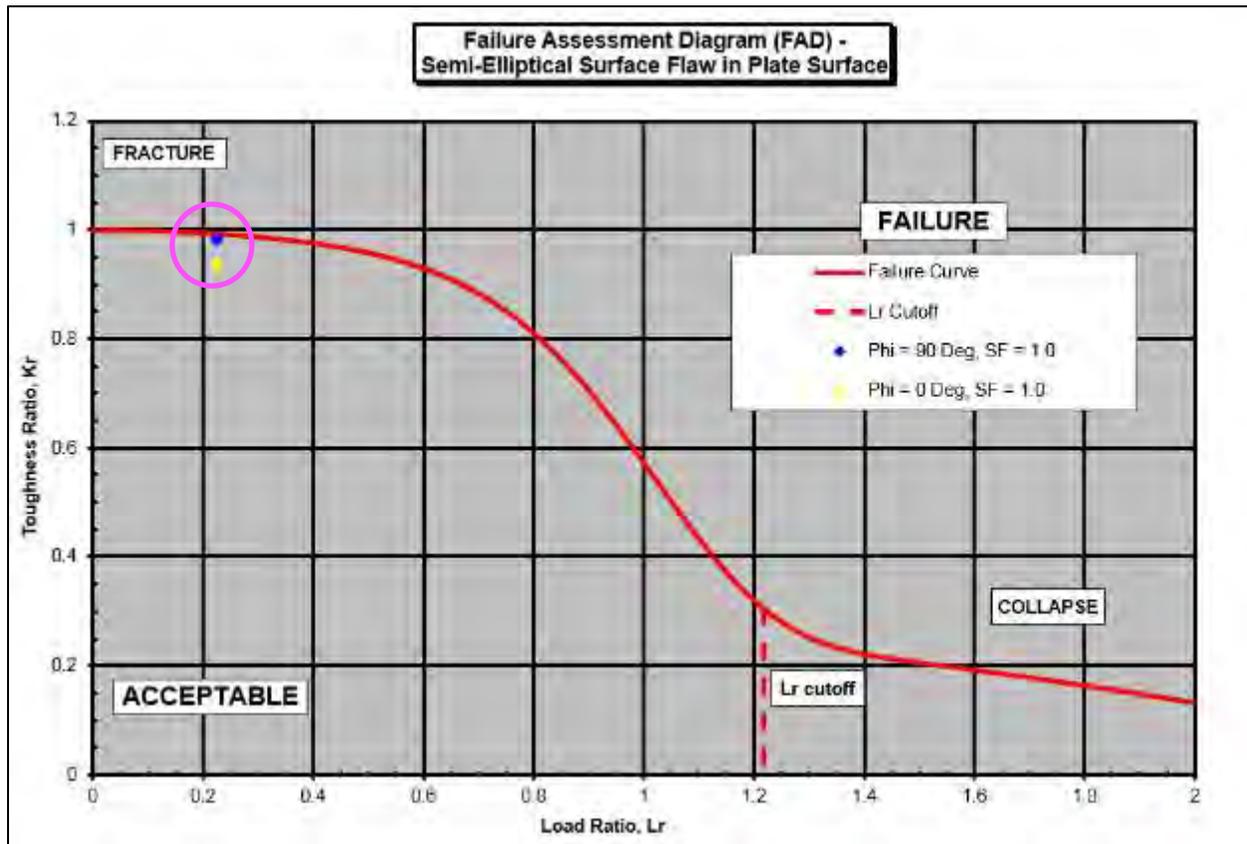
Fig. 69. Failure assessment diagram (FAD) demonstrating that pop-in crack propagation would not arrest at a depth of 0.38 in. under the Fig. 40 residual stresses with a crack arrest fracture toughness lower than approximately 50 ksvin.
