**LPI, Inc. Consulting Engineers**

*Advanced Analysis & Fitness for Service  
Failure & Materials Evaluation  
Nondestructive Engineering*

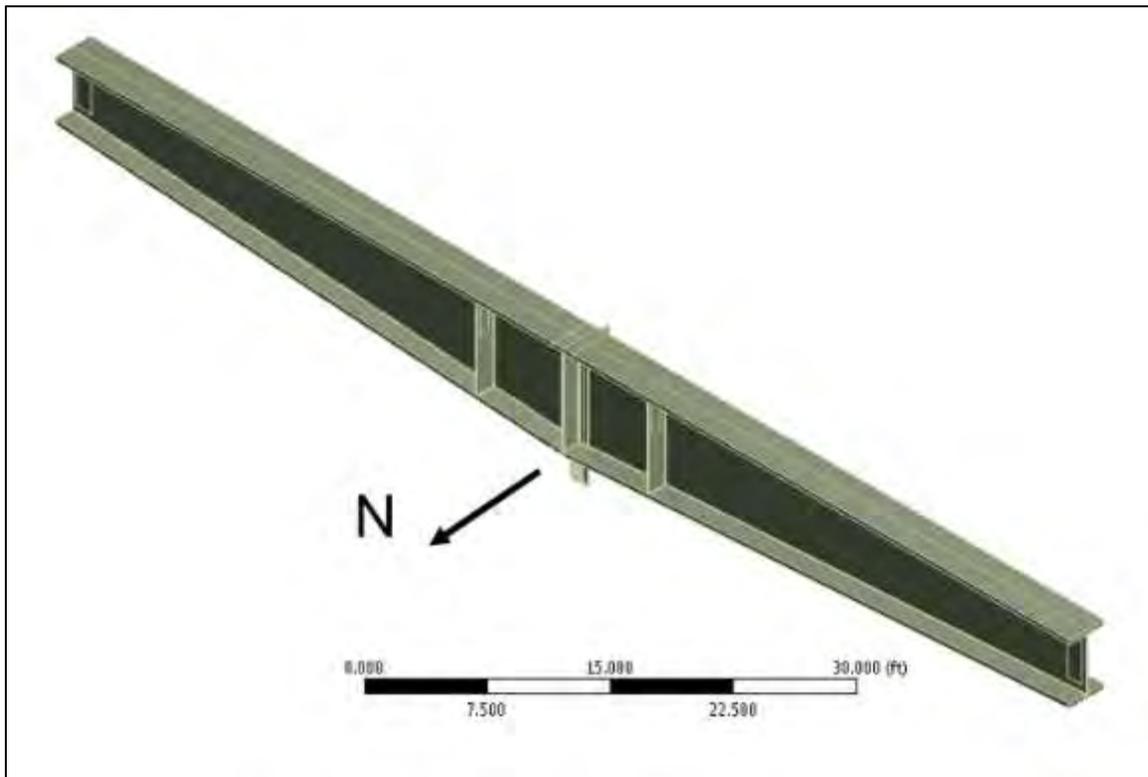
Fig. 70. TPG3 girder geometric model – Fremont Street D.4 line

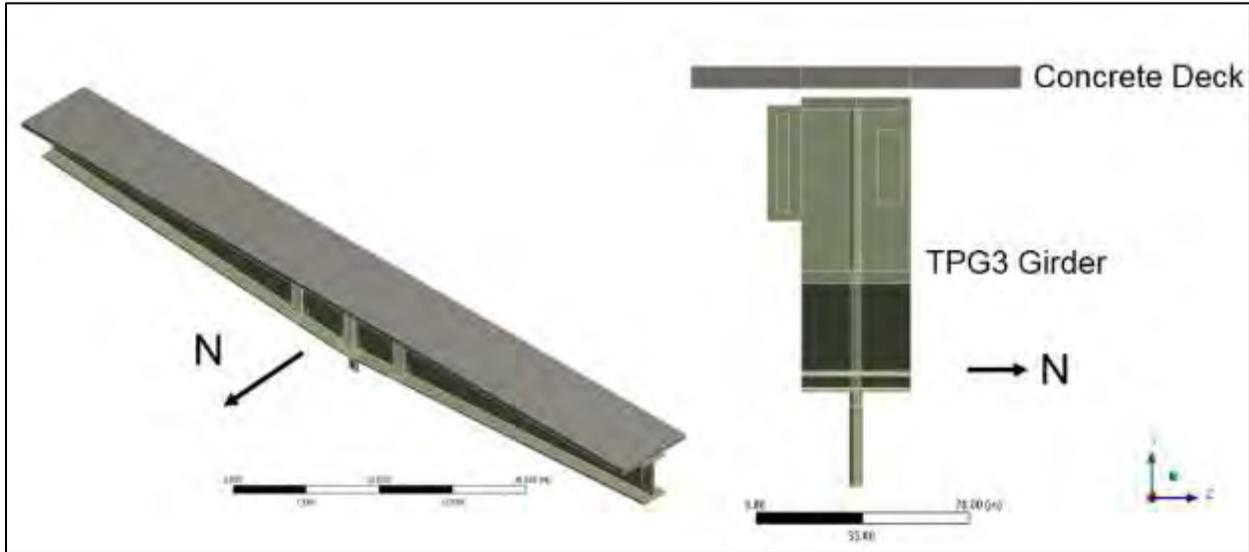
**Fig. 71. Composite TPG3 girder geometric model with the concrete deck included – Fremont Street D.4 line**

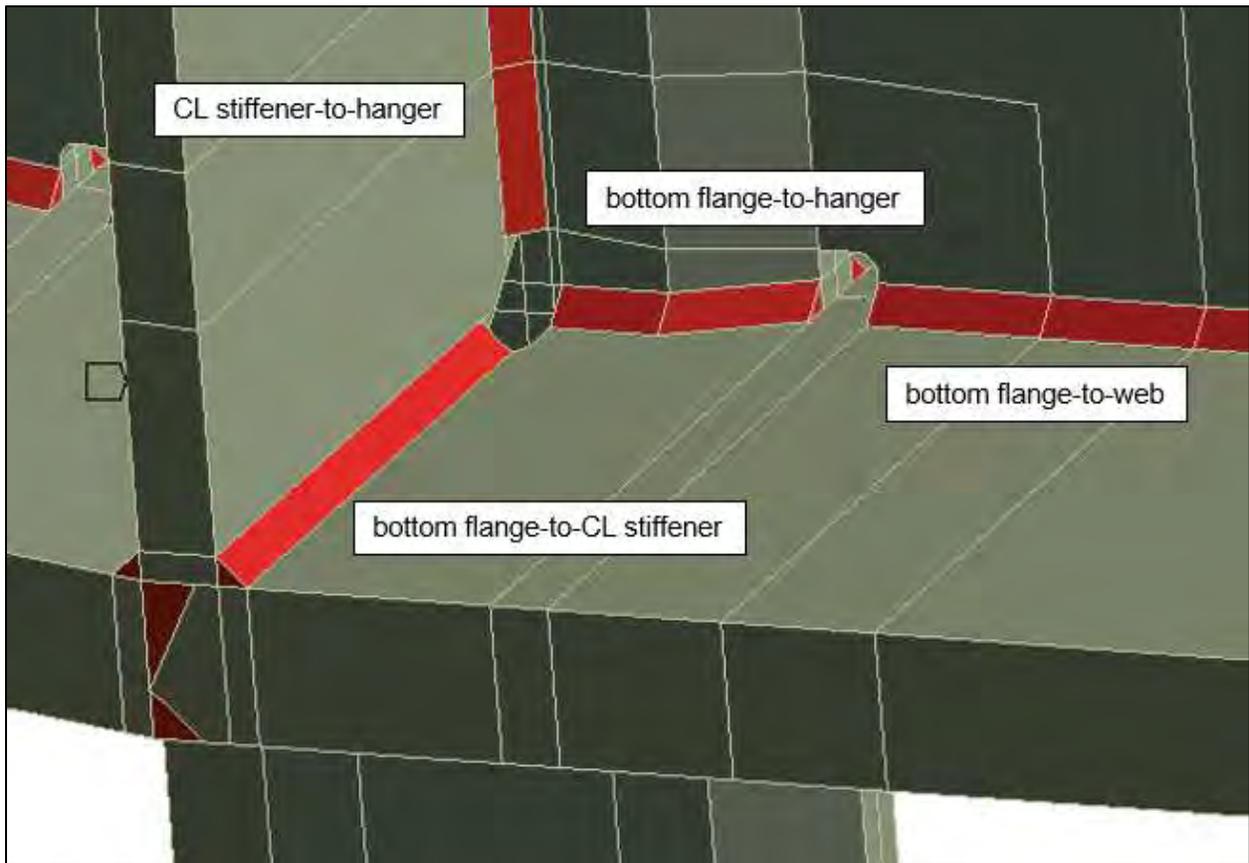
**Fig. 72. Fillet welds in the region of interest near the weld access holes (3/4 in. leg length).**

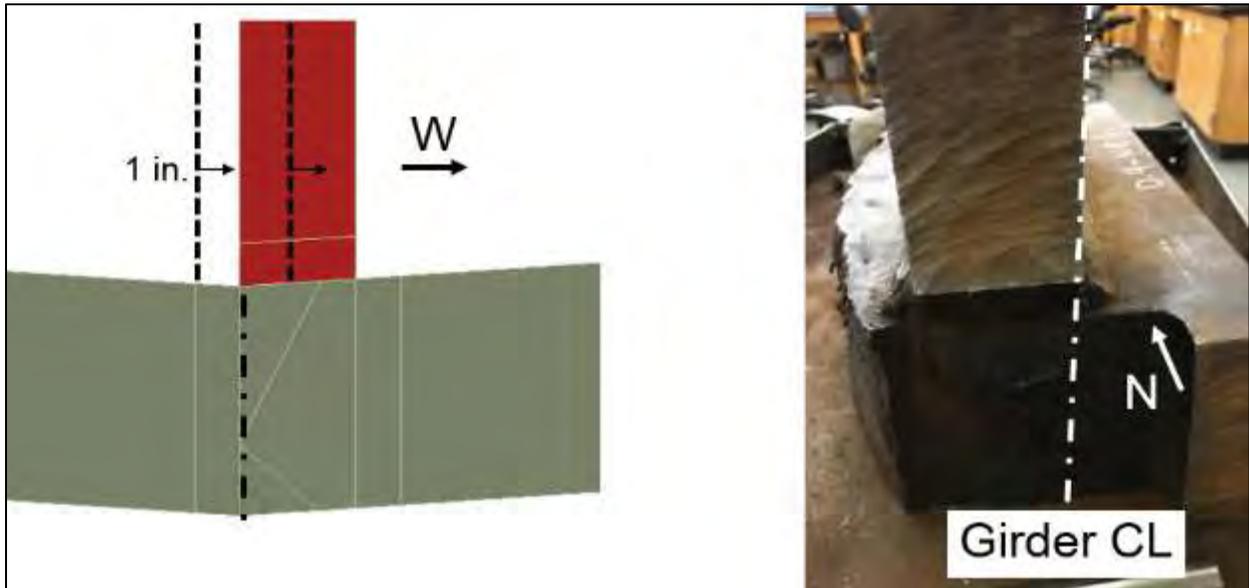
Fig. 74. CL stiffener offset 1 in. to the west of the TPG3 girder CL on the Fremont Street D.4 line

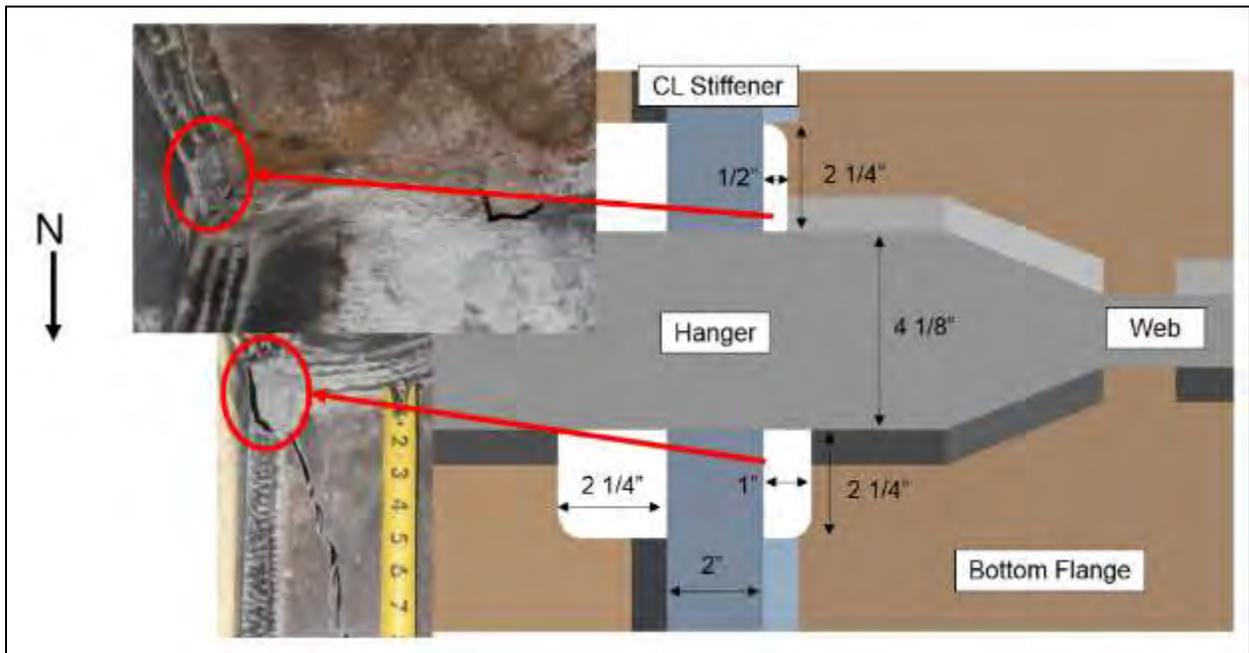
Fig. 75. Weld access hole dimensions for the TPG3 girder on the Fremont Street D.4 line. Note that Appendix D contains all relevant TPG3 girder dimensions.

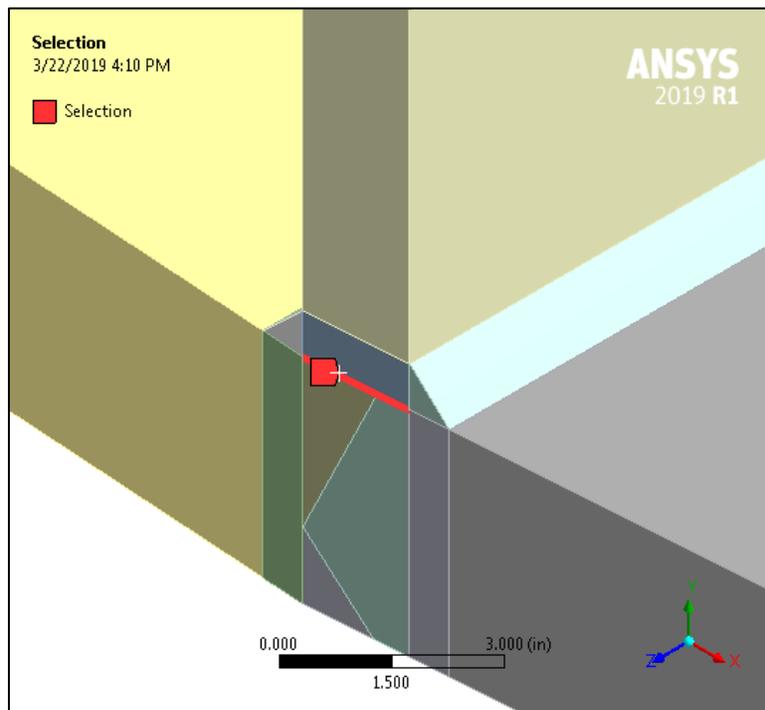
**Fig. 79. Instance of frictionless faying contact shown by red-highlighted edge.**

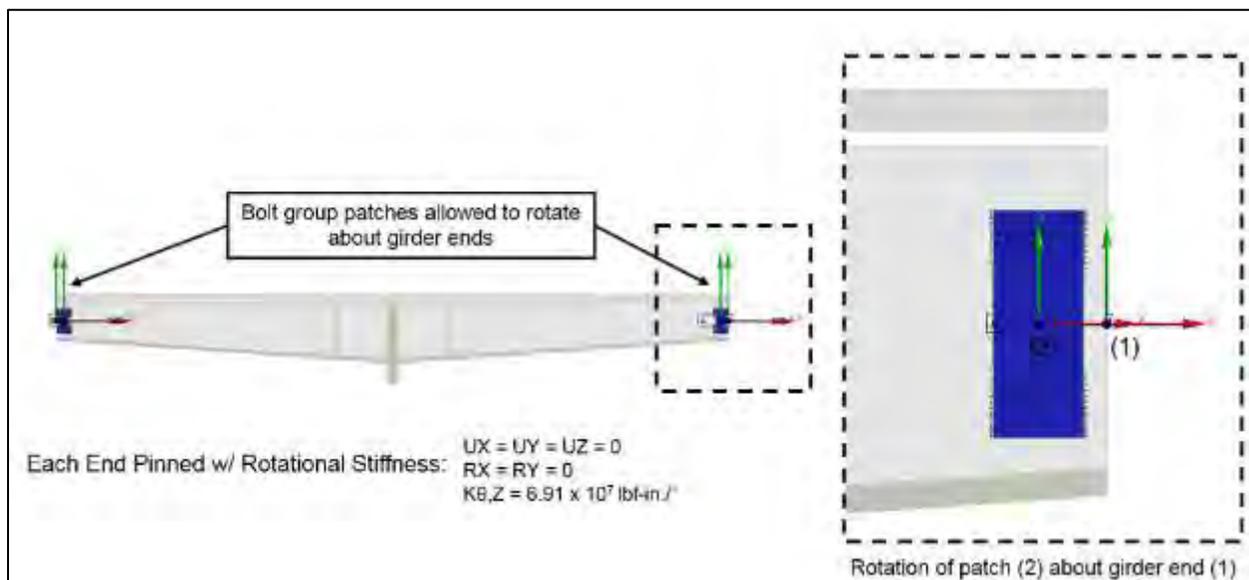
Fig. 80. End boundary conditions showing pinned connections with rotational constraint of the bolt group patches about the girder ends.

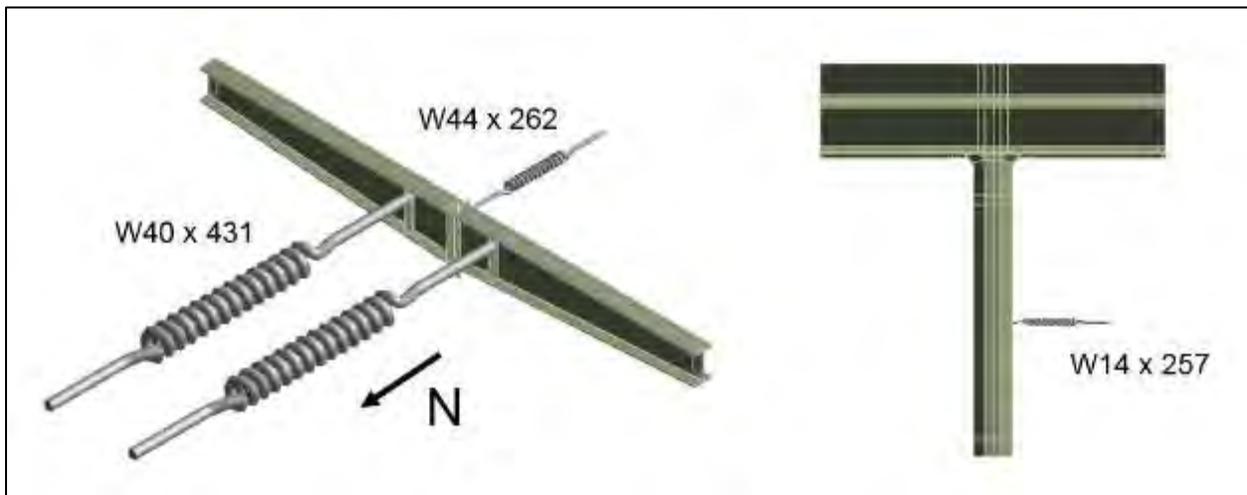
**Fig. 81. Lateral constraint boundary conditions. An equivalent linear spring was attached to each respective bolt group patch.**

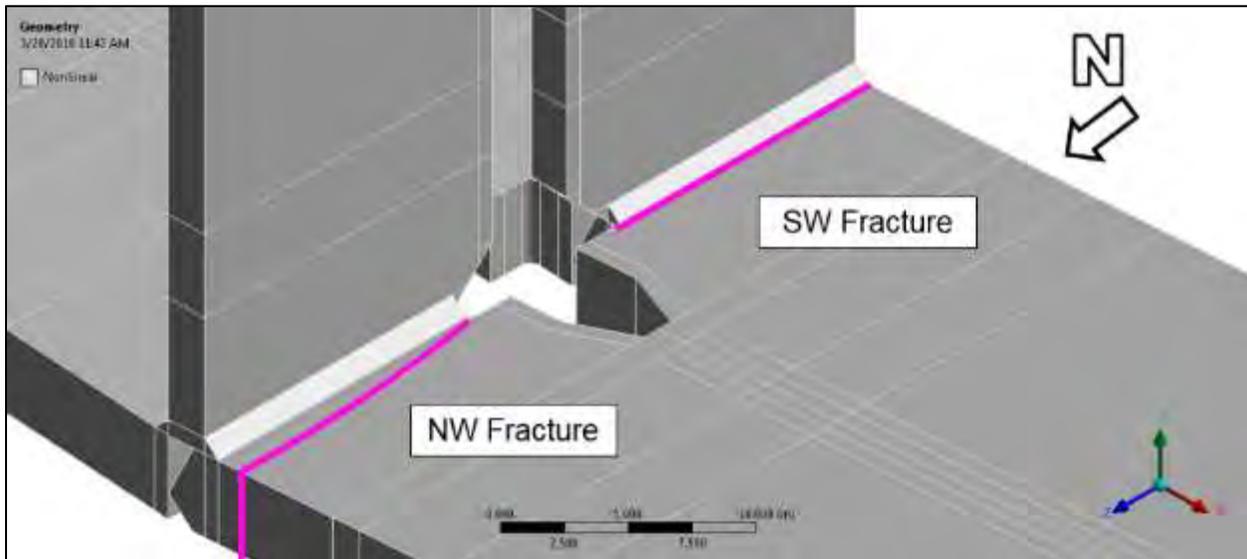
**Fig. 84. Fremont Street D.4 FE model with both the NW and SW fractures included (highlighted in purple). Note that only the bottom flange, CL stiffeners, and welds are shown.**

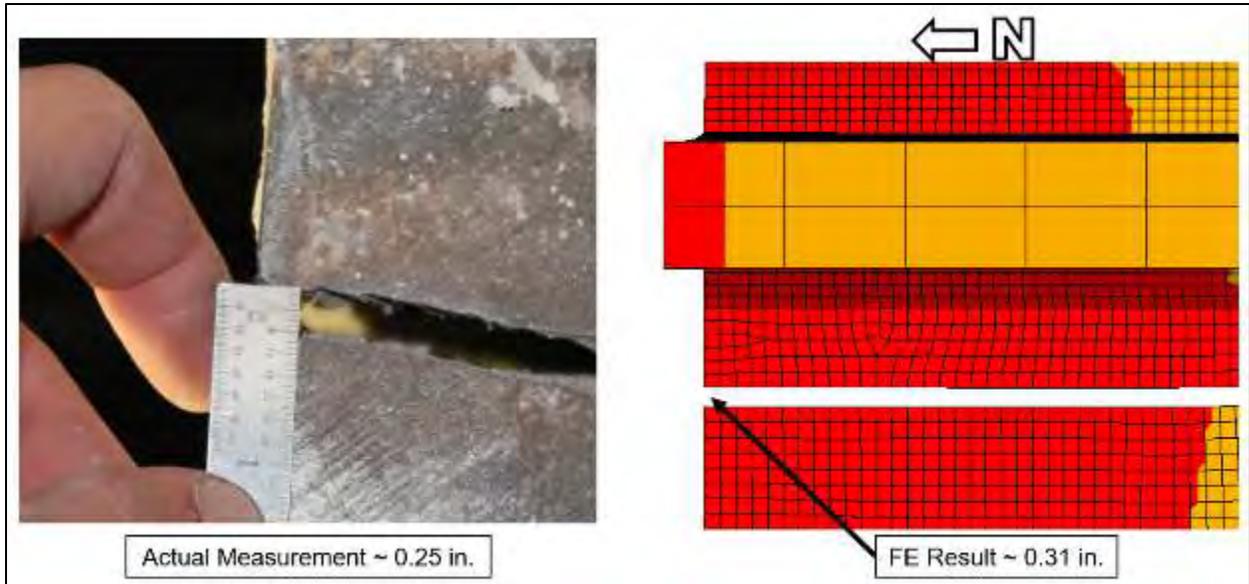
**Fig. 85. Fremont Street D.4 crack opening comparison between the measured crack opening and the FE crack opening results – NW fracture at 1.0(DL+SDL) + 1.0(LL).**

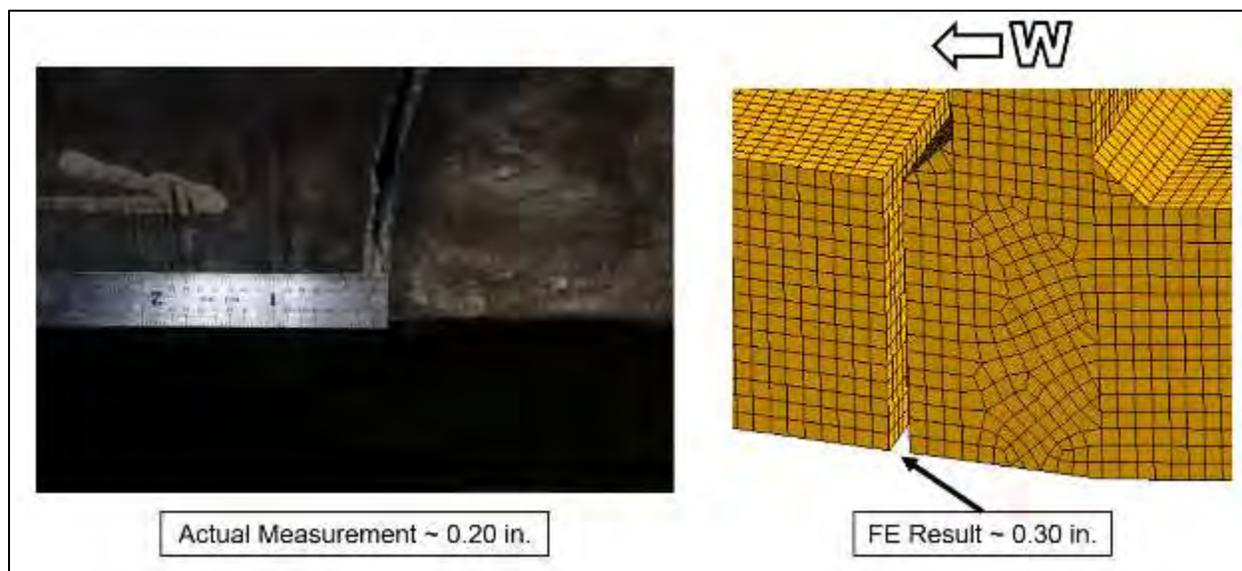
**Fig. 86. Fremont Street D.4 crack opening comparison between the measured crack opening and the FE crack opening results – SW fracture at 1.0(DL+SDL) + 1.0(LL).**

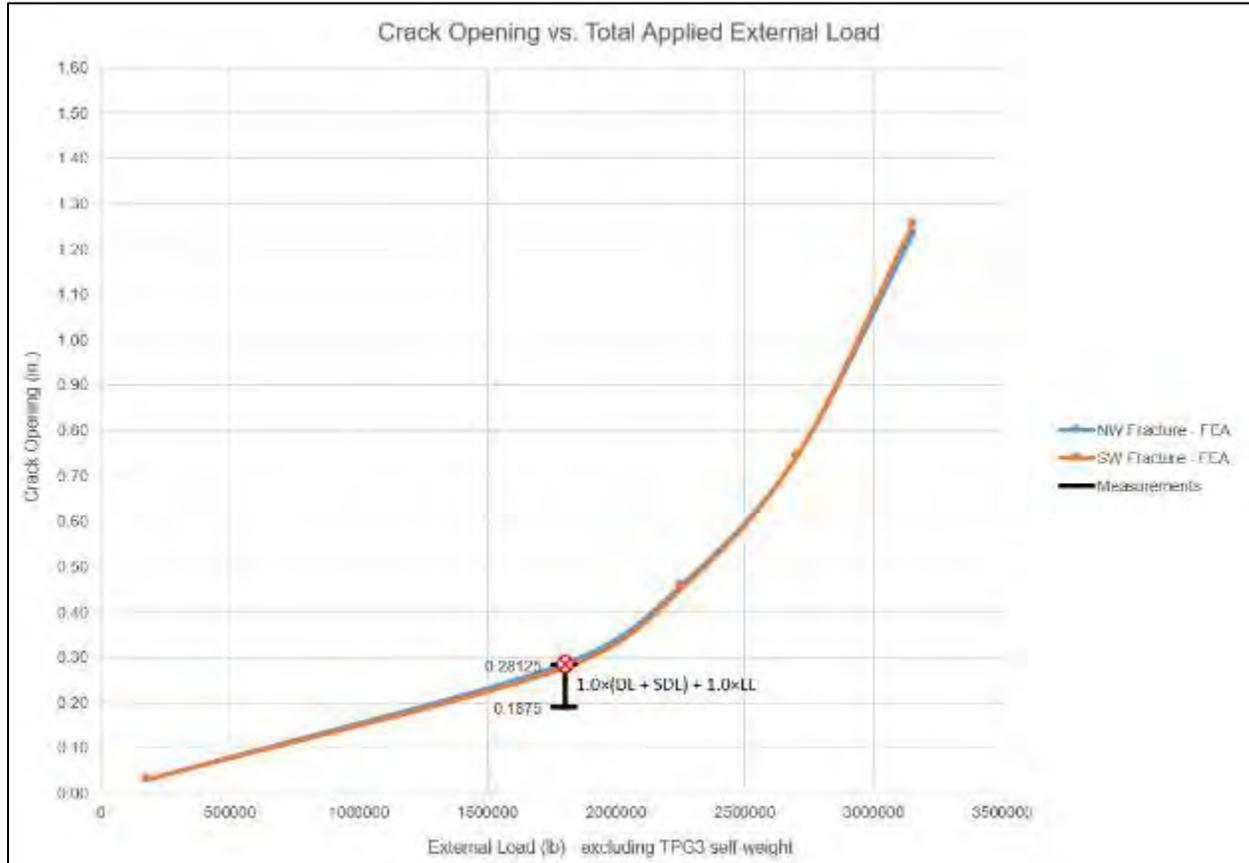
Fig. 87. Fremont Street D.4 crack opening sensitivity to total applied load.

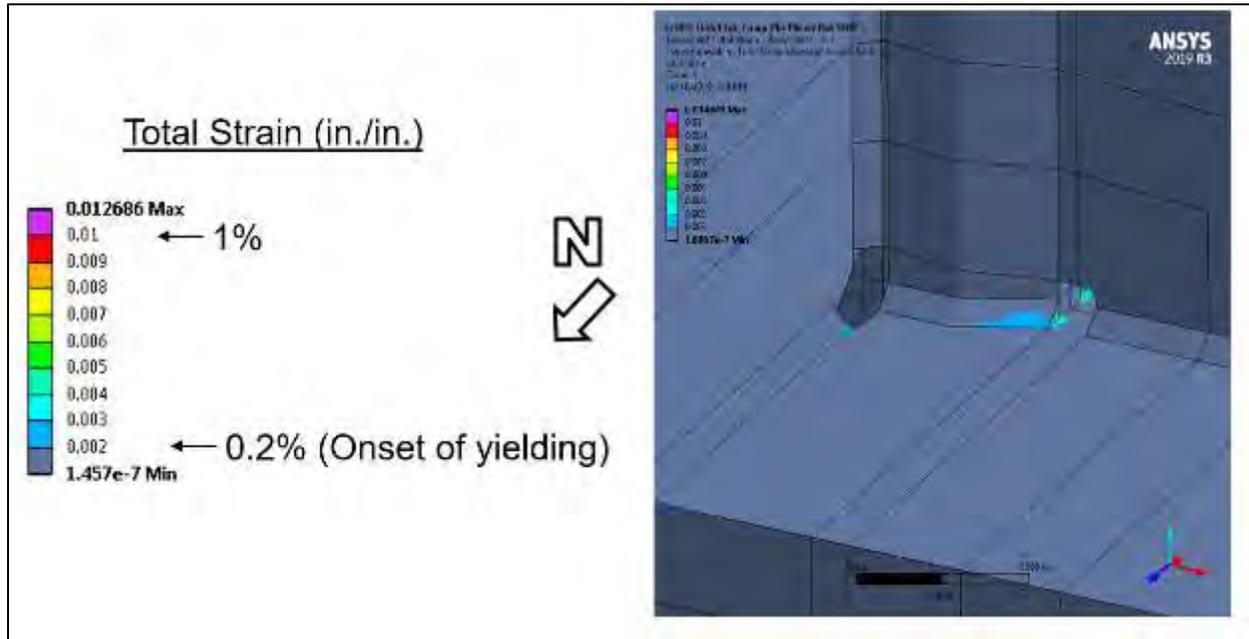
**Fig. 88. Total strain (in./in.) near the NW weld access hole indicating only localized areas at fillet weld toes exceeded the material yield strength (grey is below yield) at 1.0(DL+SDL) + 1.0(LL).**

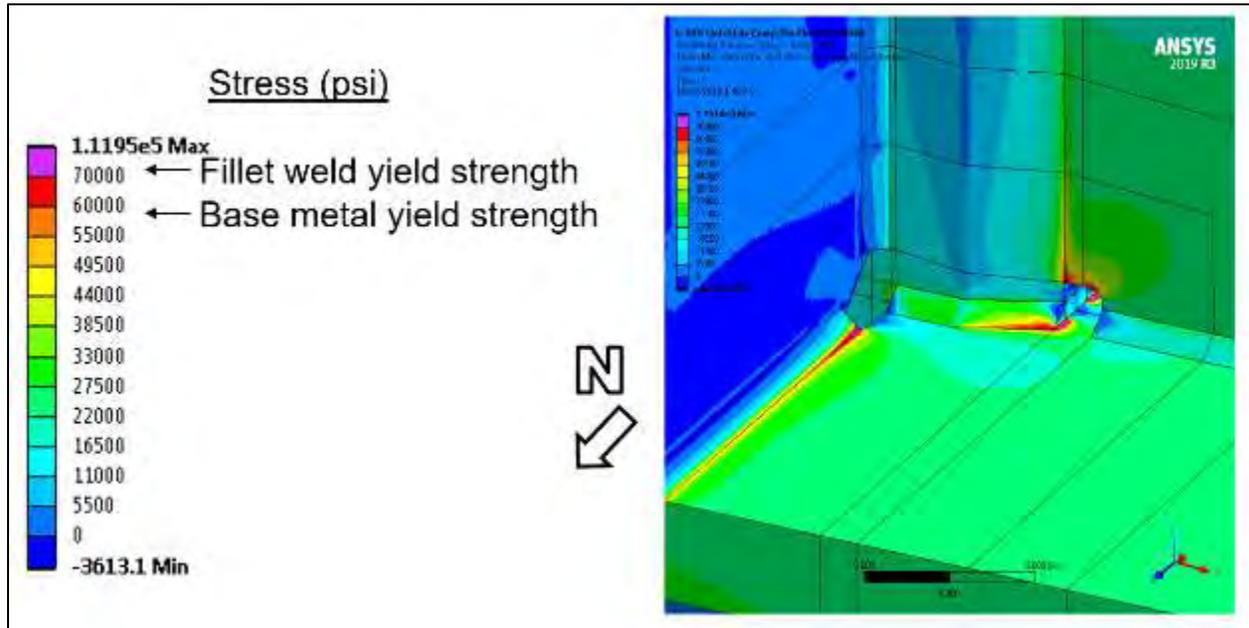
Fig. 89. Maximum principal stress (psi) near the NW weld access hole indicating only localized areas experienced tensile stresses that exceeded the material yield strength at 1.0(DL+SDL) +1.0(LL).

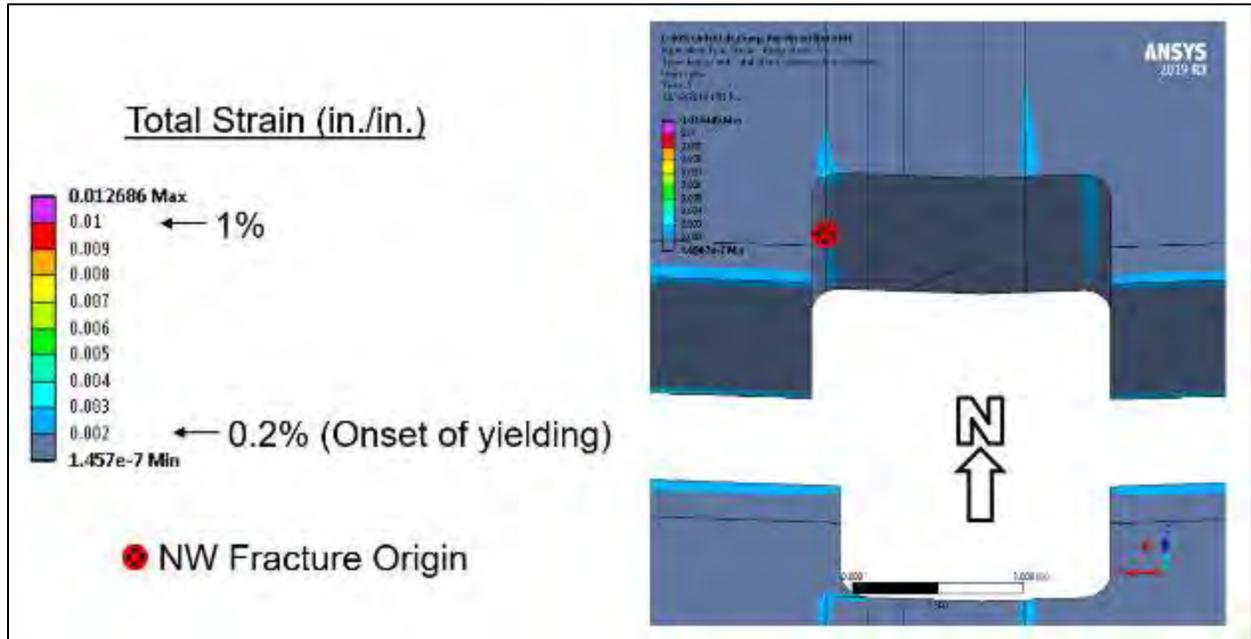
Fig. 90. D.4 north bottom flange weld access hole total strain (in./in.) with the NW fracture origin highlighted (red circle) at loading corresponding to 1.0(DL+SDL) + 1.0(LL). Contour plot is at an angled view looking into the access hole with the hanger removed.

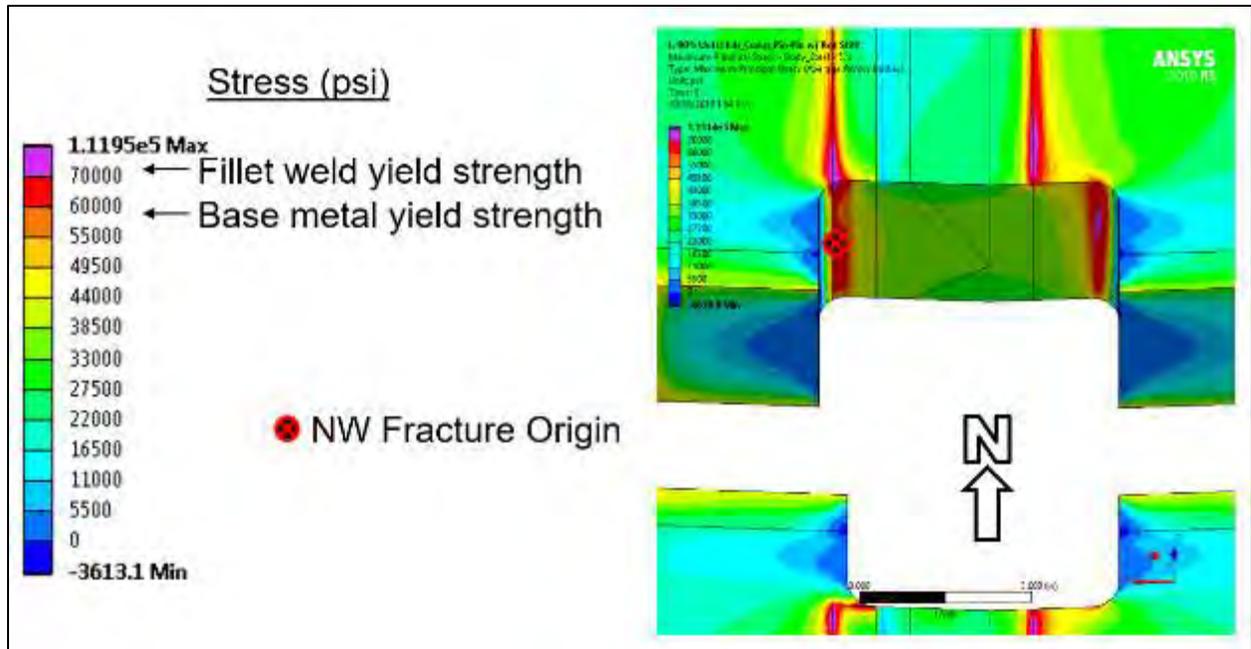
Fig. 91. D.4 north bottom flange weld access hole maximum principal stress (psi) with the NW fracture origin highlighted at 1.0(DL+SDL) + 1.0(LL). Contour plot is at an angled view looking into the access hole with the hanger removed.

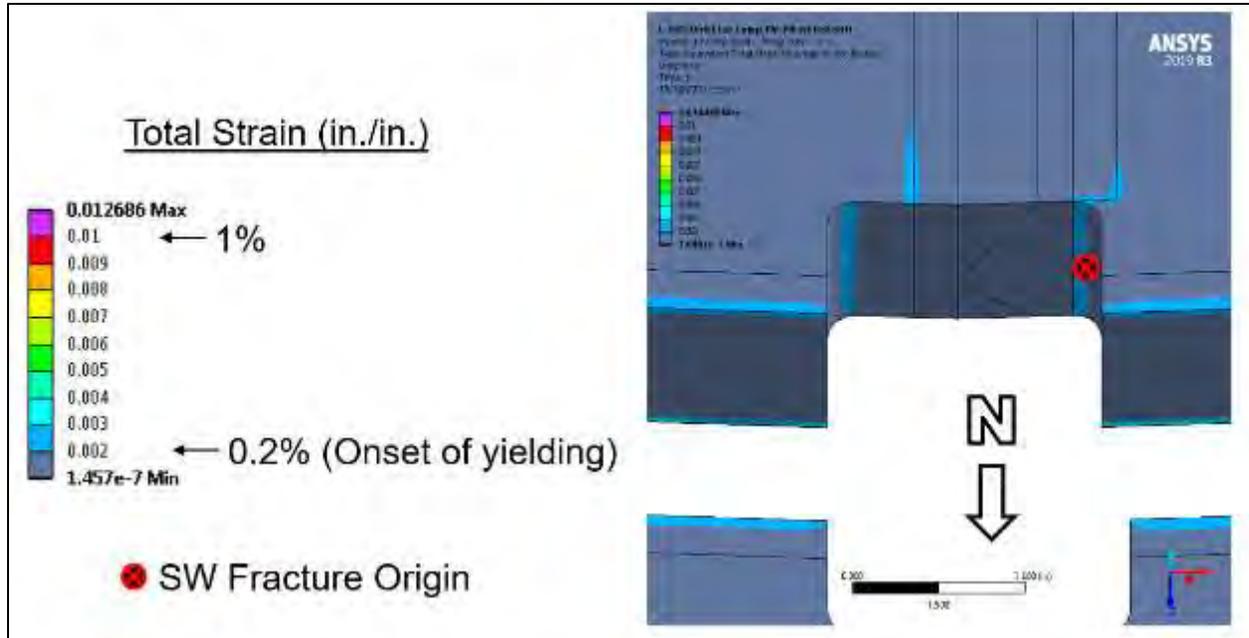
**Fig. 92. South bottom flange weld access hole total strain (in./in.) with the SW fracture origin highlighted at 1.0(DL+SDL) + 1.0(LL). Contour plot is at an angled view looking into the access hole with the hanger removed.**

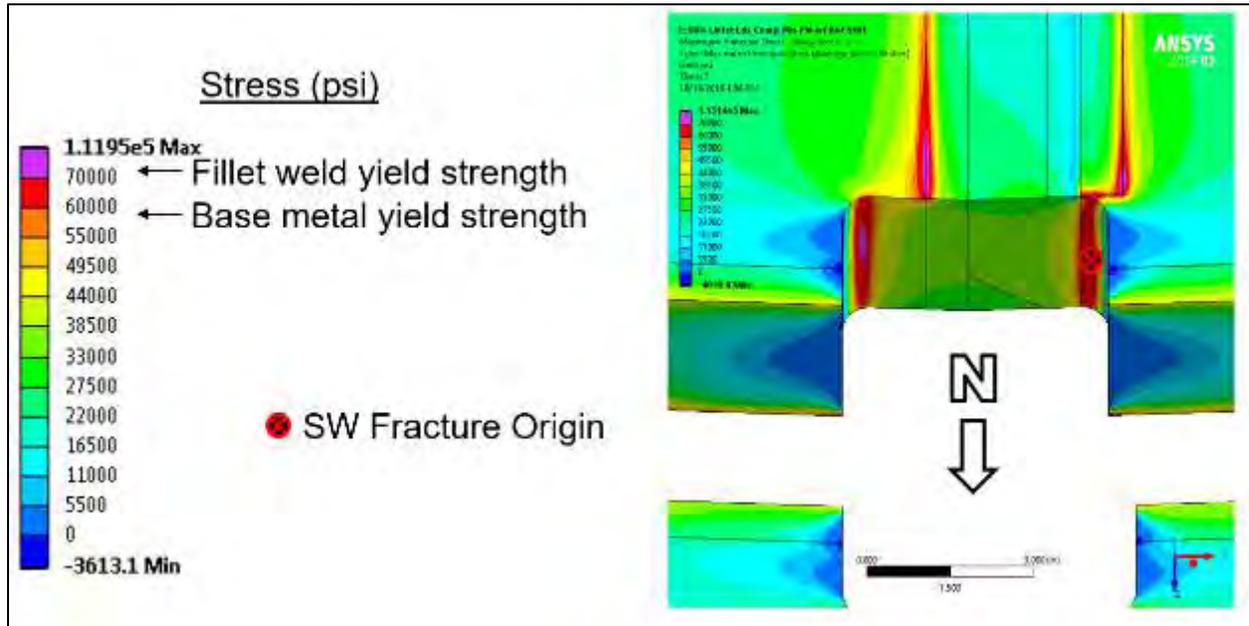
**Fig. 93. South bottom flange weld access hole maximum principal stress (psi) with the SW fracture origin highlighted at 1.0(DL+SDL) + 1.0(LL). Contour plot is at an angled view looking into the access hole with the hanger removed.**

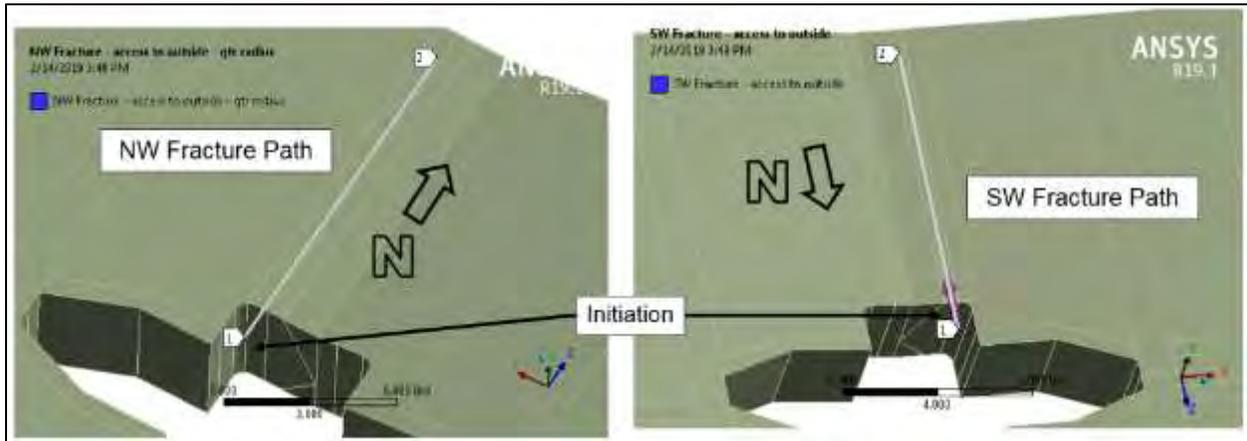
**Fig. 94. Stress paths through the mid-thickness of the bottom flange originating at the NW and SW weld access hole fracture initiation sites.**

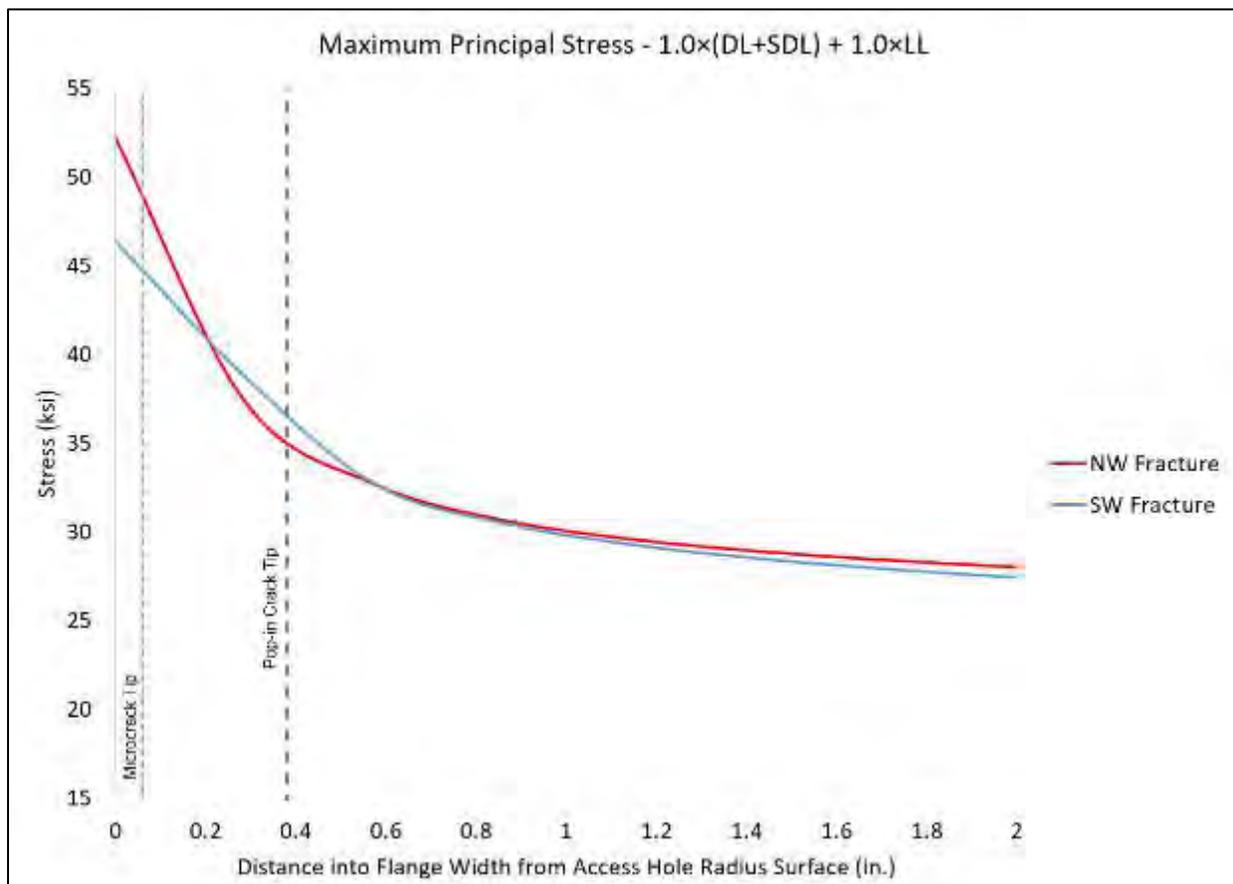
**Fig. 95. Maximum principal stress along the NW and SW fracture paths (shown in Fig. 94). The relative locations on the microcrack and pop-in crack tips are identified by dashed vertical lines.**

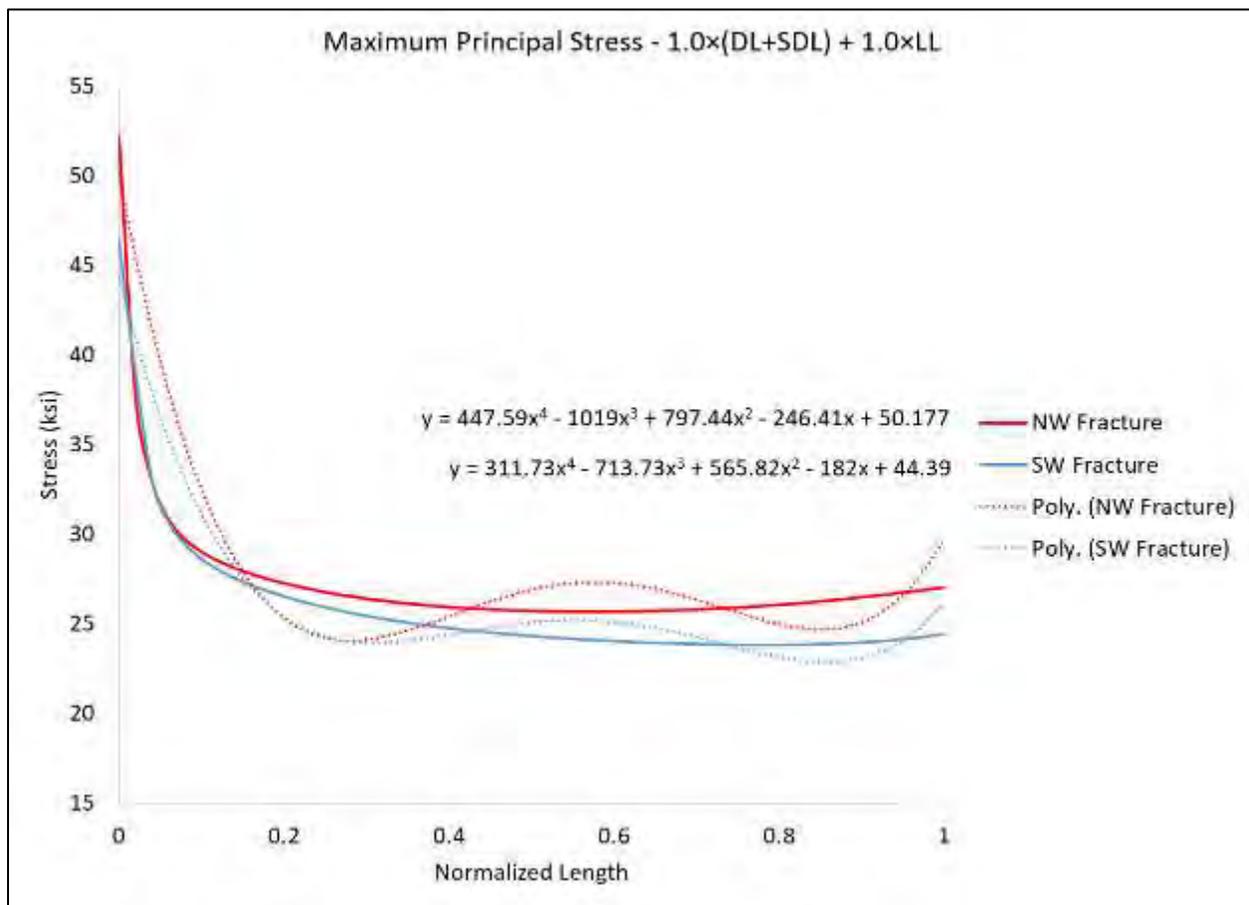
Fig. 96. Flange maximum principal stress along the normalized fracture paths from the weld access holes (0) to the flange edges (1) (see Fig. 94) with the 4<sup>th</sup> order polynomial fit shown (dashed lines).

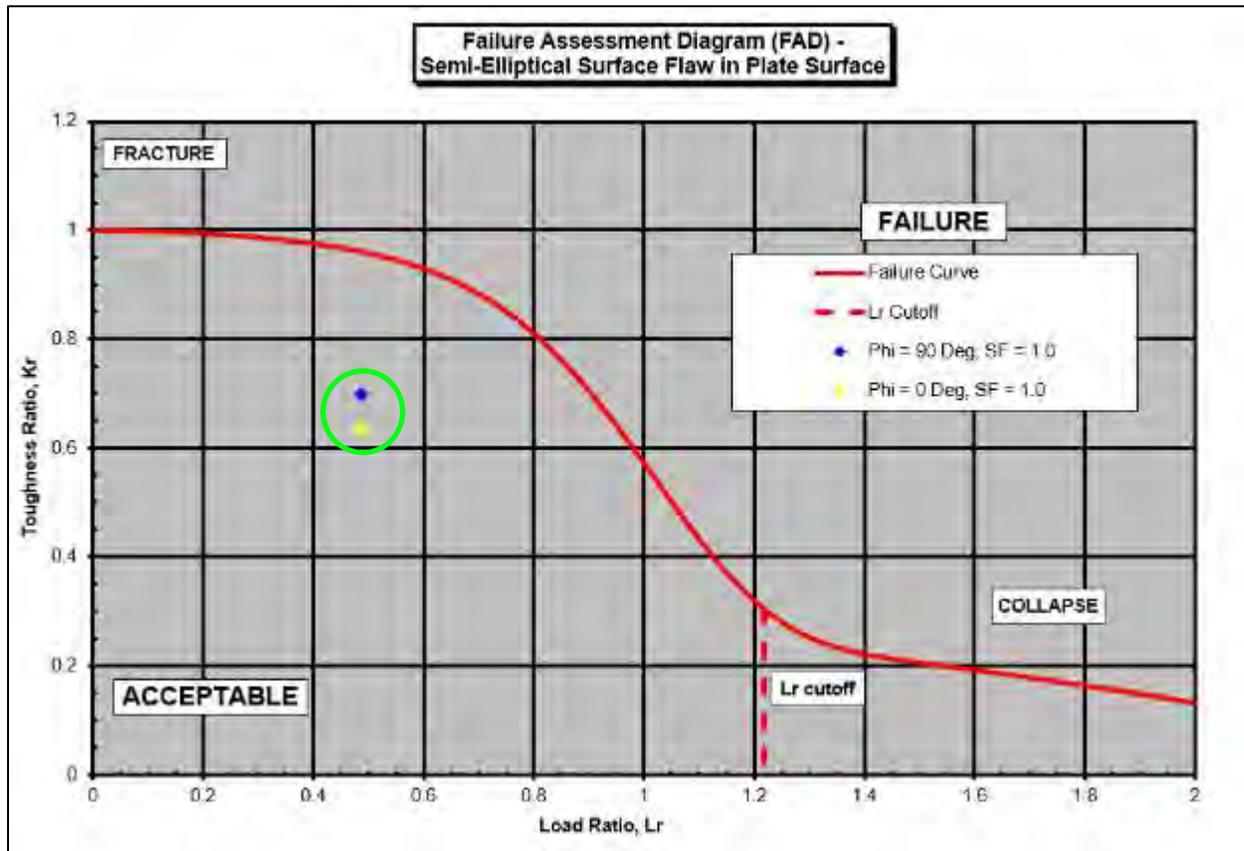
Fig. 97. FAD assessment points, circled in green, due to service stresses only at a fracture toughness of approximately 55 to 60 ksiv.in.

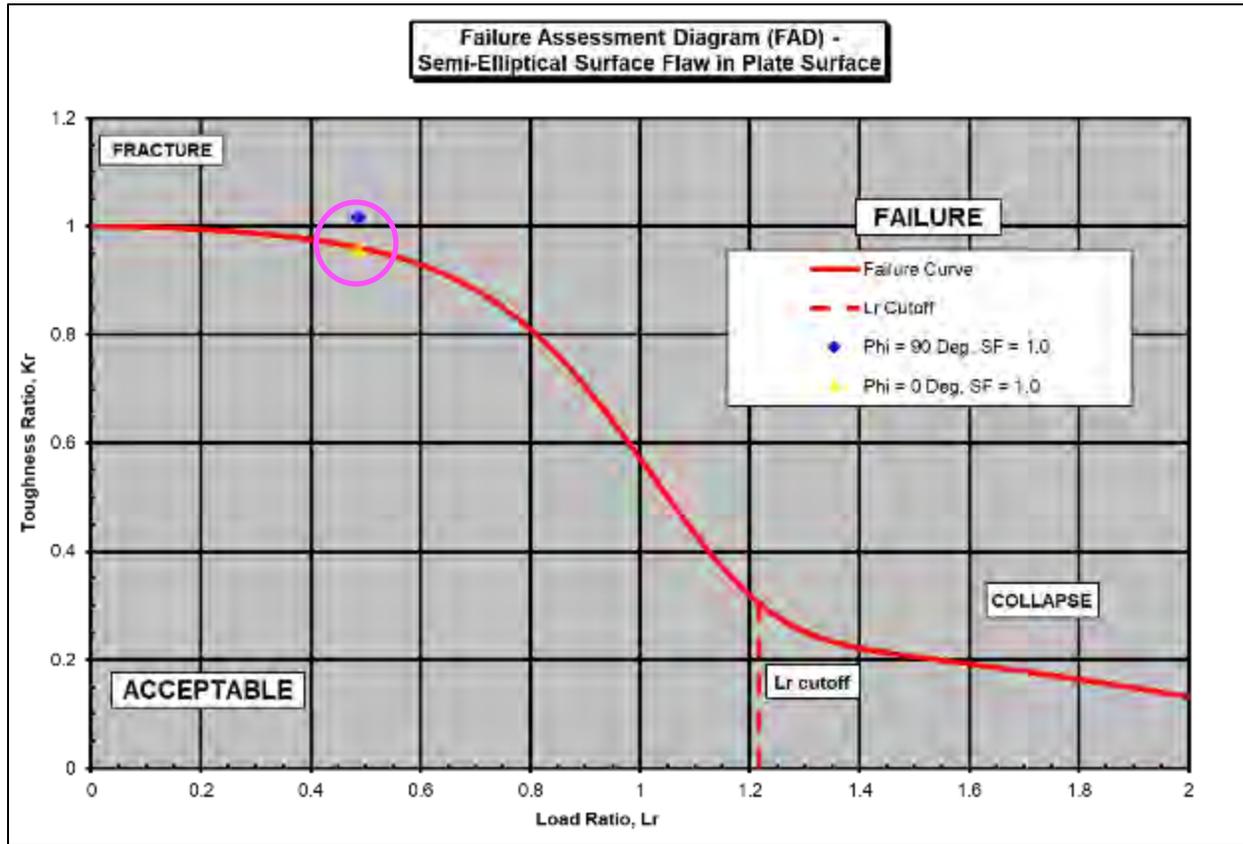
Fig. 98. FAD assessment points, circled in purple, due to service stresses and an additional stress intensity factor due to residual stresses at a fracture toughness of approximately 55 to 60 ksi/in.

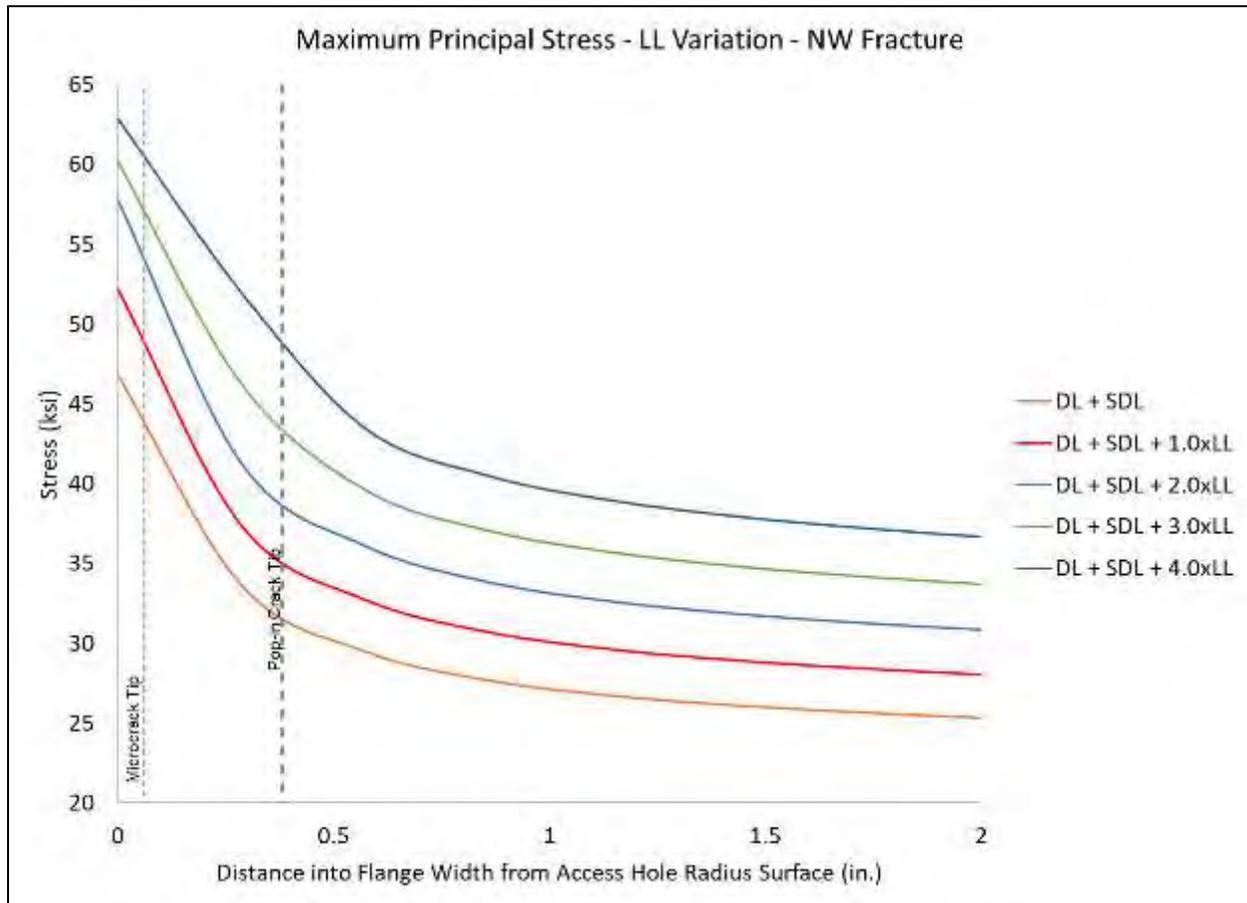
**Fig. 99. Maximum principal stress along the NW fracture path for various applied LL. The relative locations on the microcrack and pop-in crack tips are identified by dashed vertical lines.**

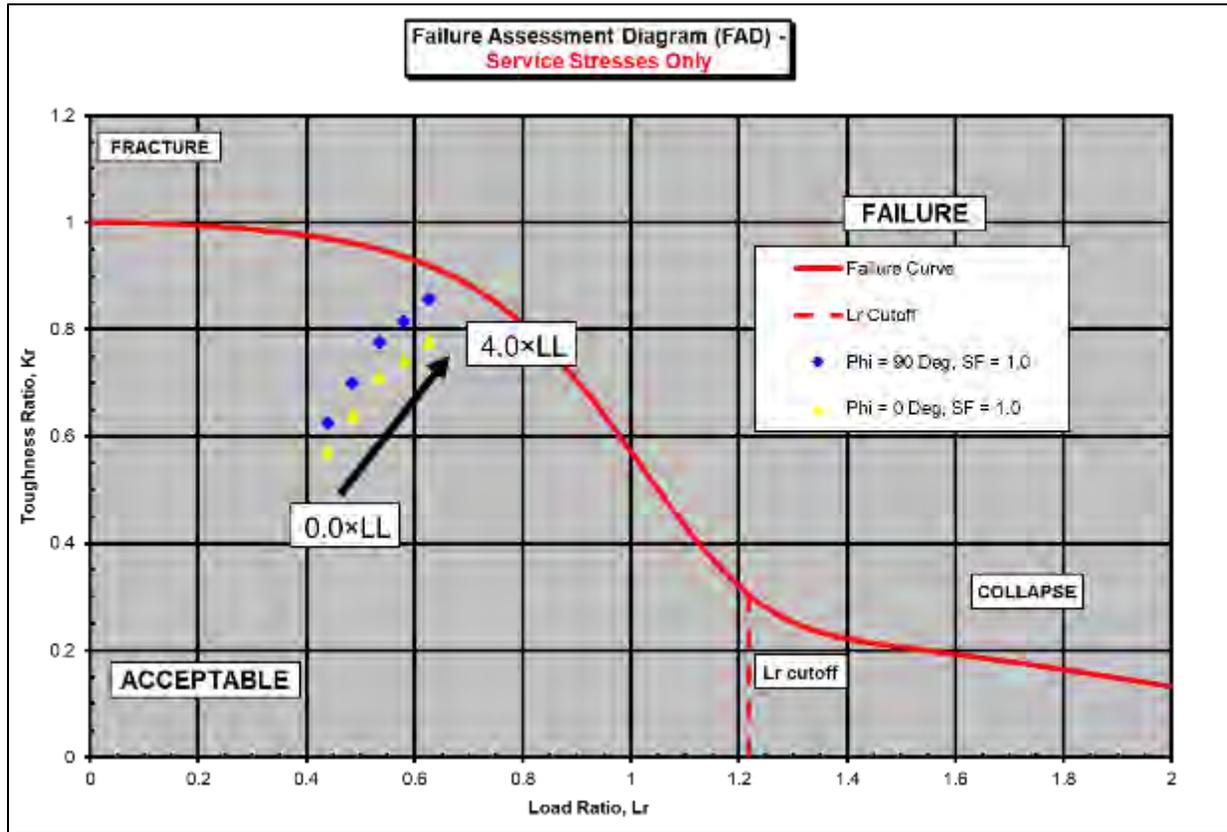
Fig. 100. FAD assessment points due to service stresses only at a fracture toughness of approximately 55 to 60 ksi/in. – LL sensitivity analyses
