**LPI, Inc. Consulting Engineers**

*Advanced Analysis & Fitness for Service  
Failure & Materials Evaluation  
Nondestructive Engineering*

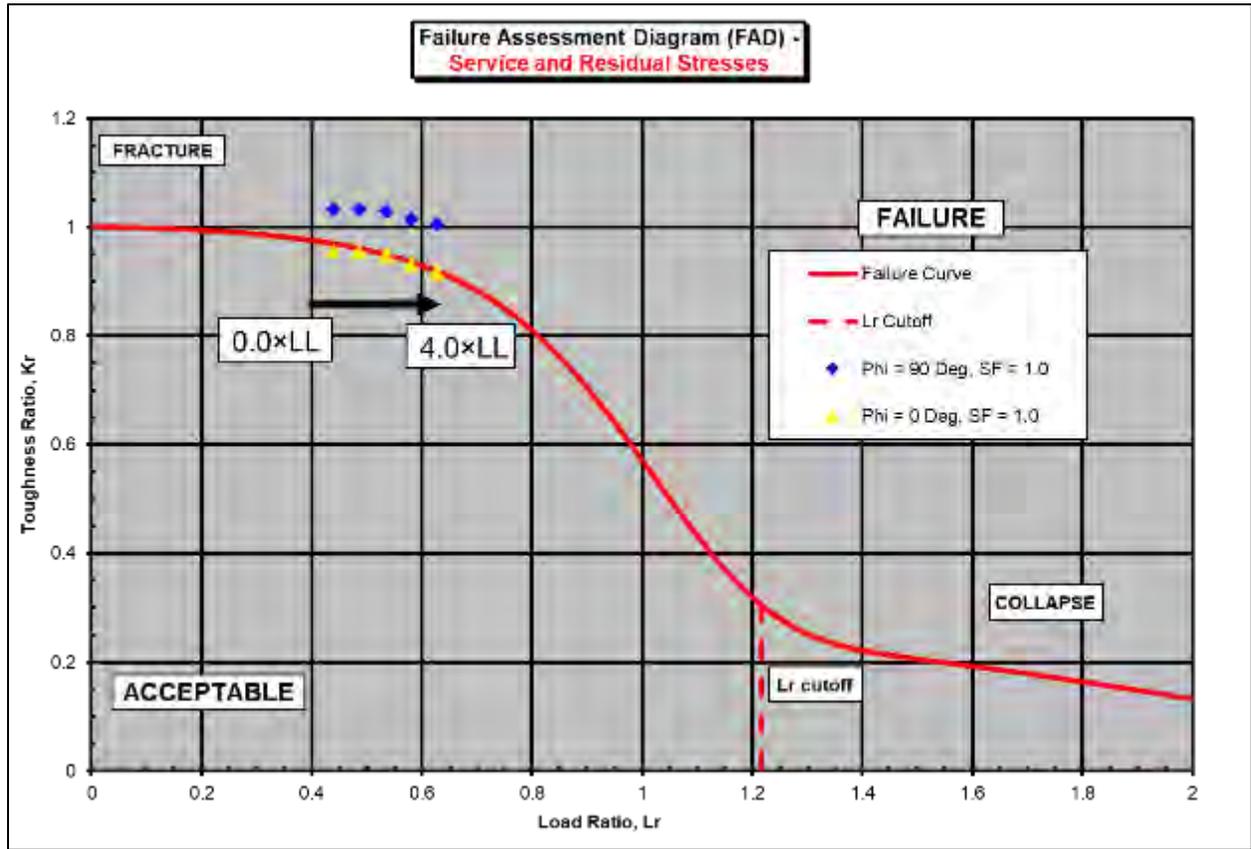
Fig. 101. FAD assessment points due to service stresses and an additional stress intensity factor due to residual stresses at a fracture toughness of approximately 55 to 60 ksi√in. – LL sensitivity analyses

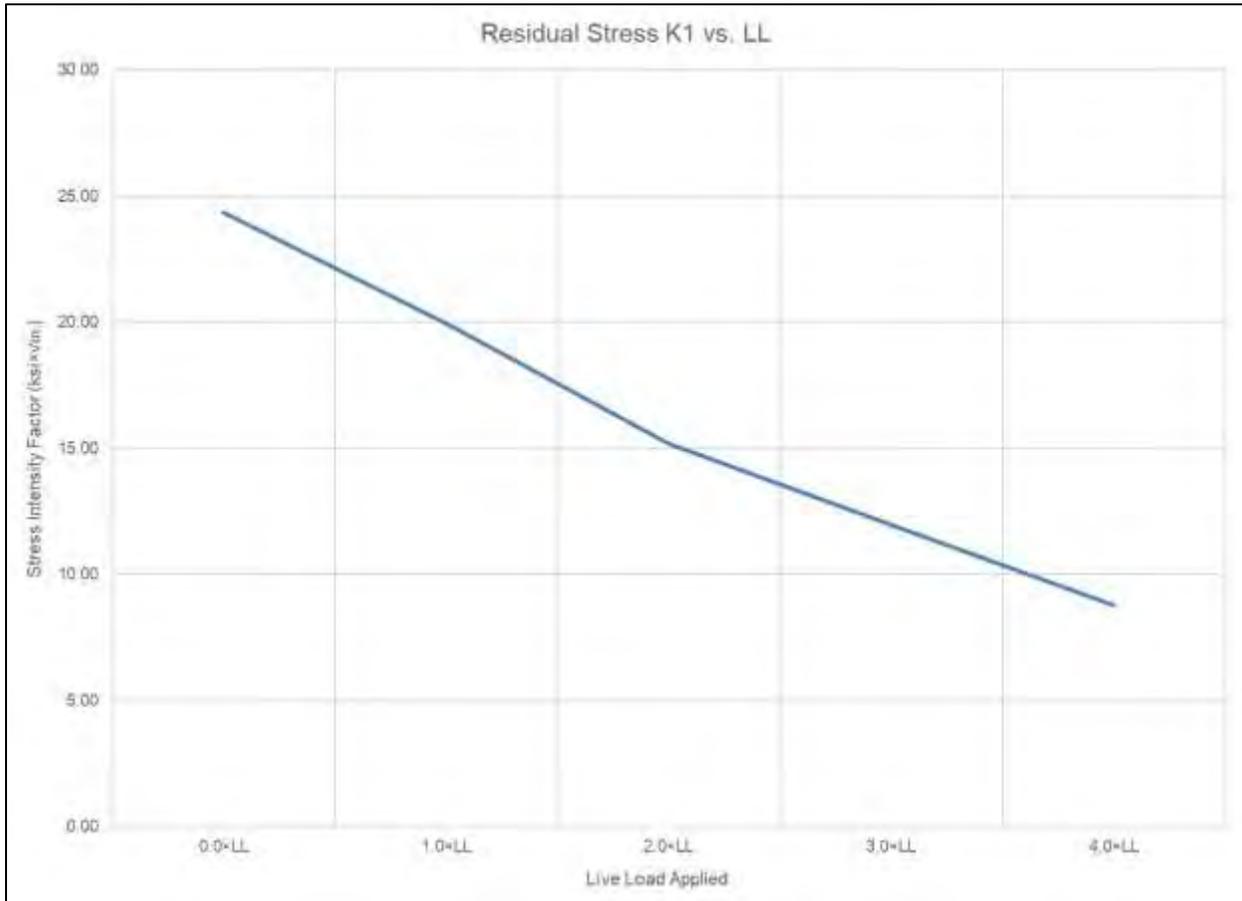
**Fig. 102. Residual stress  $K_1$  necessary to cause fracture of the Fig. 100 assessment points, as shown in Fig. 101, at a fracture toughness of approximately 55 to 60 ksi√in. – LL sensitivity analyses**

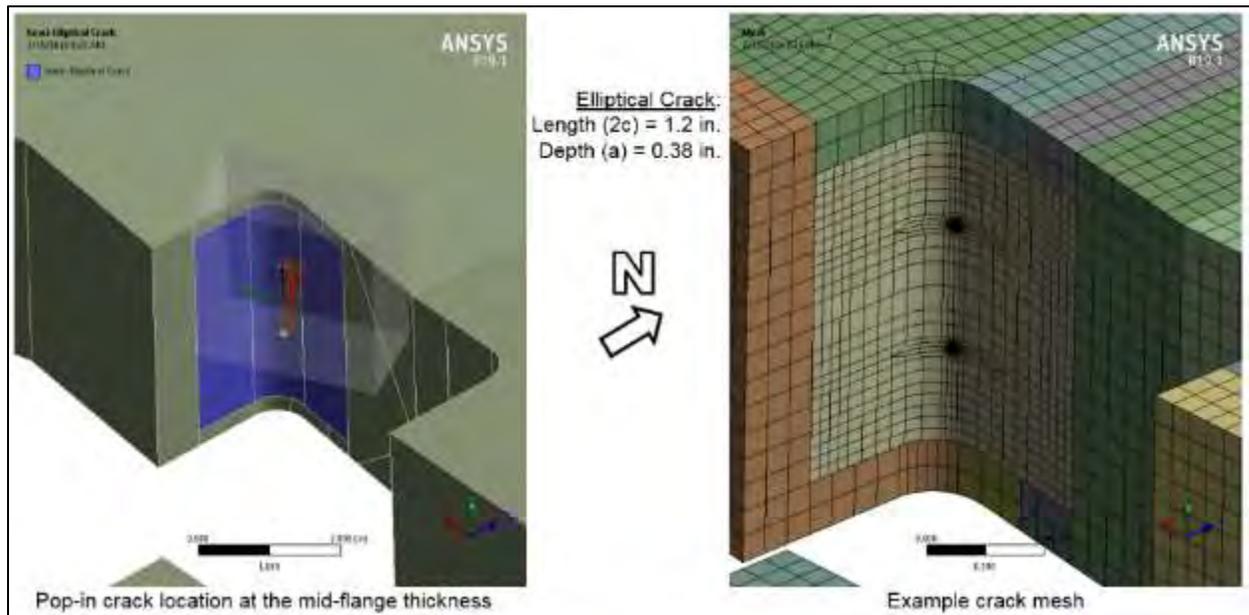
**Fig. 103. FE model and mesh with the pop-in crack included.**

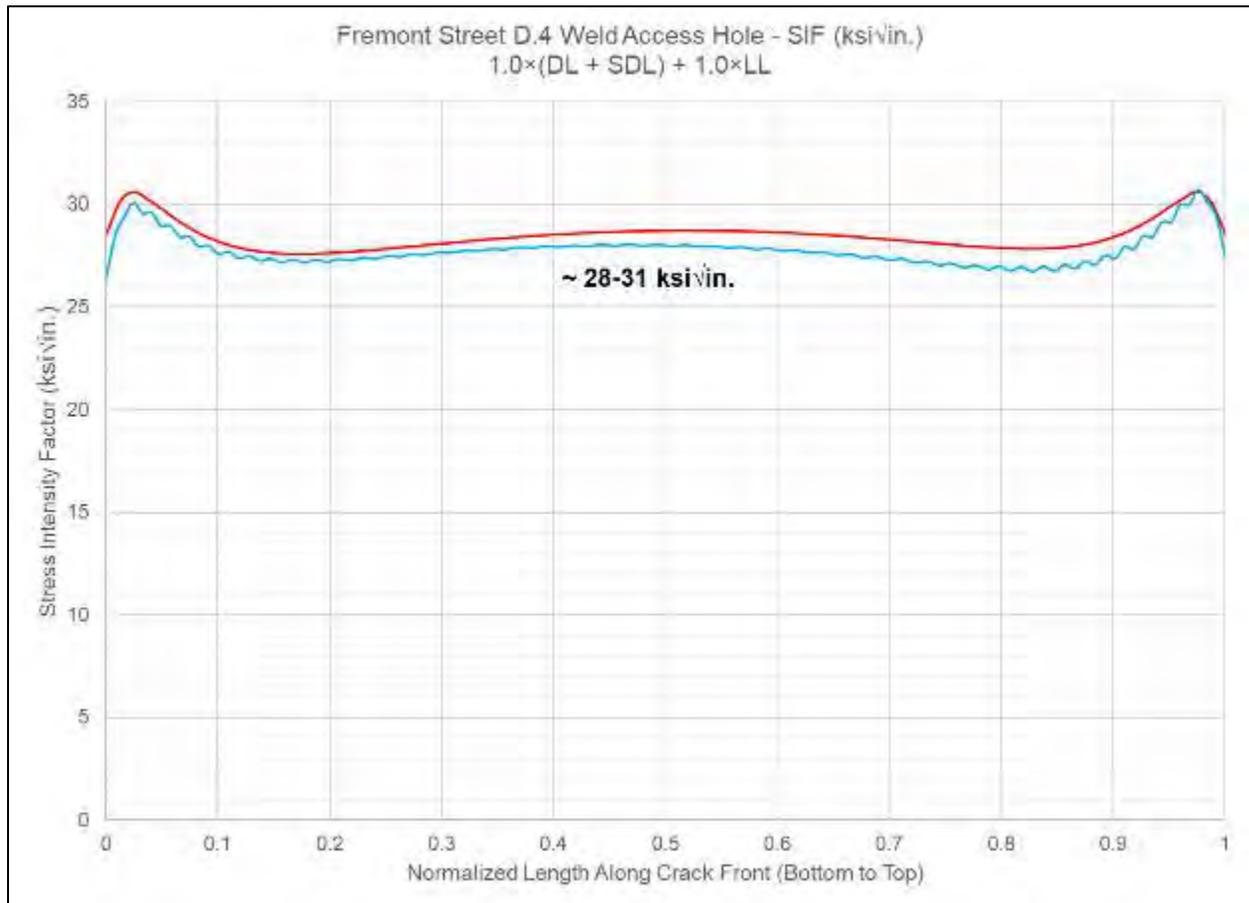
**Fig. 104. FE stress intensity factor along the pop-in crack front due to service loading.**

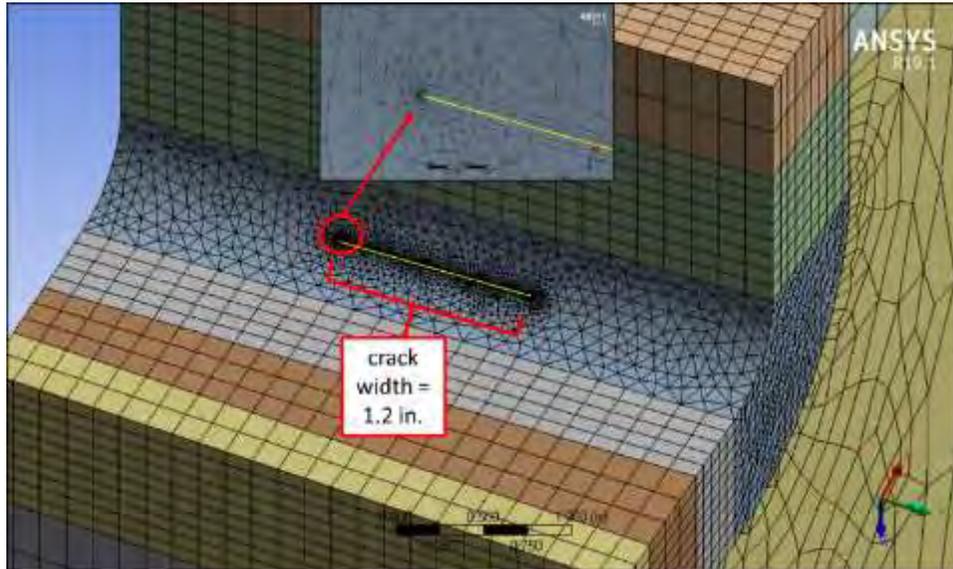
**Fig. 105. Fremont Street crack mesh for the 0.06 in. deep x 1.2 in. long pre-existing microcrack prior to pop-in crack formation. Free surface of microcrack is shown in yellow.**

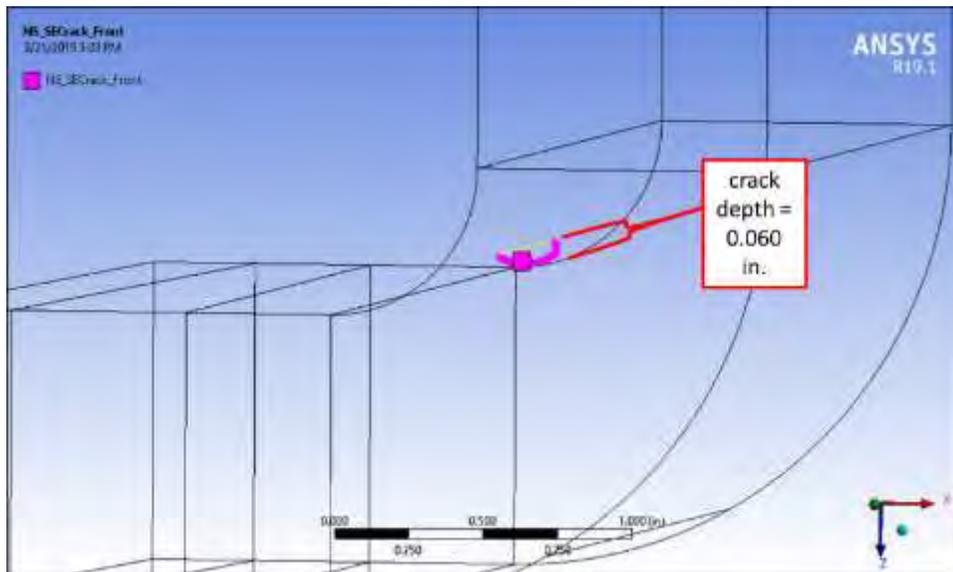
**Fig. 106. Wireframe view showing depth of the microcrack of Fremont Street FE model. The purple line indicates the crack front.**

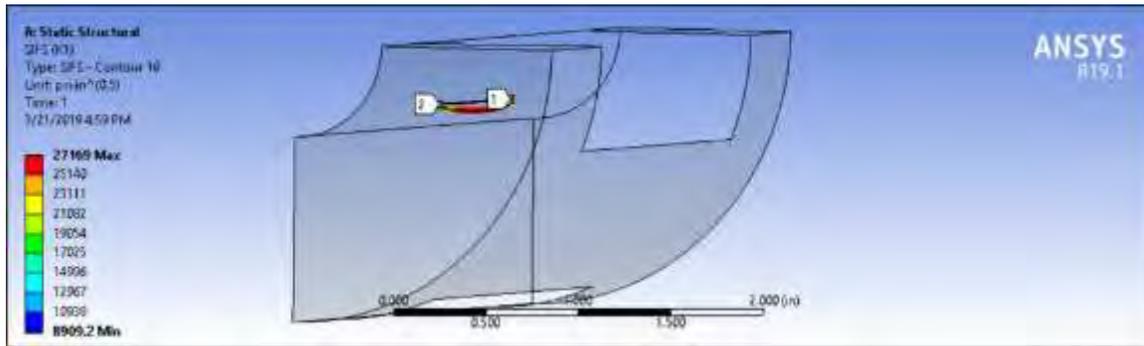
**Fig. 107. Microcrack stress intensity factor plot the Fremont Street FE model subject to weld-shrinkage loading. Plot corresponds to outermost contour around the crack front, with a peak  $K_1$  of approximately 27  $\text{ksi}\sqrt{\text{in}}$ .**

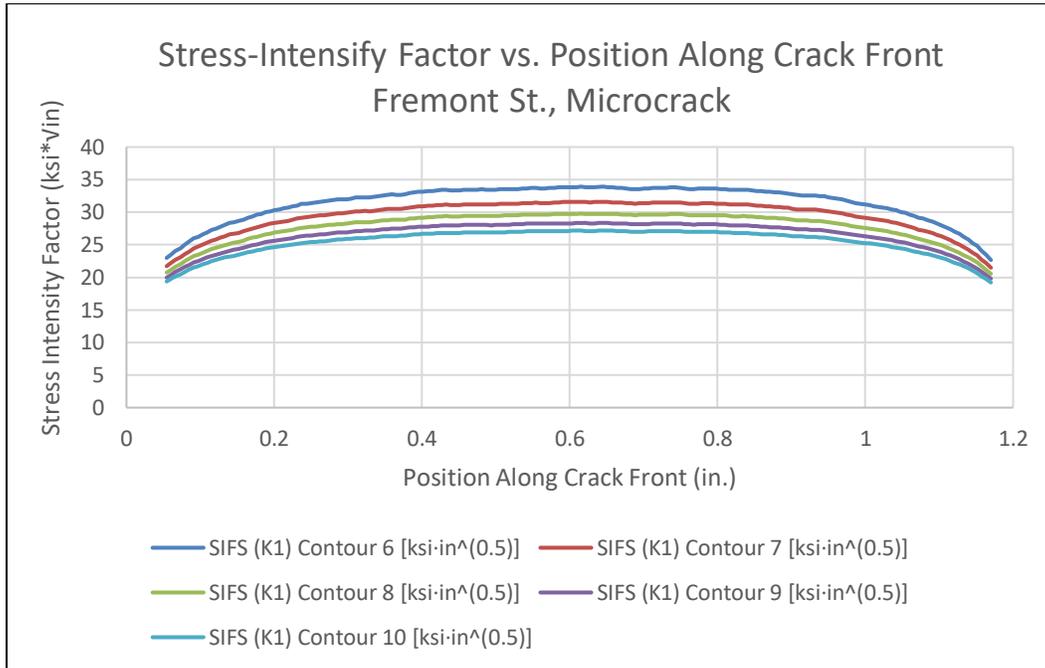
**Fig. 108. Stress intensity factor ( $K_I$ ) versus position along crack front for the microcrack in the Fremont Street FE model under groove-weld-shrinkage loading. Contours 6 through 10 show a converging trend (from top curve to bottom curve) toward a  $K_I$  of approximately  $27 \text{ ksi}\sqrt{\text{in}}$ .**

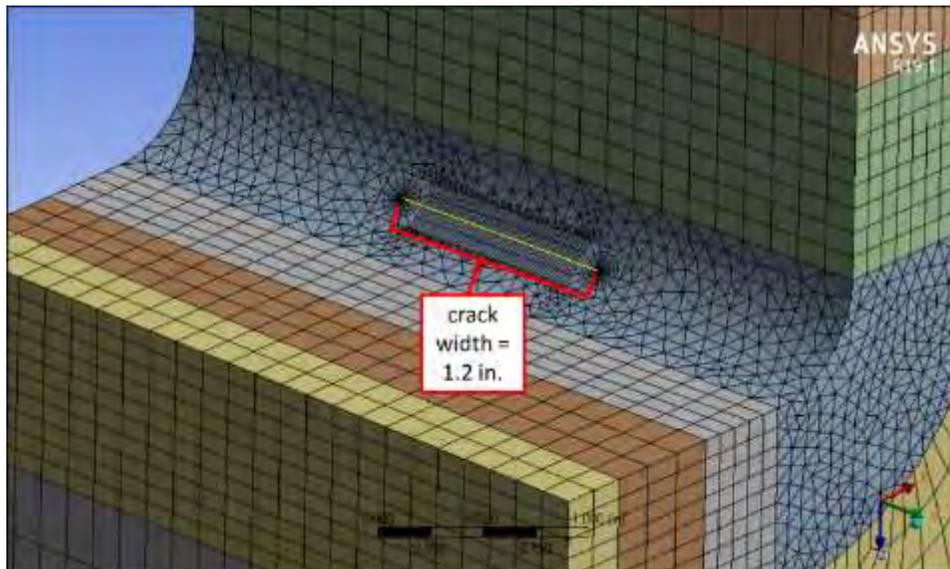
**Fig. 109. Fremont Street crack mesh for the 0.38 in. deep x 1.2 long pre-existing pop-in crack. The free surface of crack is shown in yellow.**

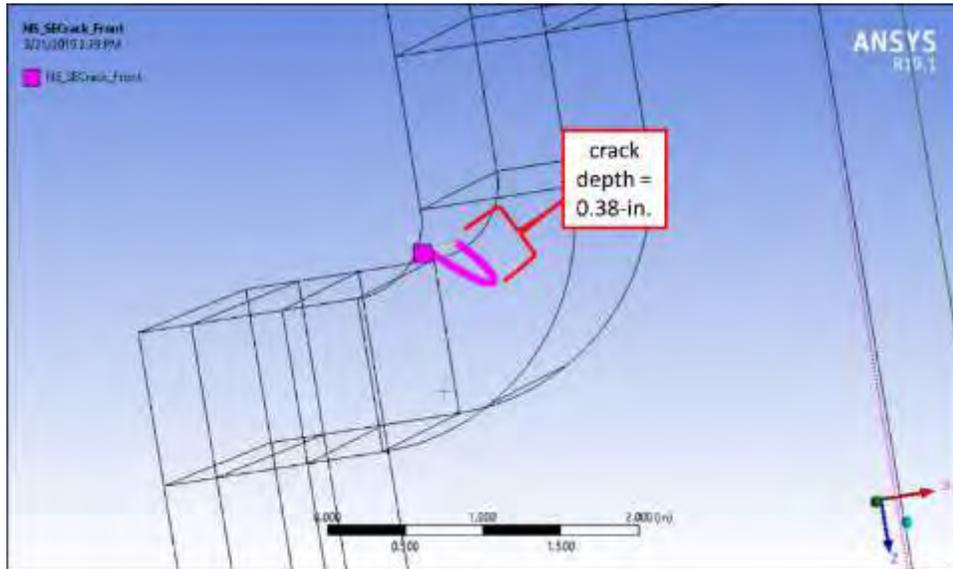
**Fig. 110. Wireframe view showing the depth of the Fremont Street pop-in crack. The purple line indicates the crack front.**

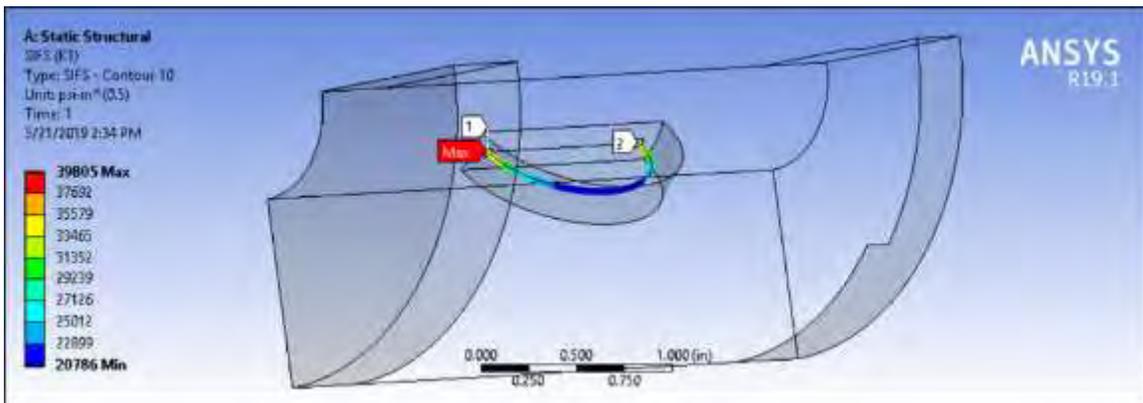
**Fig. 111. Stress intensity factor across the crack front of the Fremont Street pop-in crack due to weld-shrinkage loading.**

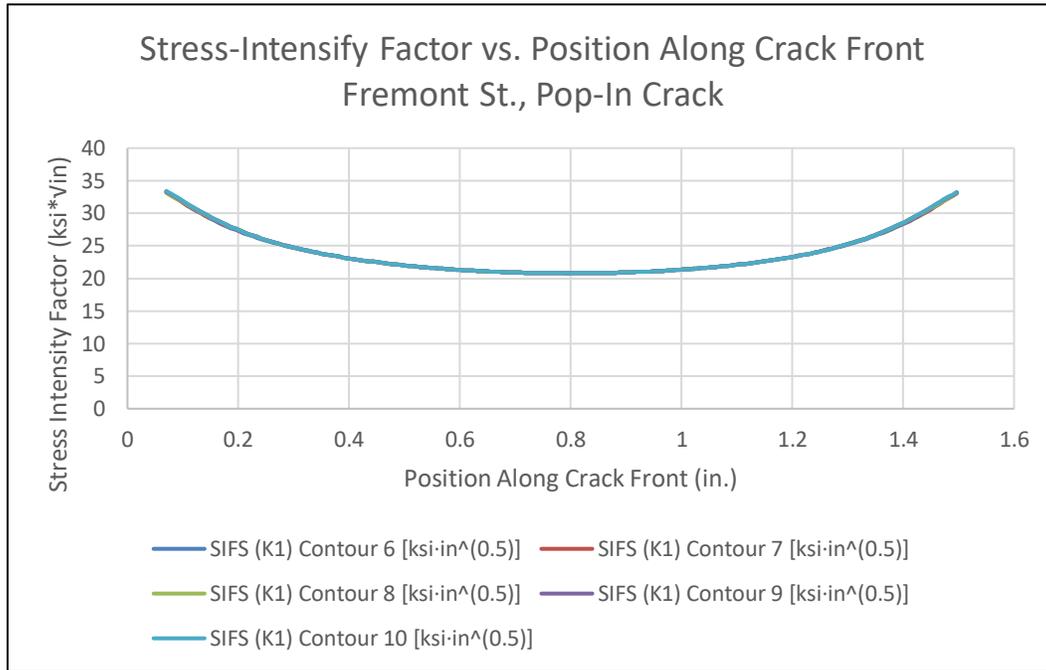
**Fig. 112. Stress intensity factor ( $K_1$ ) versus position along crack front for the pop-in crack in the Fremont Street FE model under groove-weld-shrinkage loading. Contours 6 through 10 show a converging trend (from top curve to bottom curve) toward a  $K_1$  of approximately  $21 \text{ ksi}\sqrt{\text{in}}$ .**

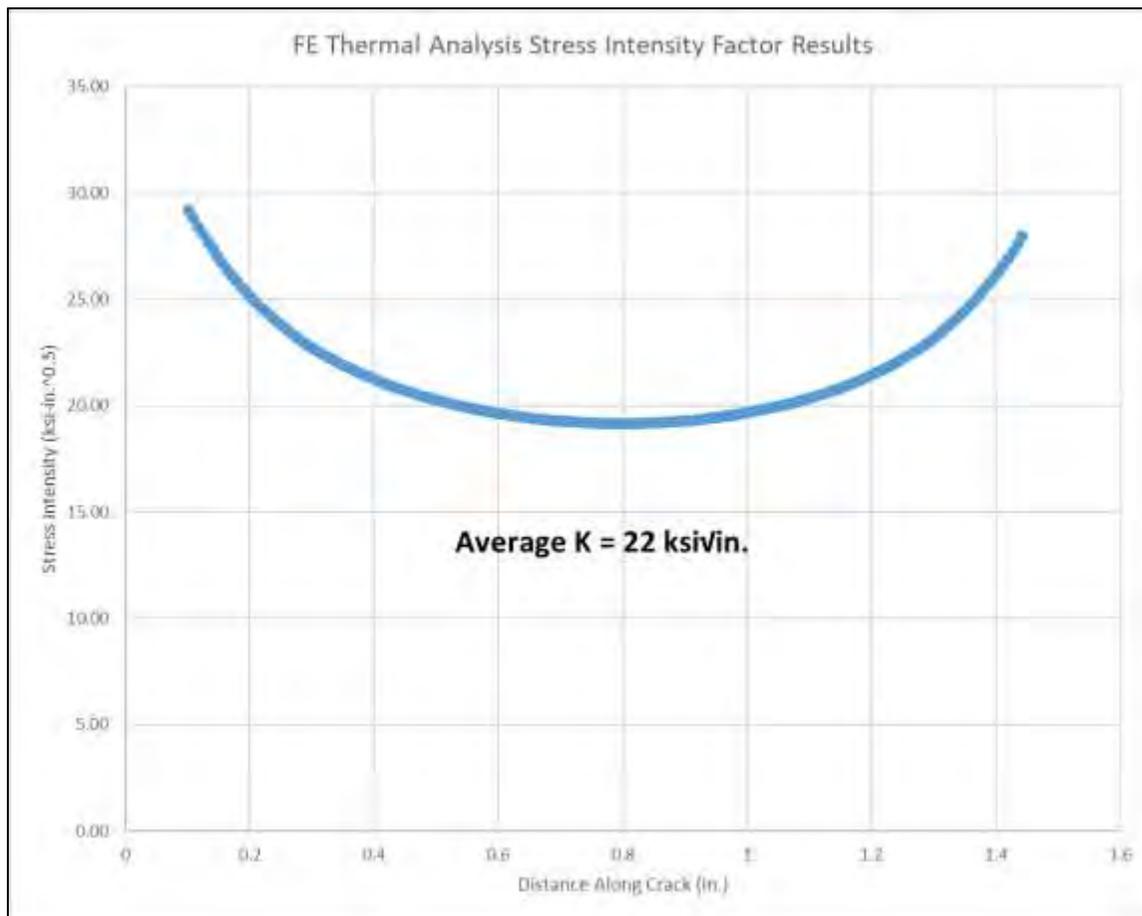
Fig. 113. FE stress intensity factor along the pop-in crack front due to weld-shrinkage thermal loading (residual stresses).

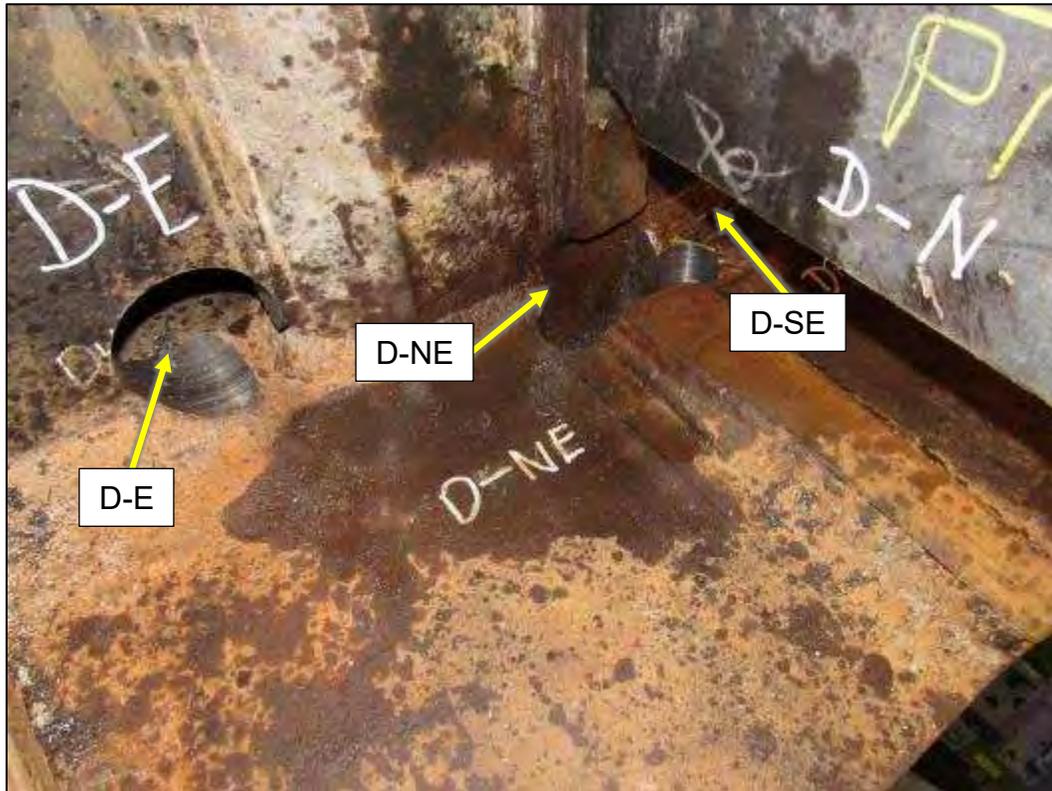
**Fig. 114. North girder above First Street after core sample removal.**

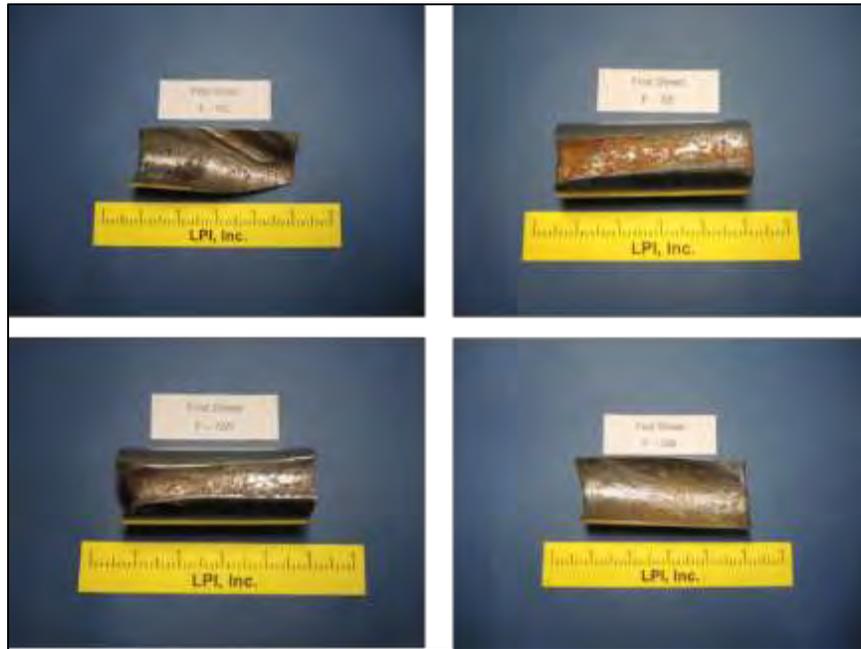
**Fig. 116. Flange core samples from the south girder above First Street (Girder F) in the as-received condition.**

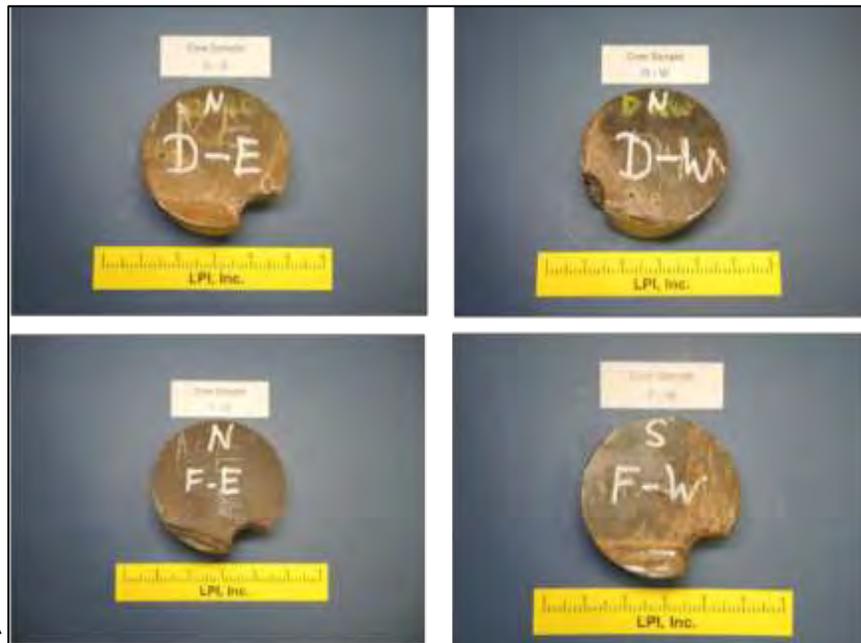
**Fig. 117. Web core samples from the girders above First Street (Girders D and F) in the as-received condition.**

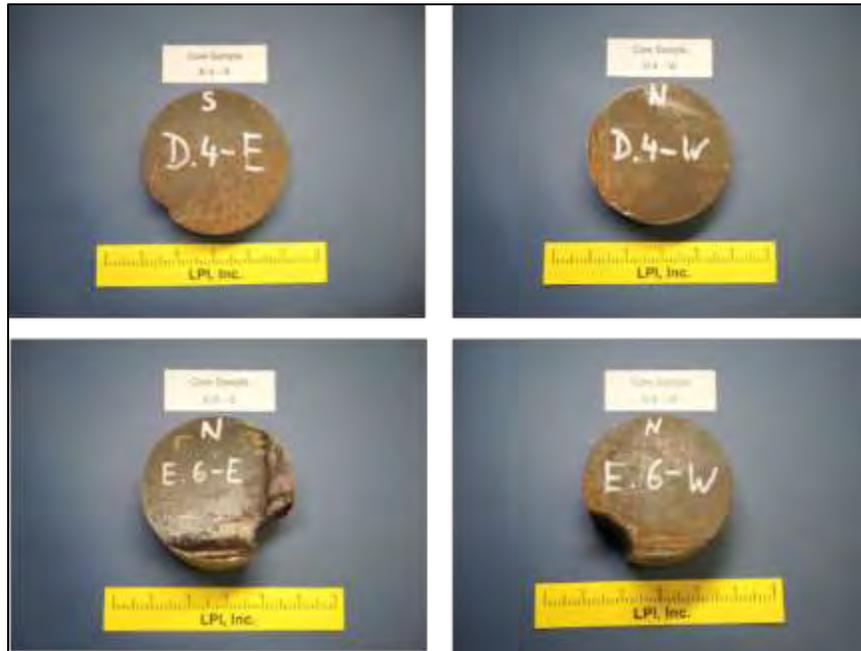
**Fig. 118. Web core samples from the girders above Fremont Street (Girders D.4 and E.6) in the as-received condition.**

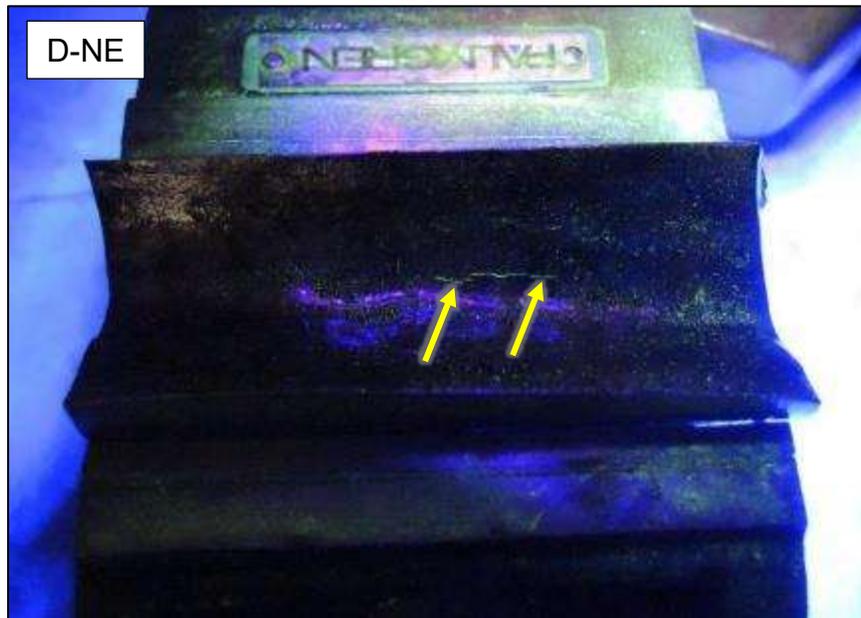
**Fig. 119. Representative image of the flange weld access hole surface of core sample D-NE following wet fluorescent magnetic particle testing showing cracks (arrows).**

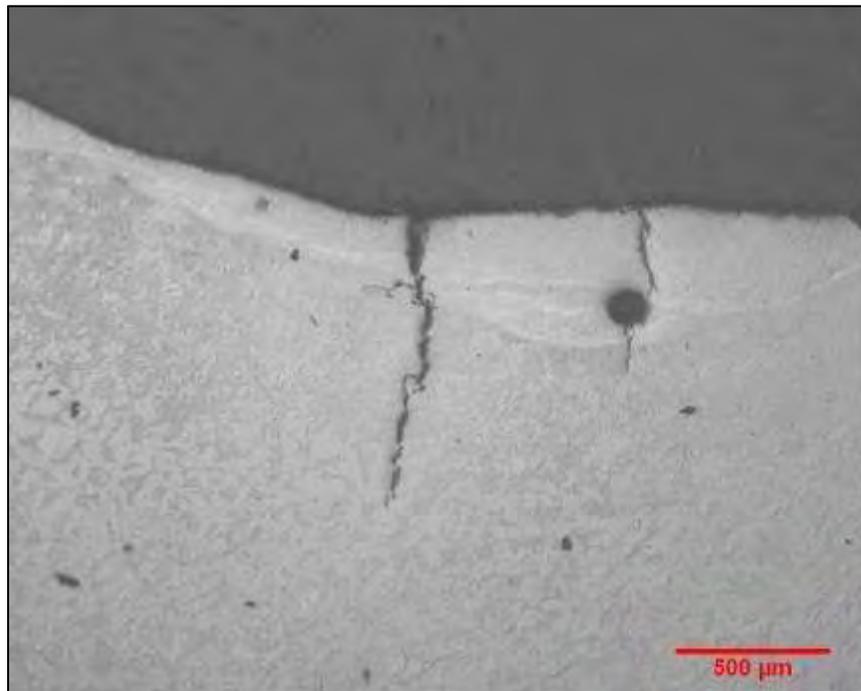
**Fig. 120. Representative metallographic image of the flange weld access hole surface of core sample D-NW revealing cracks in the martensitic surface layer.**

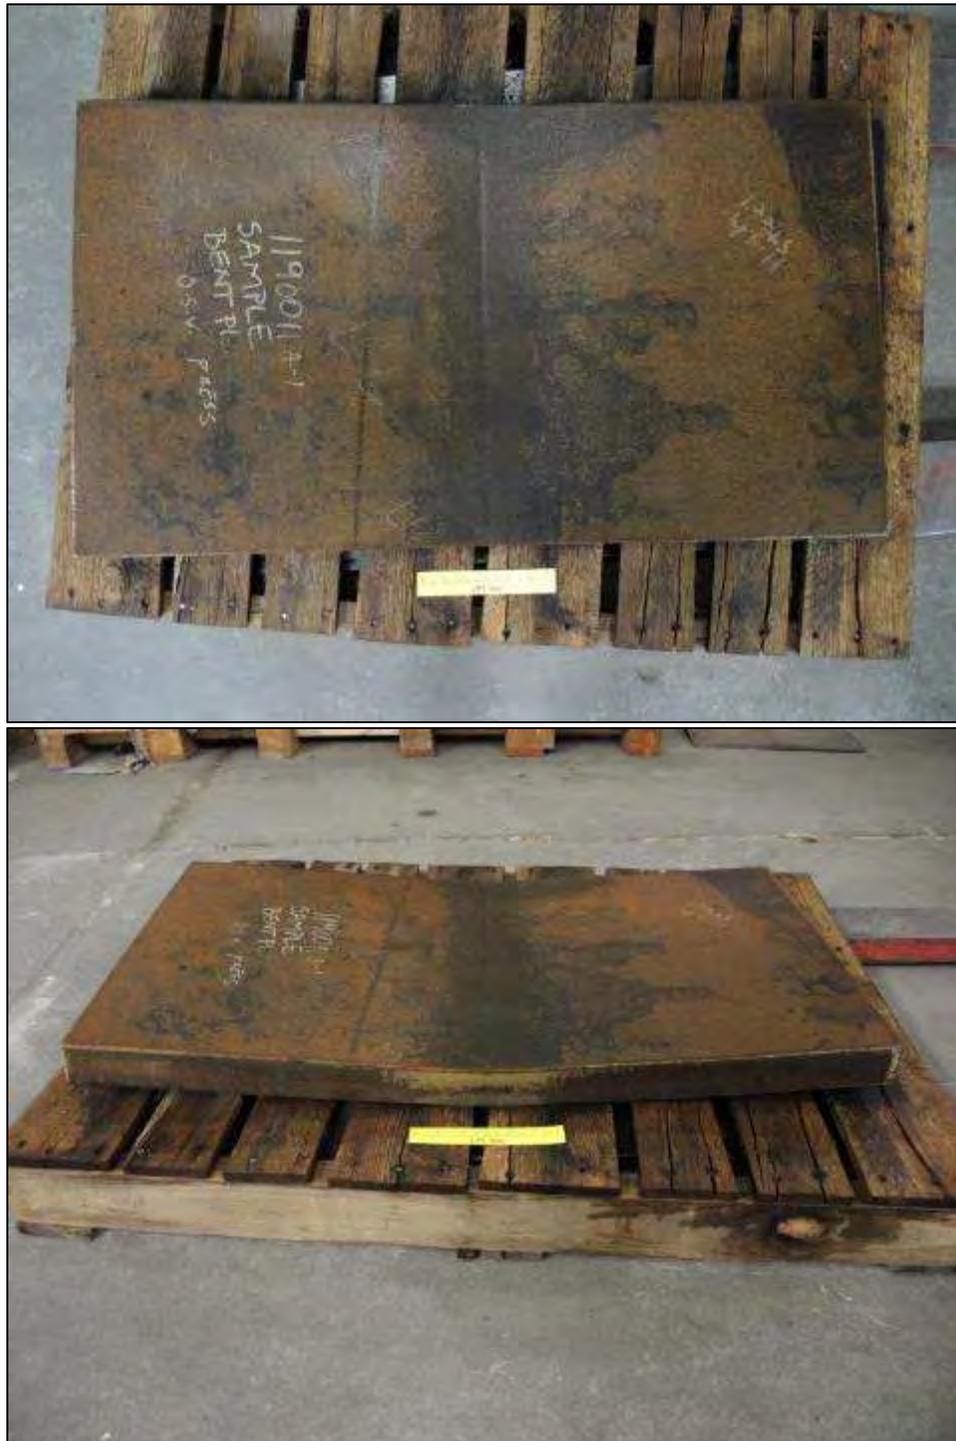
**Fig. 121. Sample repair plate in the as-received condition.**

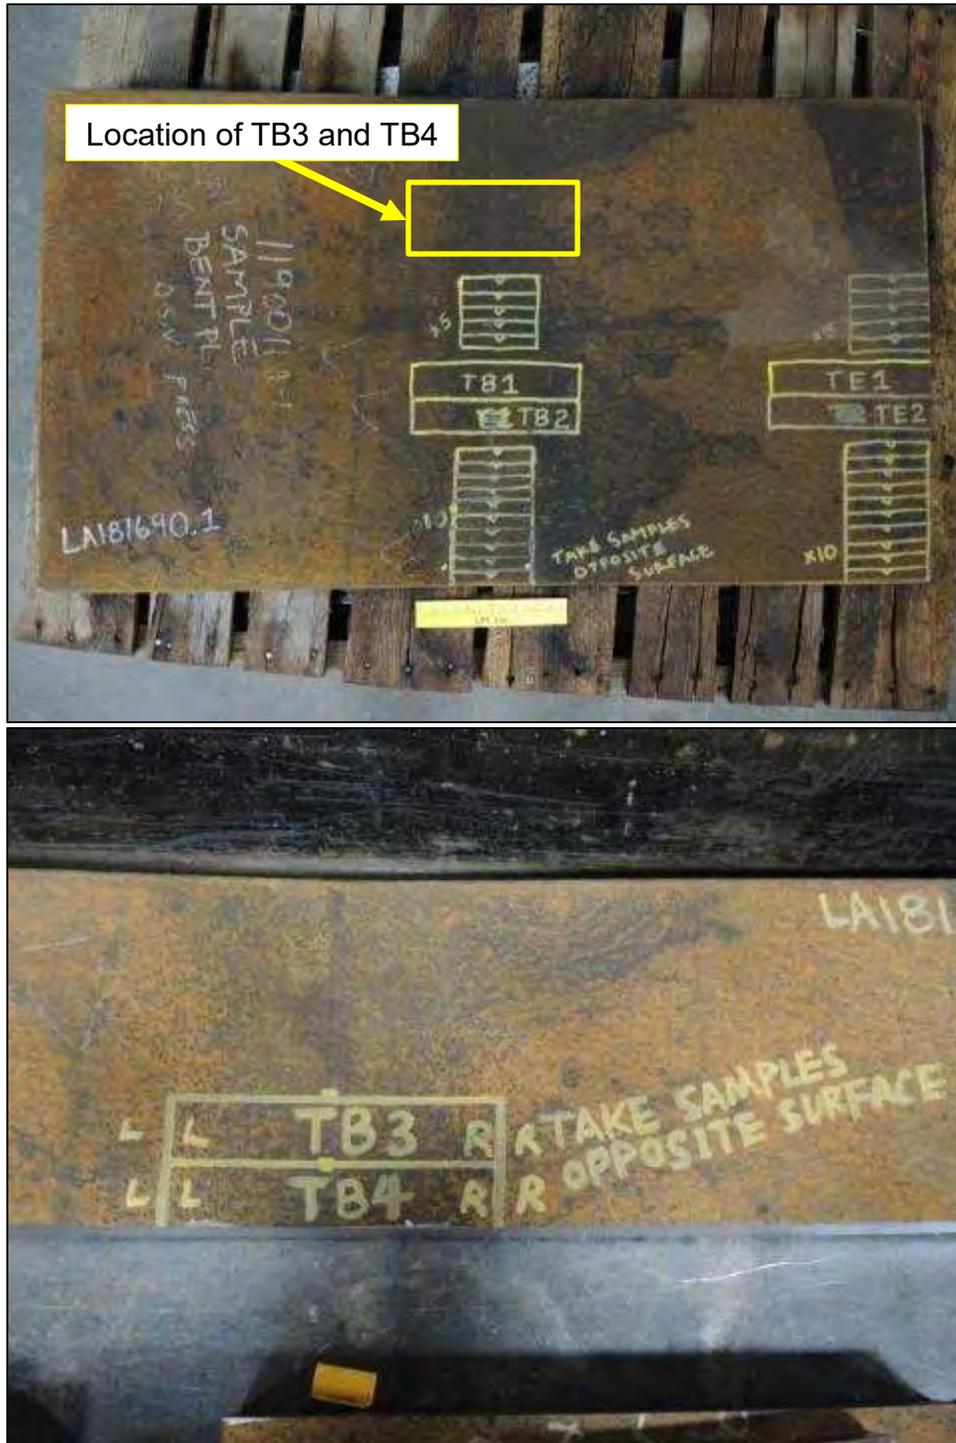
Fig. 122. Tensile and CVN specimen location mark-up prior to sectioning.

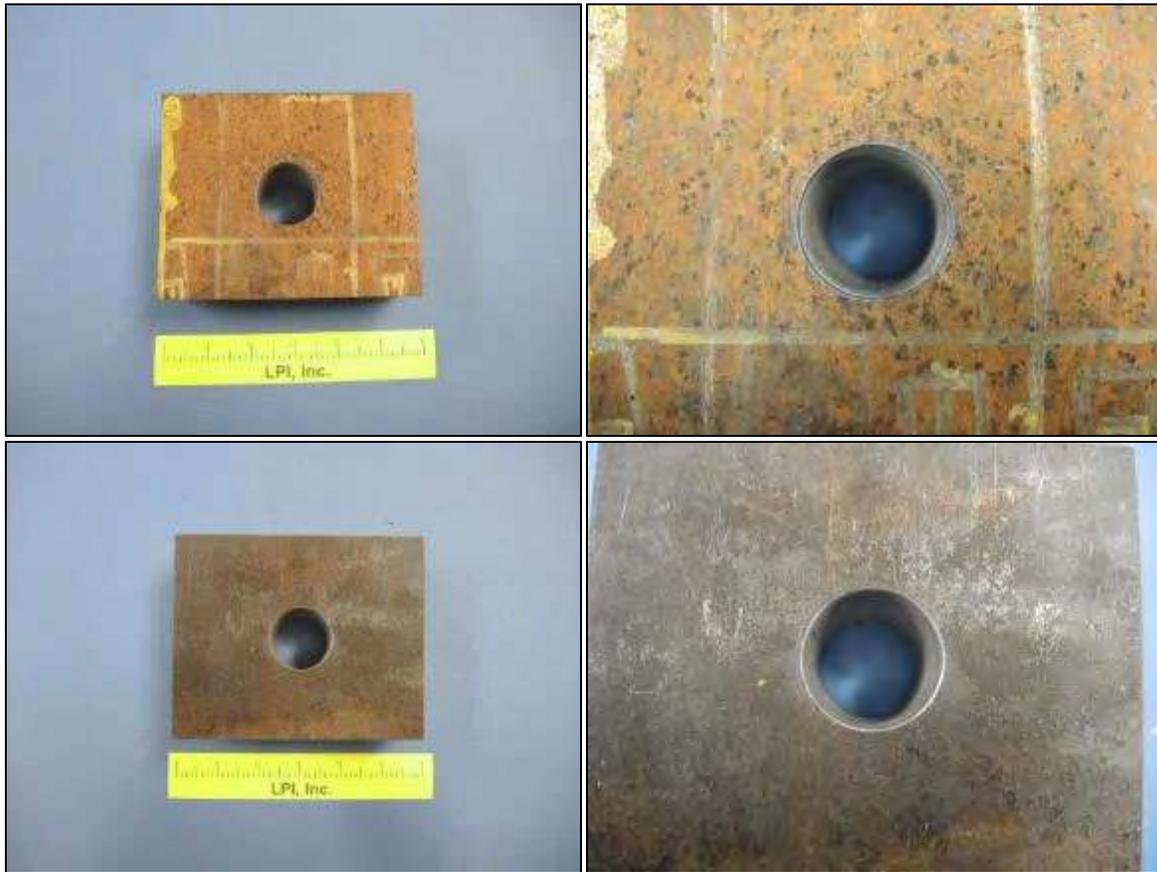
Fig. 123. Overall and close-up images of the two bolt holes drilled in the sample repair plate.

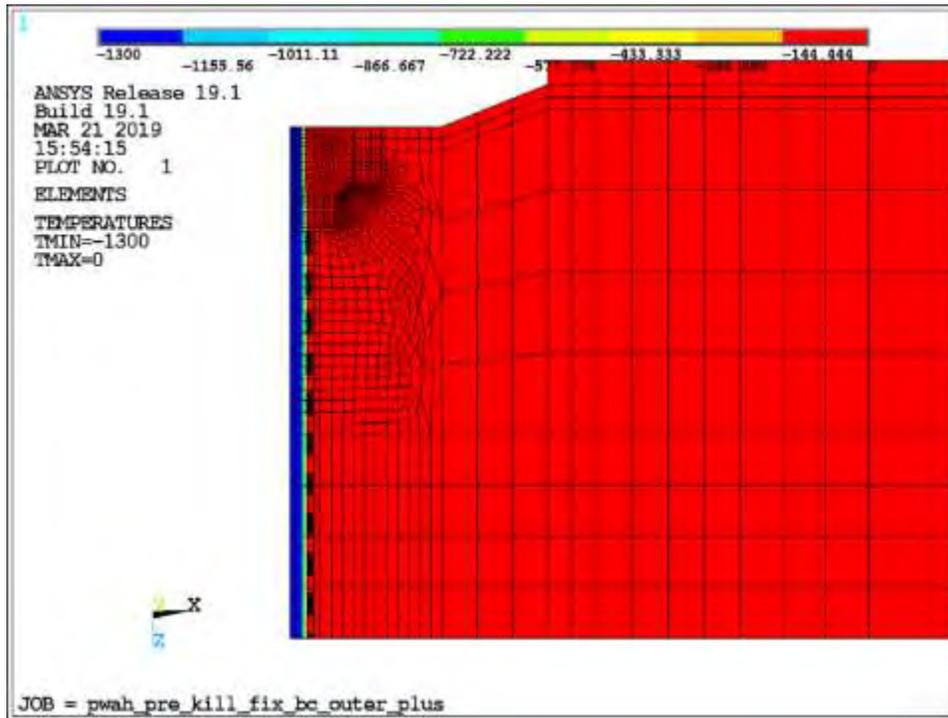
Fig. 126. Dashed line indicates section through First Street FE model on which displacements are fixed after temperature load is first applied, but before their deletion during the simulation of access-hole cutting.

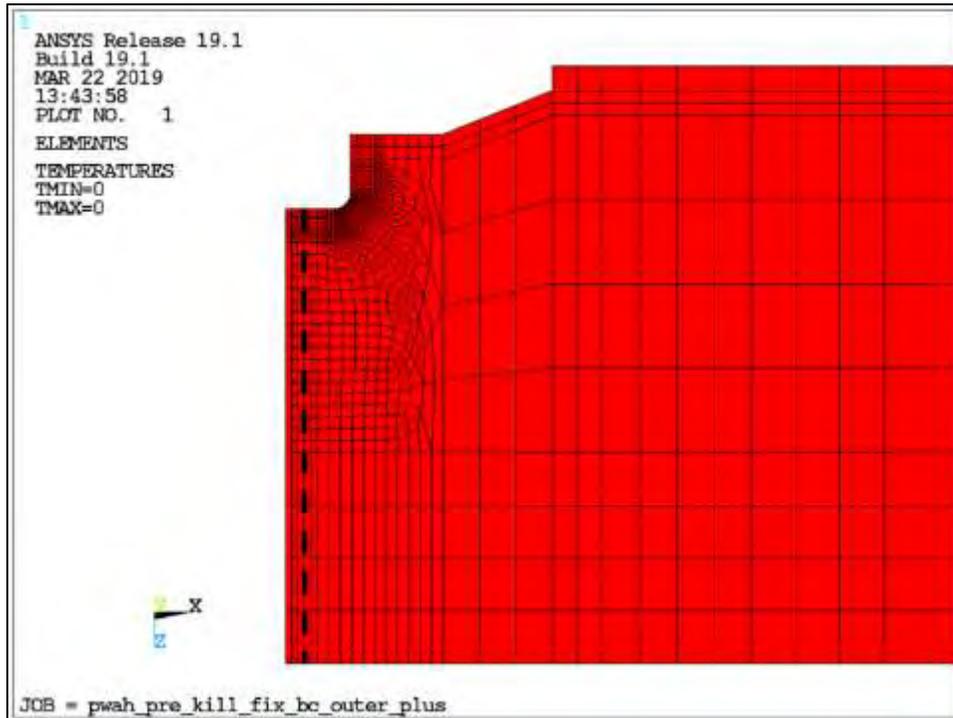
**Fig. 127. First Street FE model after the access hole was created and temperature loading removed. Dotted line indicates section on which displacements caused by initial temperature loading are fixed, thereby locking in the shrinkage effect of the weld.**

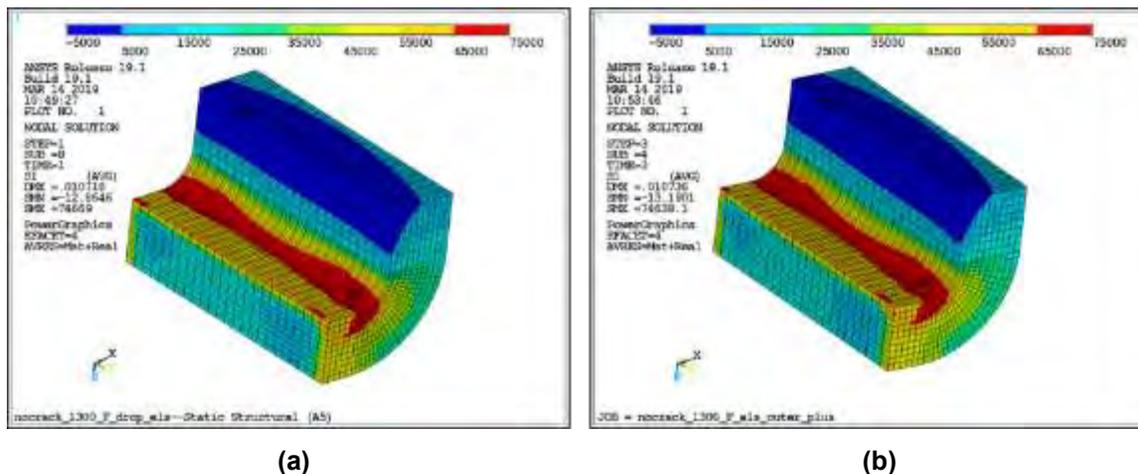
**Fig. 128. Results of applying First Street FE model's displacement-locking method to Fremont Street FE model for verification. Fig. 53 results are repeated here in (a) for comparison to results using displacement-locking followed by deleted temperature loads, (b). It is clear that the calculated stress distributions are nearly identical.**

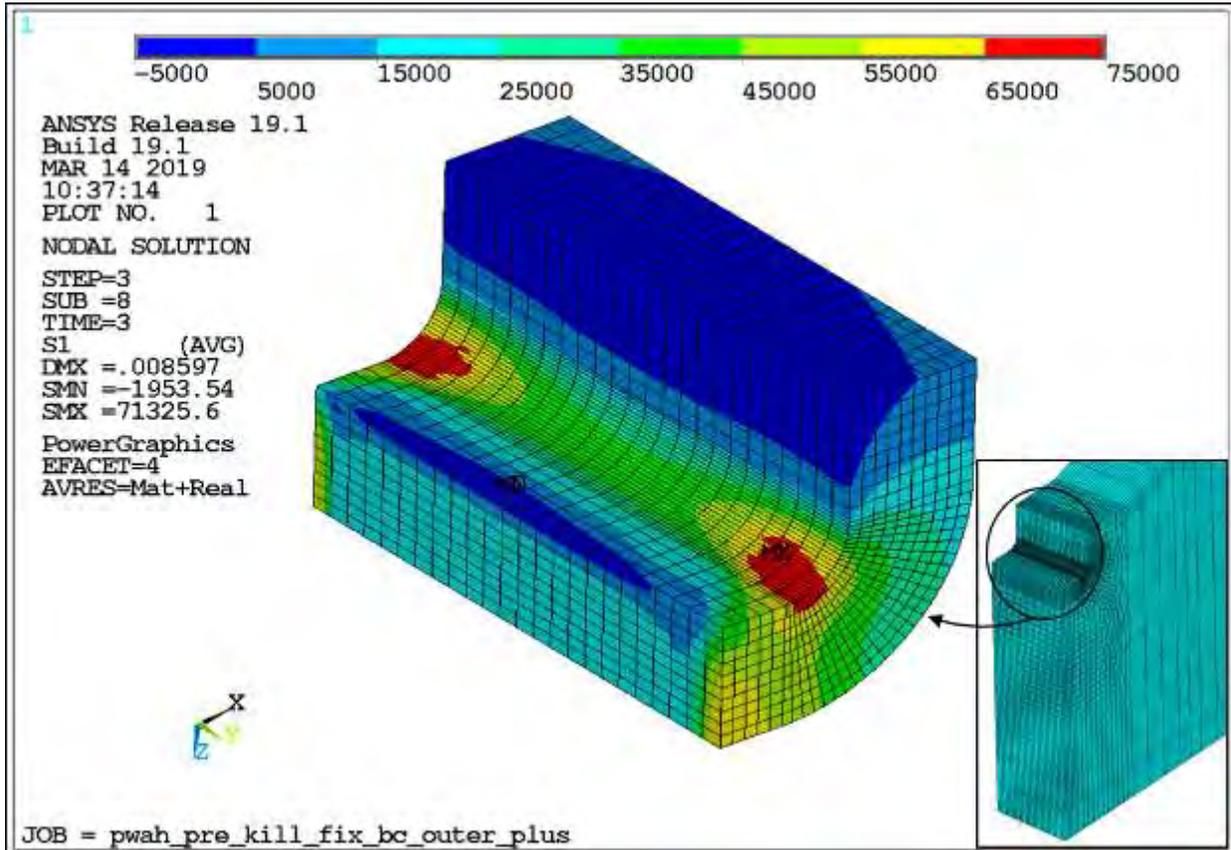
Fig. 129. Distribution of maximum principal stress local to access hole radius following cutting of the access hole in the First Street FE model. Except for the peak stress at the surfaces, the mid-thickness stresses are much lower than Fremont Street.

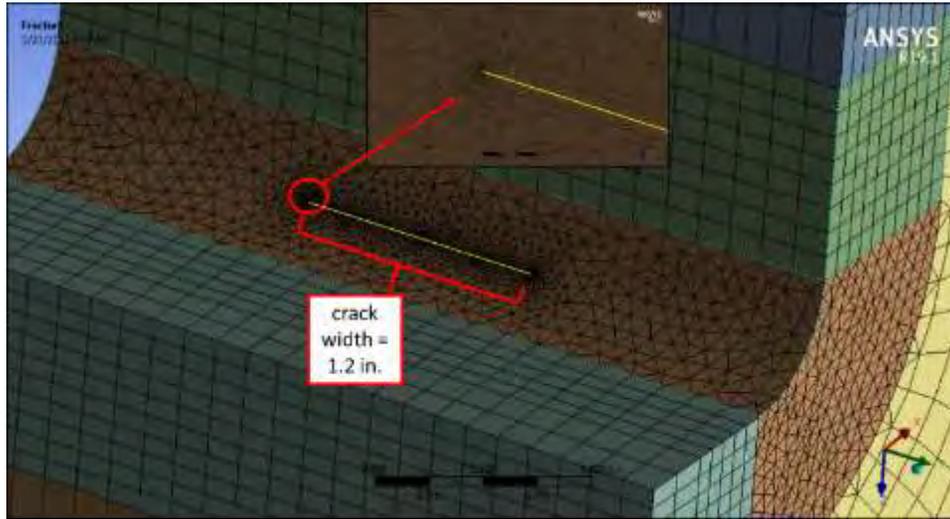
**Fig. 132. Crack mesh of First Street FE model. Crack is semi-elliptical, 0.06 in. deep x 1.2-in. long, representing microcracks existing before pop-in crack initiation. Free surface of crack shown in yellow; inset shows close-up view of the structured character of the specialized mesh employed.**

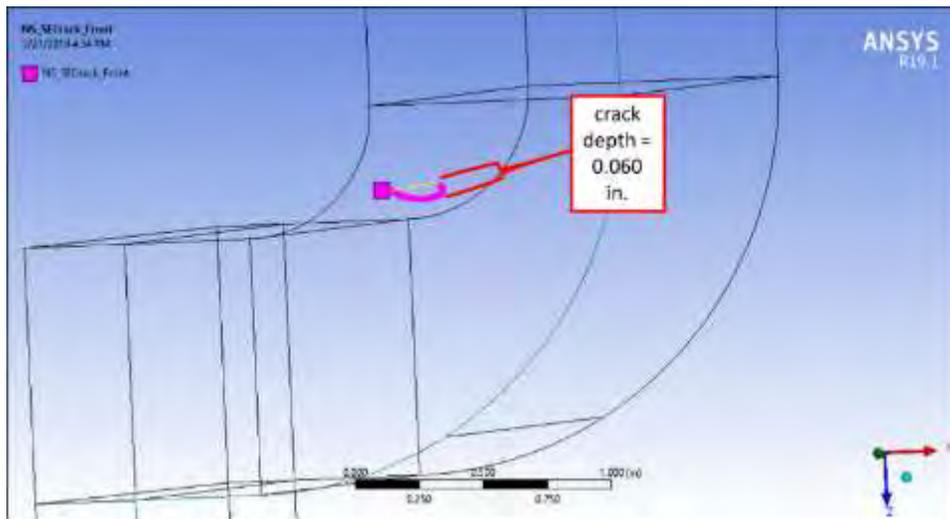
**Fig. 133. Wireframe view showing depth of the microcrack of First Street FEM. Purple line shows the crack front.**

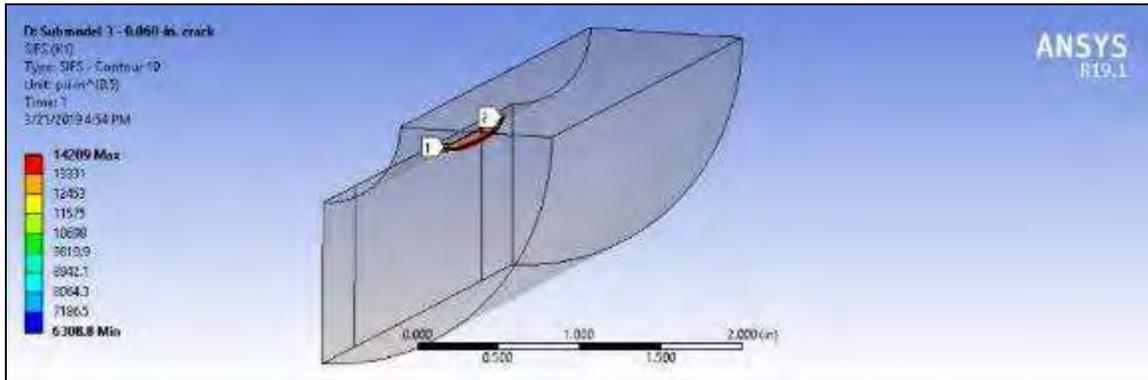
**Fig. 134. Microcrack stress intensity factor for the First Street FE model subject to weld-shrinkage loading. Plot corresponds to the outermost contour around the crack front, with a peak  $K_I$  of approximately  $14 \text{ ksi}\sqrt{\text{in}}$ .**
