**LPI, Inc. Consulting Engineers**

*Advanced Analysis & Fitness for Service  
Failure & Materials Evaluation  
Nondestructive Engineering*

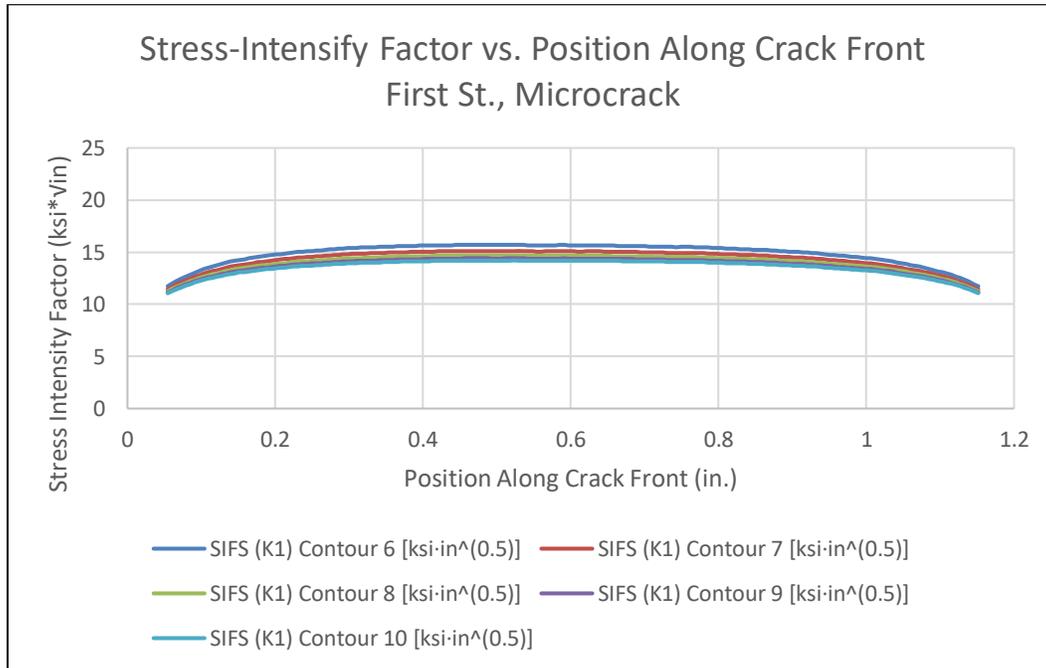
**Fig. 135. Stress intensity factor ( $K_I$ ) versus position along crack front for the microcrack in the First Street FE model under groove-weld-shrinkage loading. Contours 6 through 10 show a converging trend (from top curve to bottom curve) toward a  $K_I$  of approximately  $14 \text{ ksi}\sqrt{\text{in}}$ .**

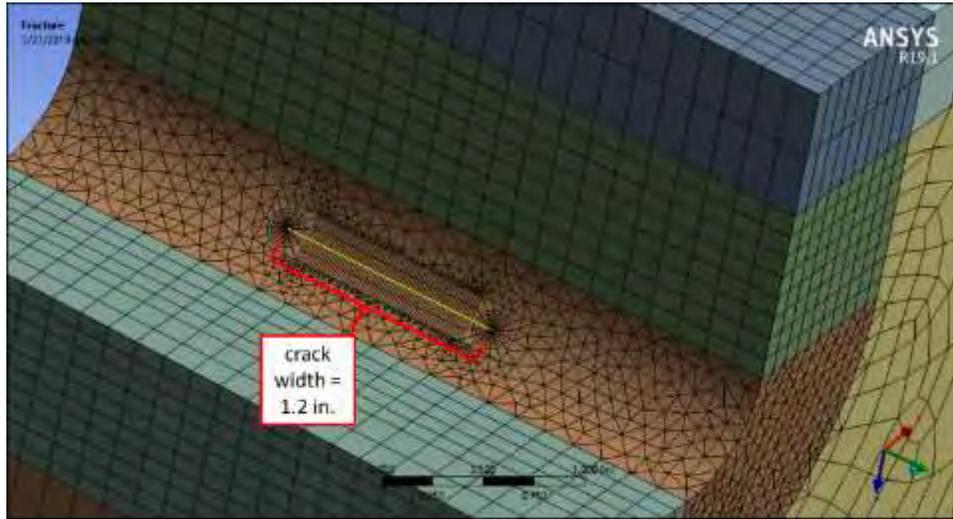
**Fig. 136. Crack mesh of First Street FE model. Crack is semi-elliptical, 0.38 in. deep x 1.2-in. wide, 0.38-in. representing the pop-in crack. Free surface of crack shown in yellow. Structured character of specialized mesh local to crack is evident.**

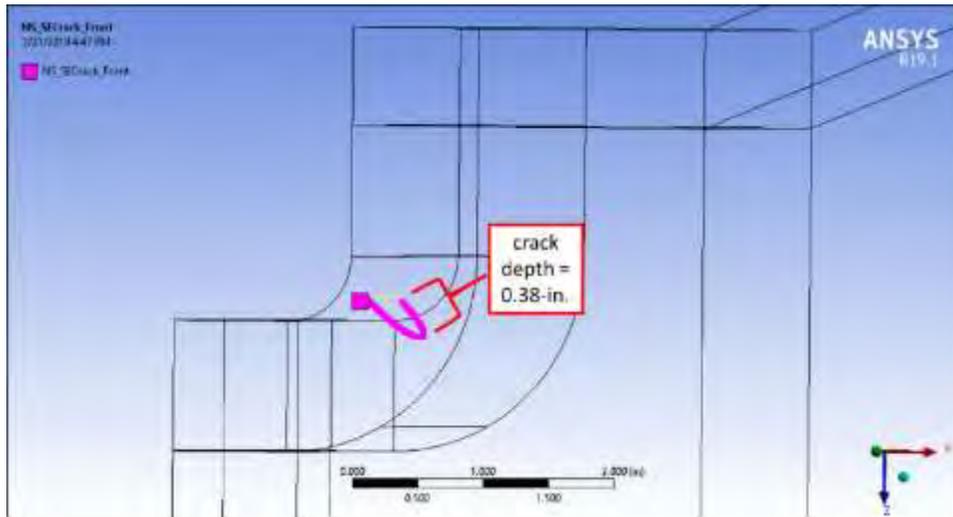
**Fig. 137. Wireframe view showing depth of the pop-in crack of First Street FEM. Purple line shows the crack front.**

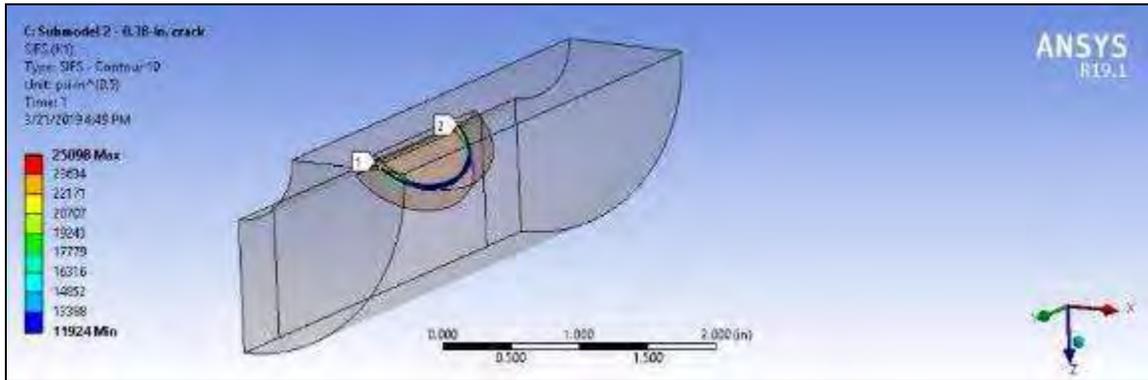
**Fig. 138. Pop-in crack stress intensity factor for the First Street FE model subject to weld-shrinkage loading. Plot corresponds to the outermost contour around the crack front, with a peak  $K_I$  of approximately 12 ksi $\sqrt{\text{in}}$ . (blue) stress-intensity-factor (SIF) plot for First Street FEM under groove-weld-shrinkage loading.**

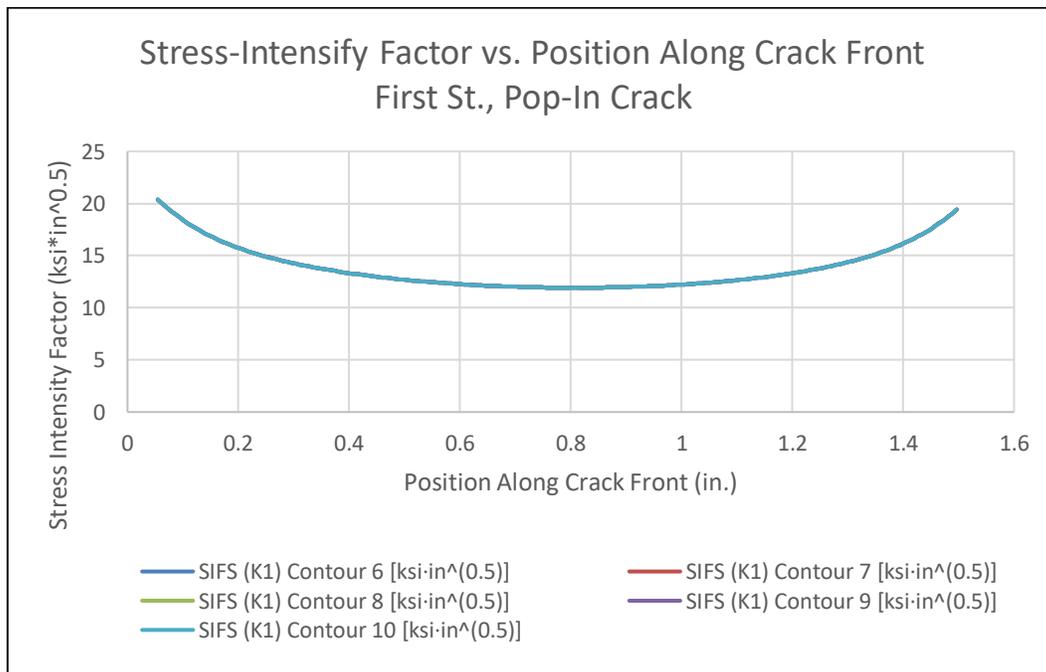
**Fig. 139. Stress intensity factor ( $K_I$ ) versus position along crack front for the microcrack in the First Street FE model under groove-weld-shrinkage loading. Contours 6 through 10 show a converging trend (from top curve to bottom curve) toward a  $K_I$  of approximately 12 ksi $\sqrt{\text{in}}$ .**

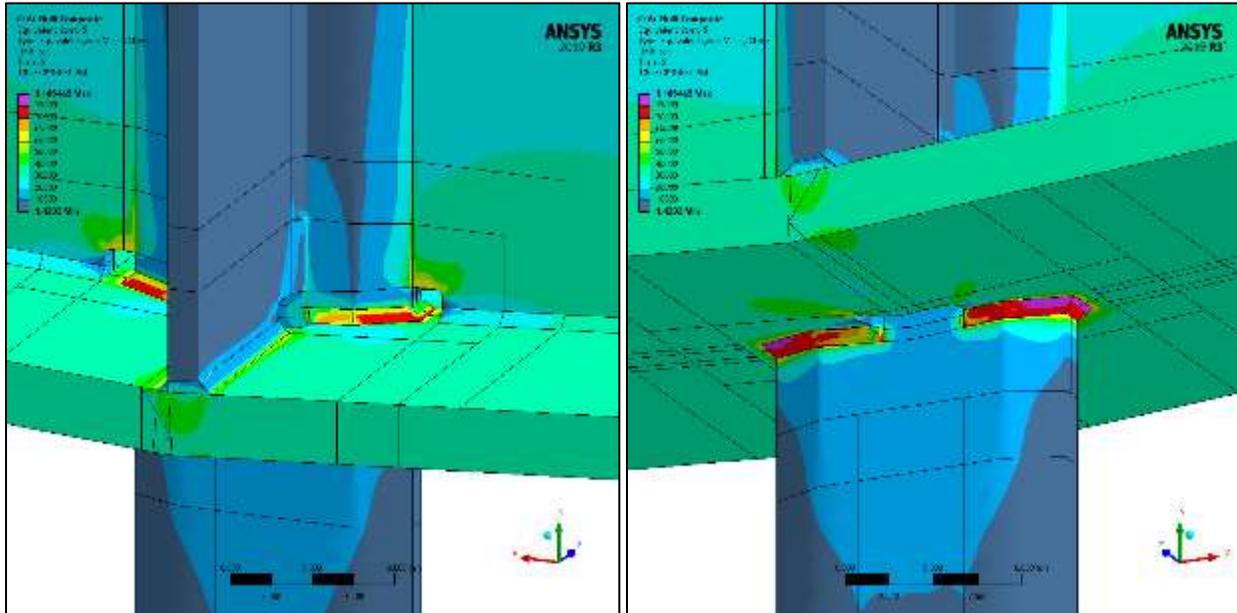
**Fig. 149. Equivalent (von Mises) stress plots, view from Southeast looking Northwest.**

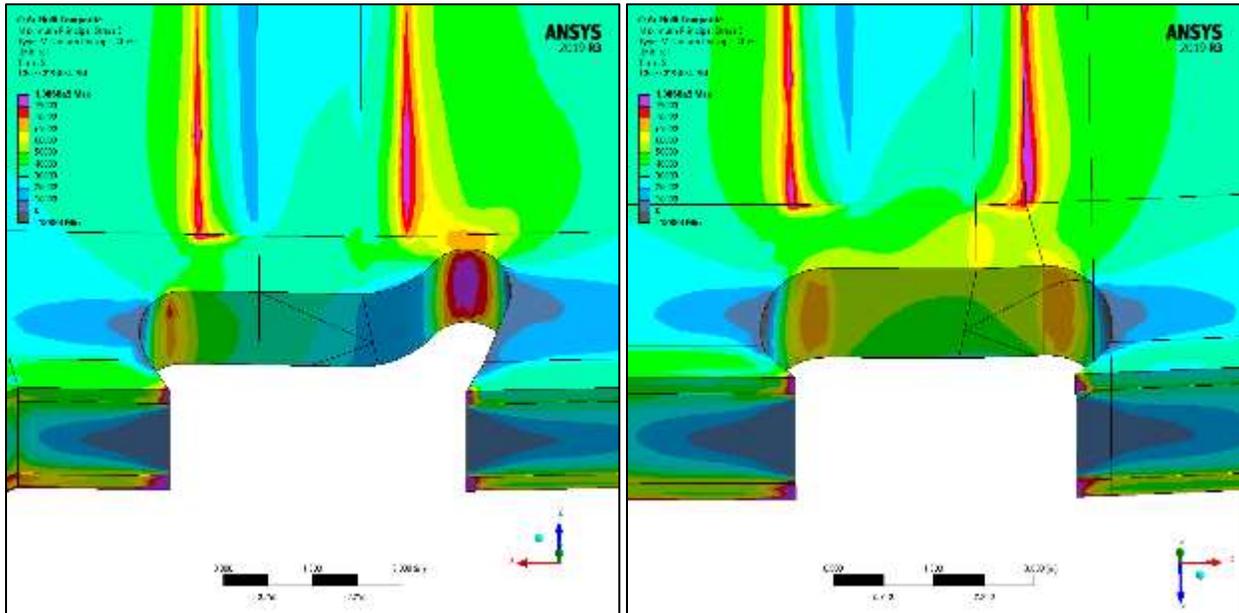
**Fig. 150. Maximum principal stress plots of north-side (left) and south-side (right) weld access holes.**

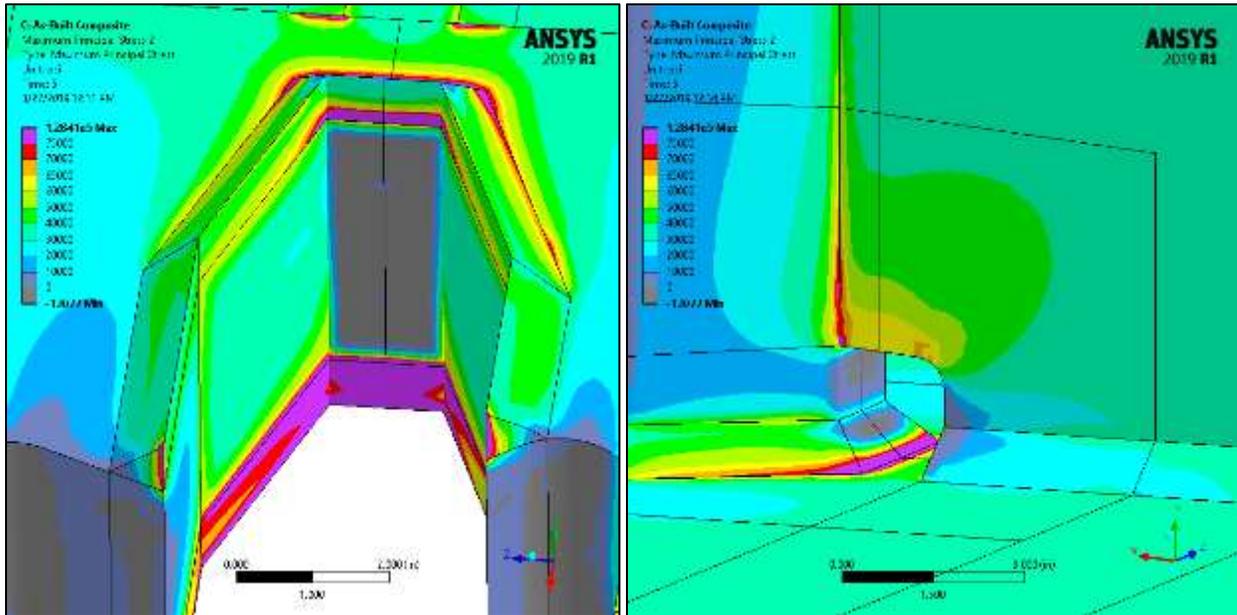
**Fig. 151. Maximum principal stress plots of bottom flange hanger slot (left) and web access hole (right).**

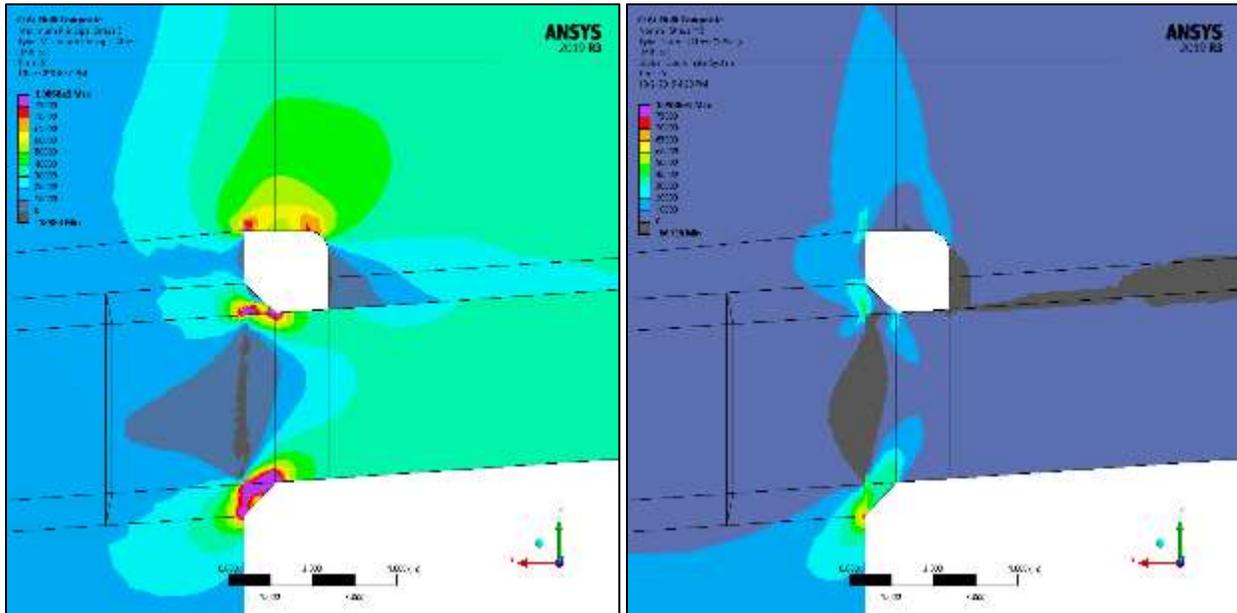
Fig. 152. Web access hole centerline section view of maximum principal stress (left) and vertical stress component (right).

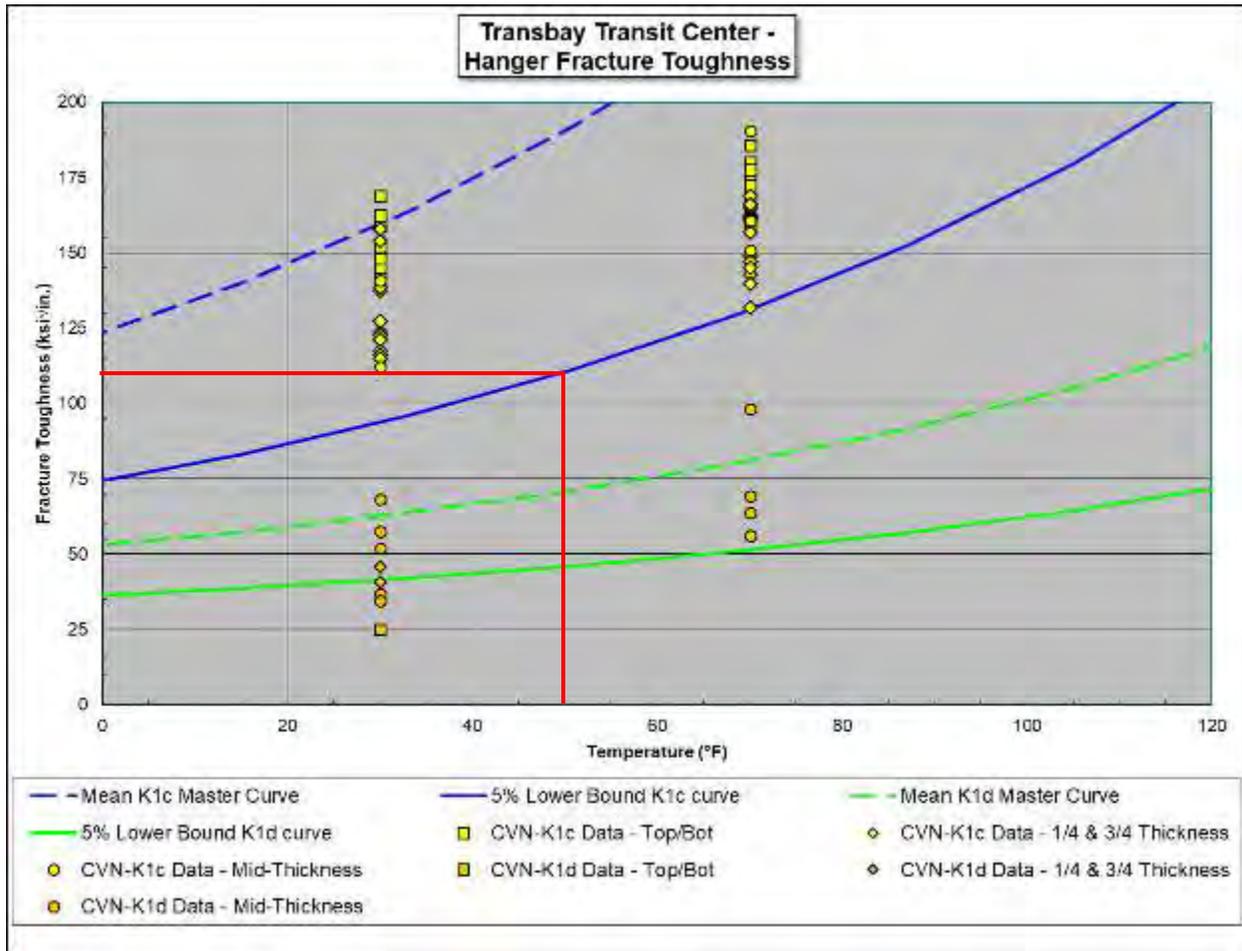
**Fig. 153. Hanger fracture toughness data.**

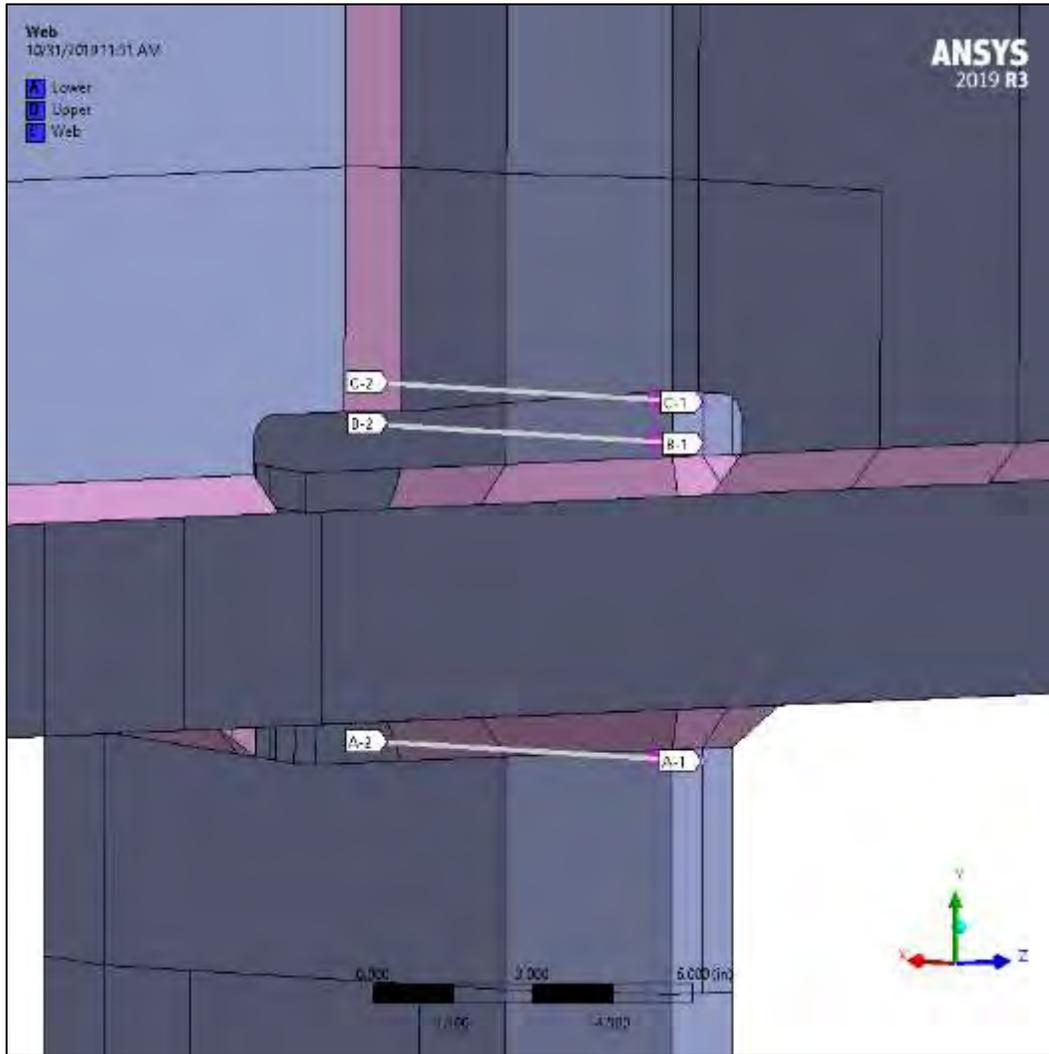
Fig. 154. Paths for hanger stress output.

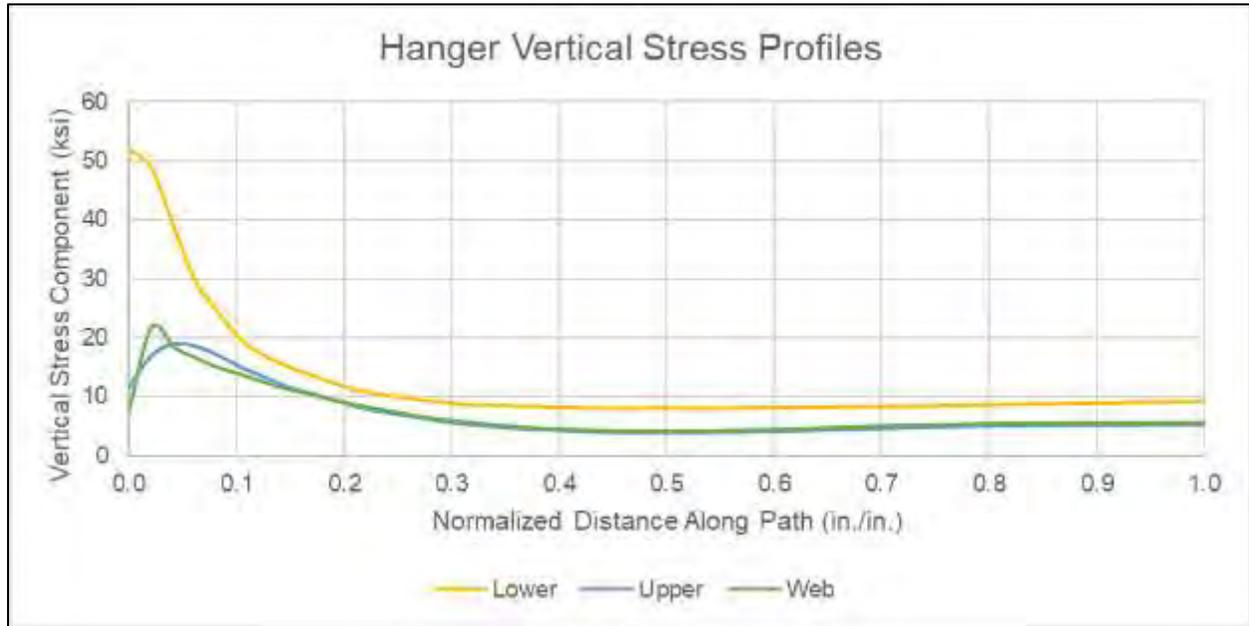
**Fig. 155. Vertical stress component profiles in the hanger when subjected to the factored design loads.**

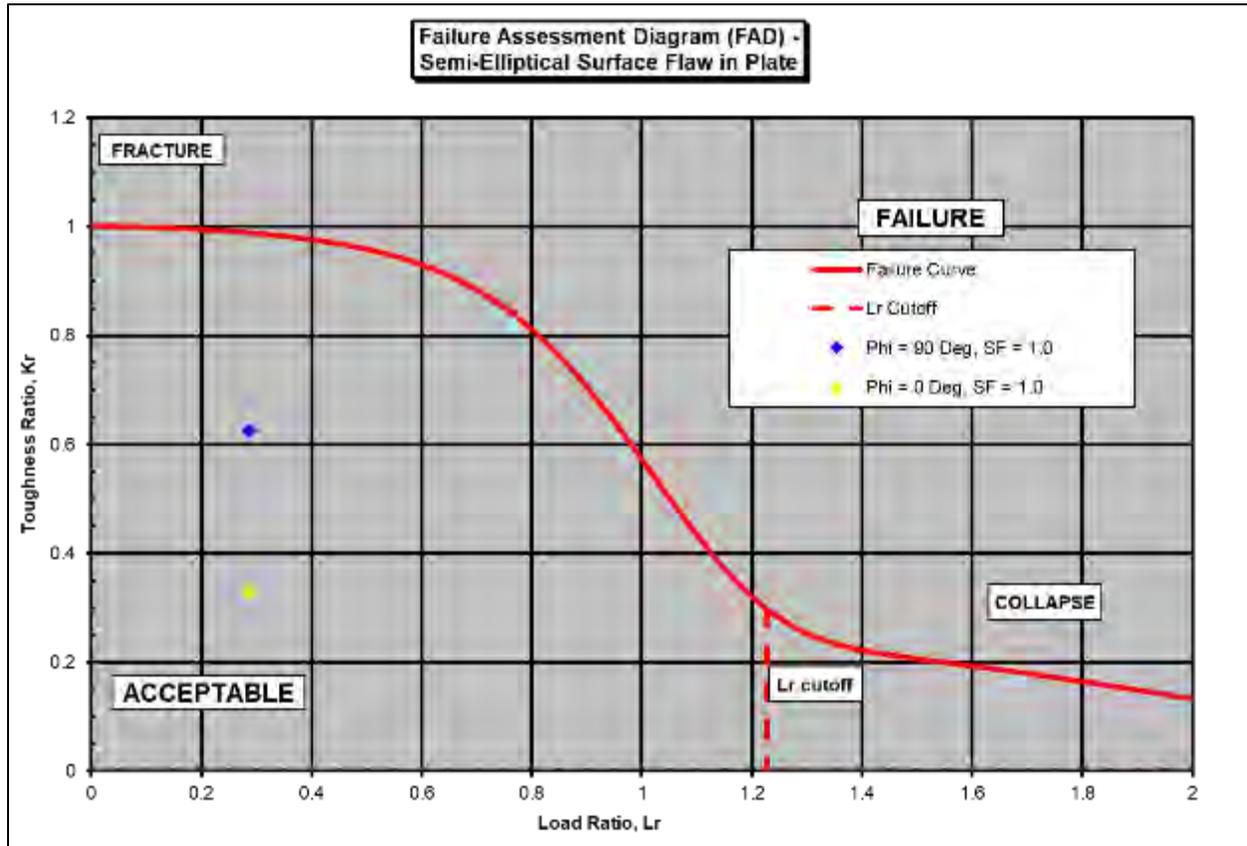
Fig. 156. FAD calculation results for an assumed 1.2 × 0.125-in. semi-elliptical surface flaw on the hanger in the as-built condition when subjected to the factored design loads.

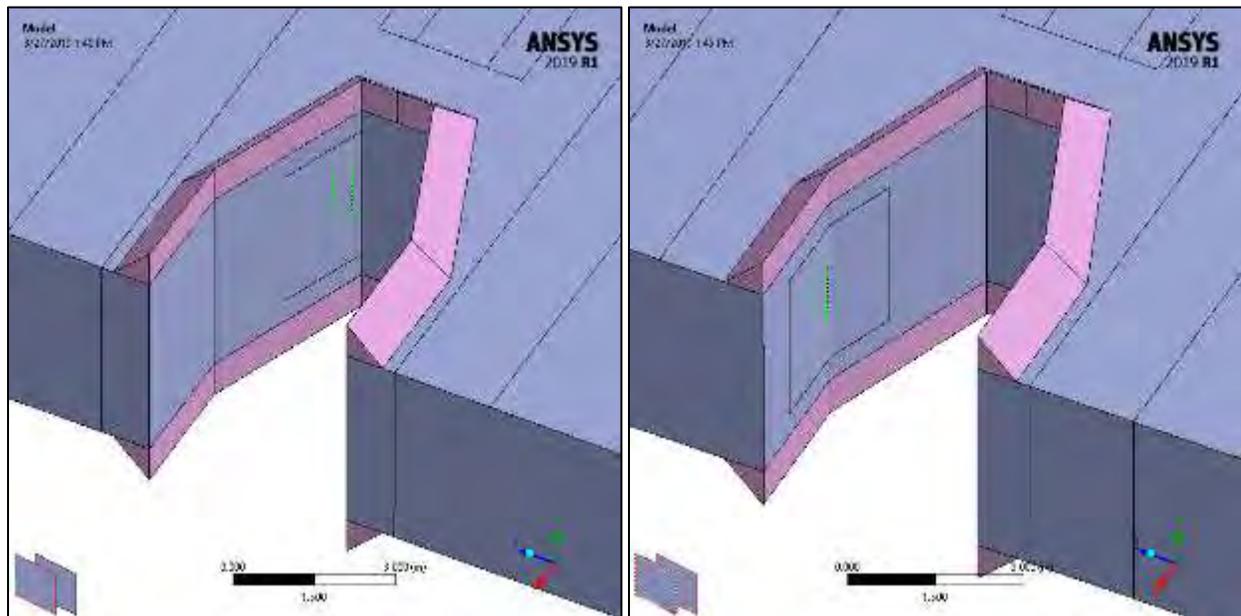
**Fig. 157. Bottom flange hanger slot end corner crack (left) and transition corner crack (right). Hanger, stiffener, and web plates are hidden from view.**

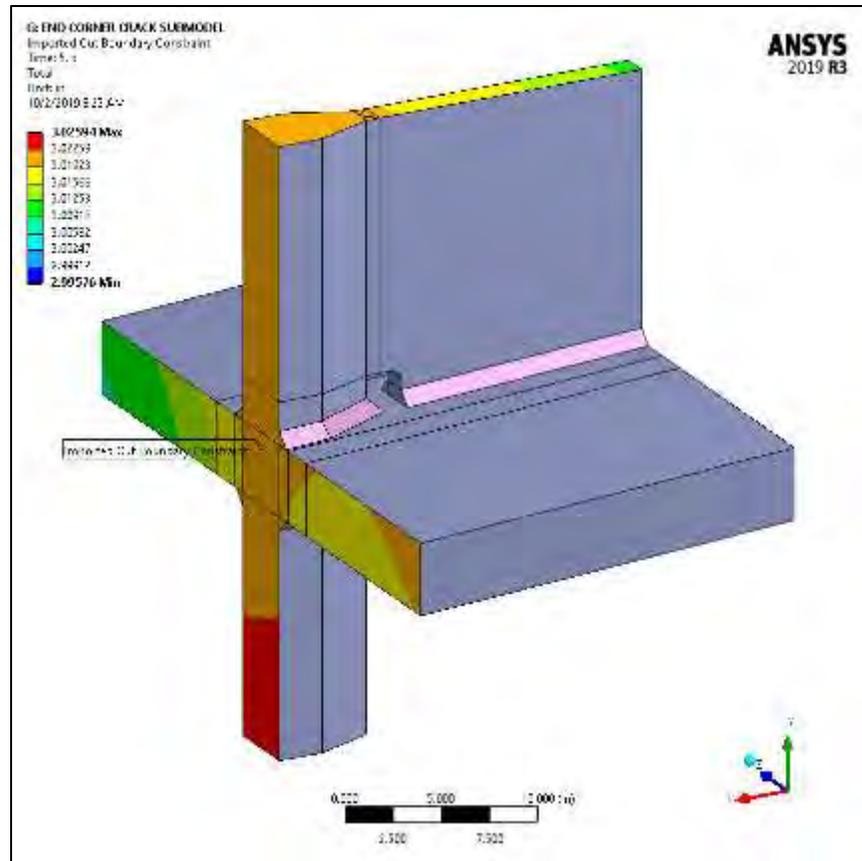
**Fig. 158. Submodel with representative cut boundary displacement constraints.**

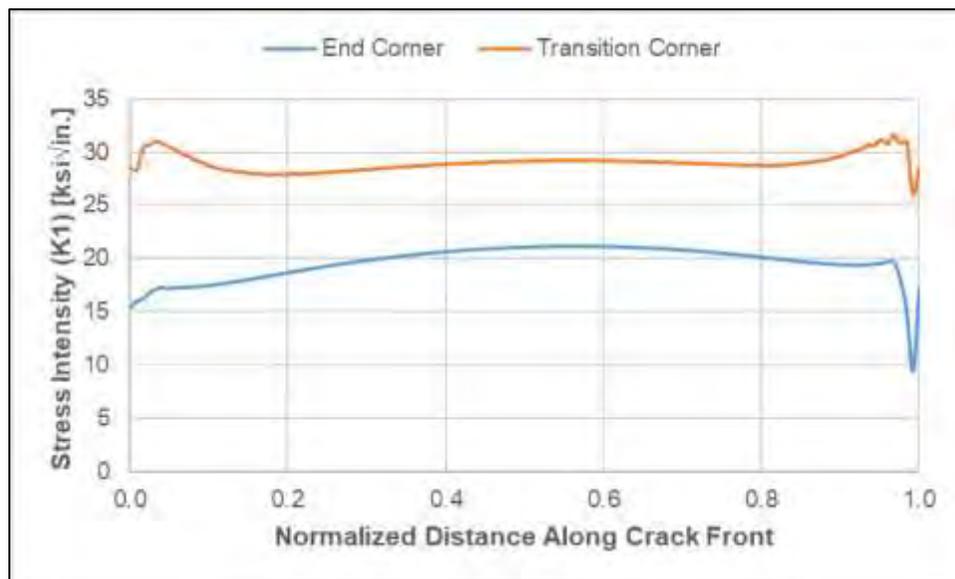
Fig. 159. Stress intensity factors along the end corner and transition corner semi-elliptical crack fronts.

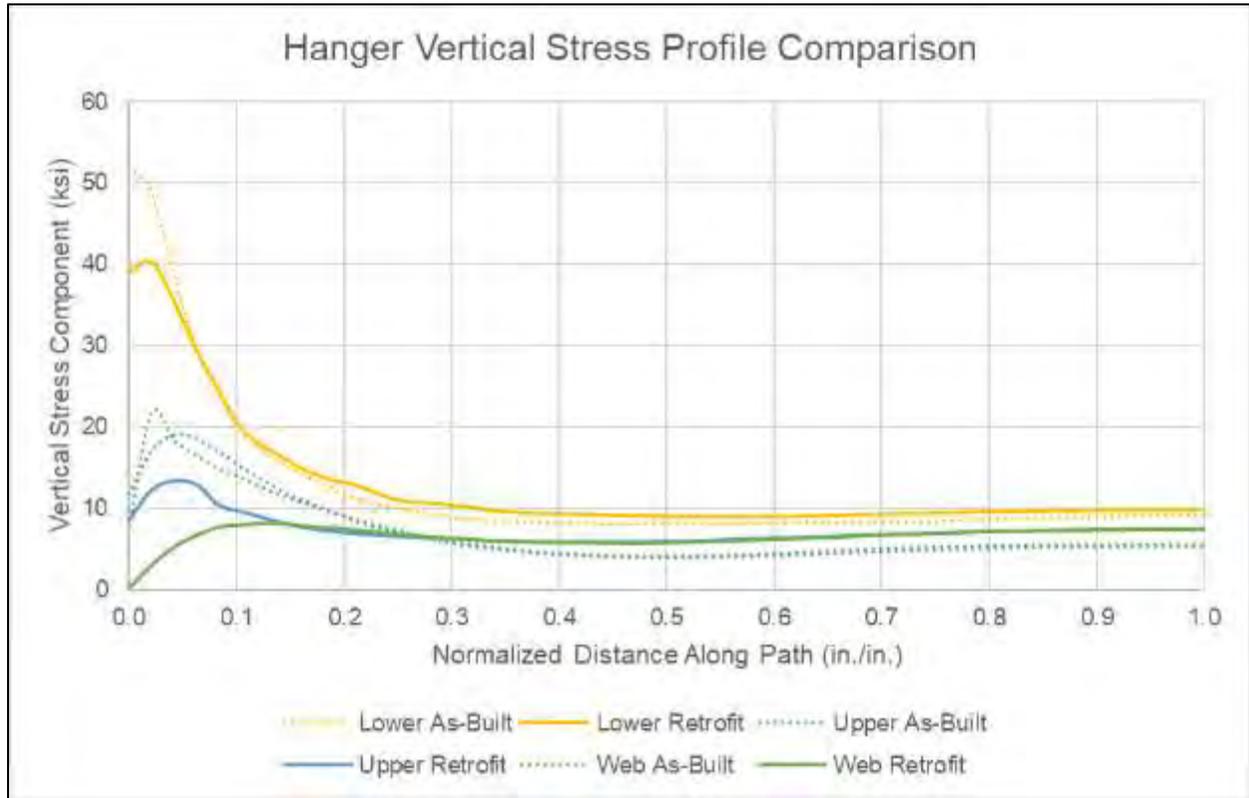
**Fig. 173. Comparison of hanger vertical stress profiles.**

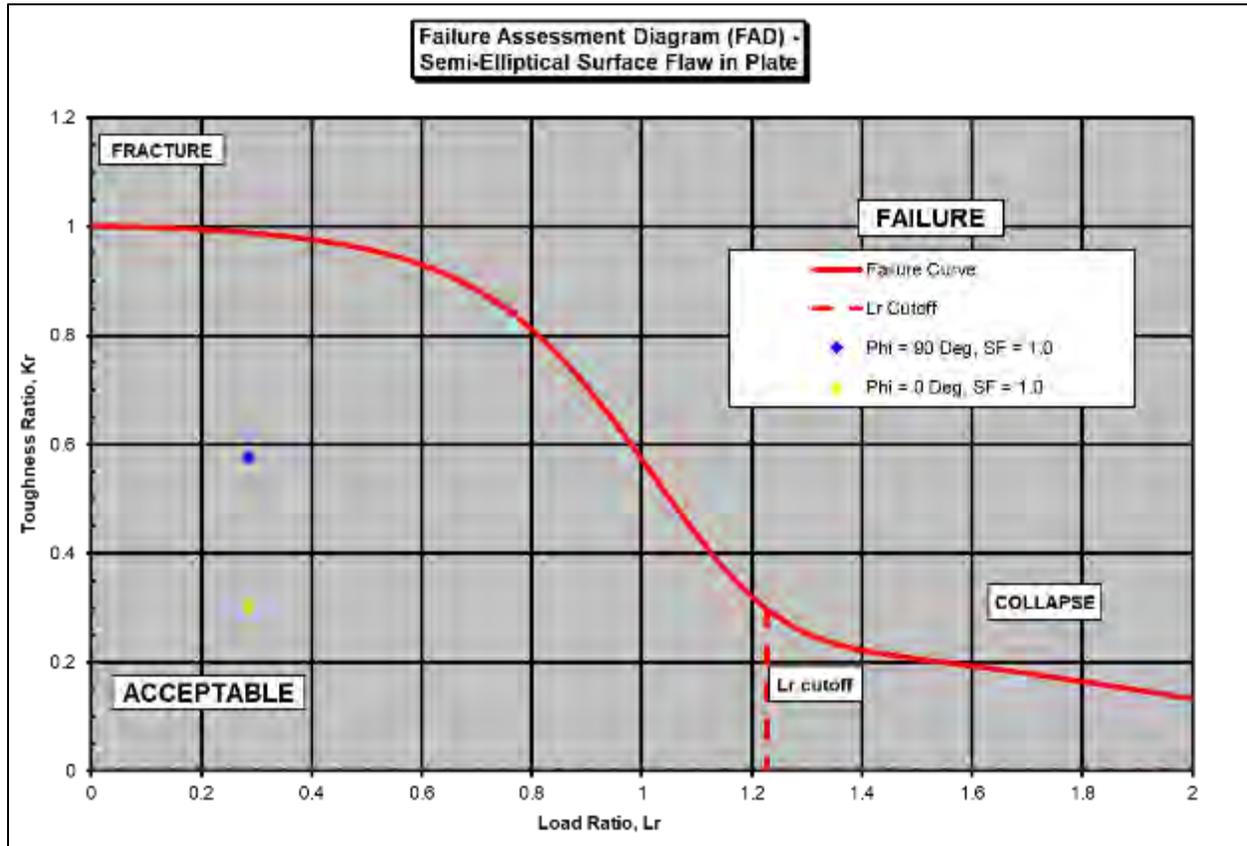
Fig. 174. FAD calculation results for an assumed 1.2 × 0.125-in. semi-elliptical surface flaw on the hanger in the as-built condition when subjected to the factored design loads.

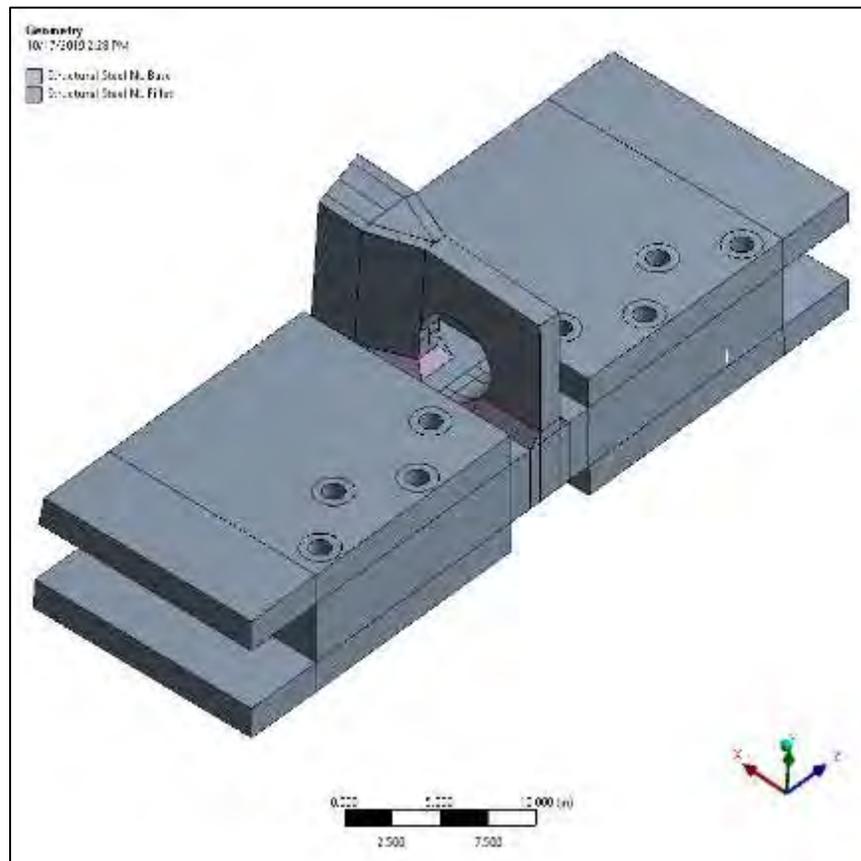
Fig. 175. Retrofit reinforcement submodel.

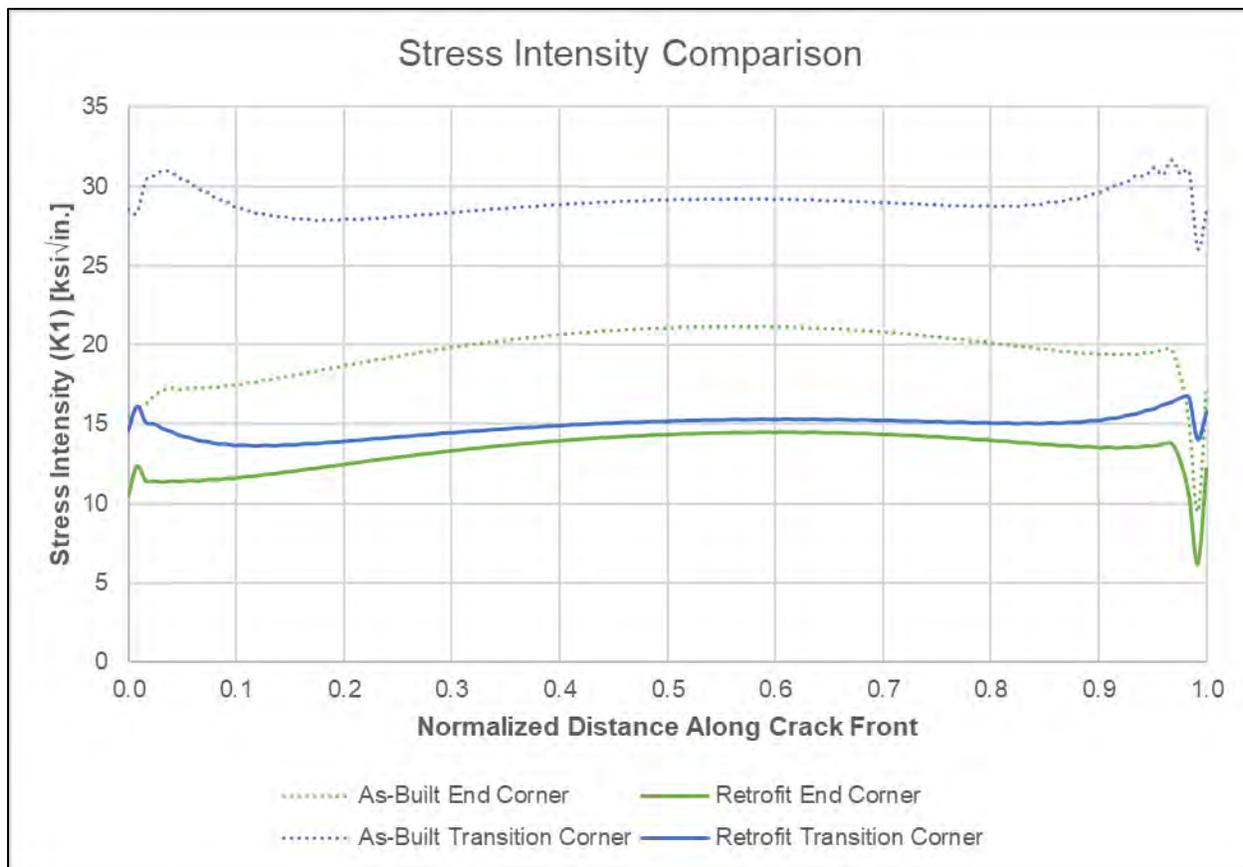
Fig. 176. Comparison of stress intensities between the retrofit and as-built configurations.
