Update on Construction and temporary closure of the Salesforce Transit Center

February 14, 2019

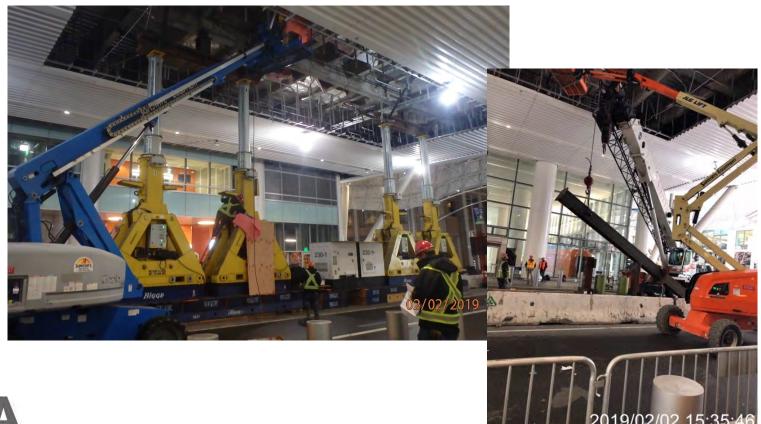
Steel column shoring installed at First street in preparation for the permanent plate installation.

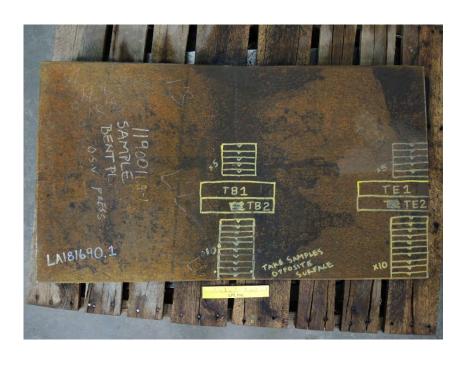
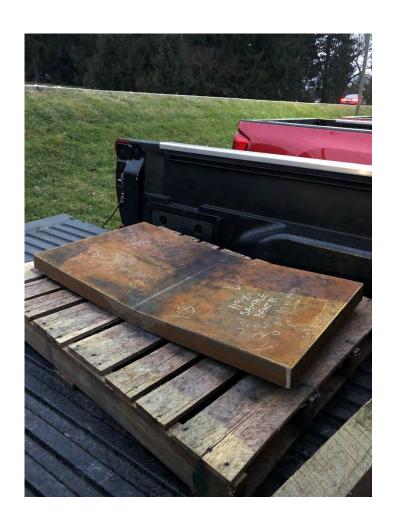
Sample plate being tested at LPI lab

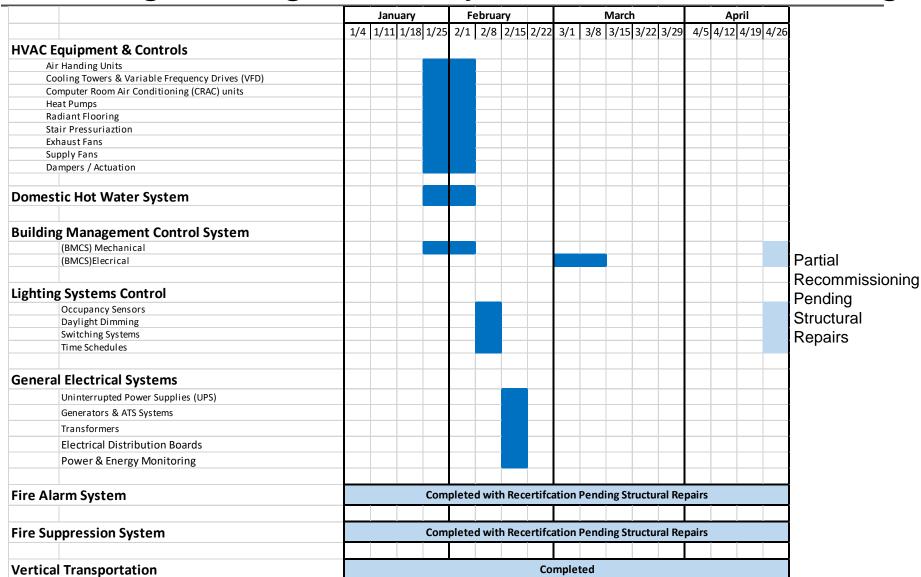
- Building Management Systems Commissioning
 - Commissioning Progress
 - Pre-functional Check-list Status:
 - Vertical Transportation Systems Complete
 - Fire/Life/Safety Complete (pending repair completion)
 - HVAC 75% complete or in process (remaining pending repairs)
 - Hot Water, BMS, Lighting & Electrical not started
 - Functional Performance Testing
 - Implement Testing Plan per Schedule (update)
 - Measure, Monitor & Report on Functional Test
 - Validate Systems Performance
 - Closeout Documentation Status:
 - Submitted Items 317
 - Unsubmitted Items 542
 - Normal Operations
 - Continual Systems Operational Parameters Monitored
 - Real-time Systems Reporting and Alarming of Issues or Failures
