**STAFF REPORT FOR CALENDAR ITEM NO.: 6  
FOR THE MEETING OF: June 13, 2019**

**TRANSBAY JOINT POWERS AUTHORITY**

This report is a summary of the events, analyses, findings, and signoff related to the fissures found on September 25, 2018, in two steel girders over Fremont street and their repair. In addition, it addresses the review and conclusions related to 1) the similarly designed girders located at First Street (which did not experience fissures), and 2) the comprehensive building-wide review effort undertaken of both structural steel and non-structural steel elements. Based on the completion of work and conclusions of the independent peer review panel, the transit center is being readied for re-activation by July 1, 2019.

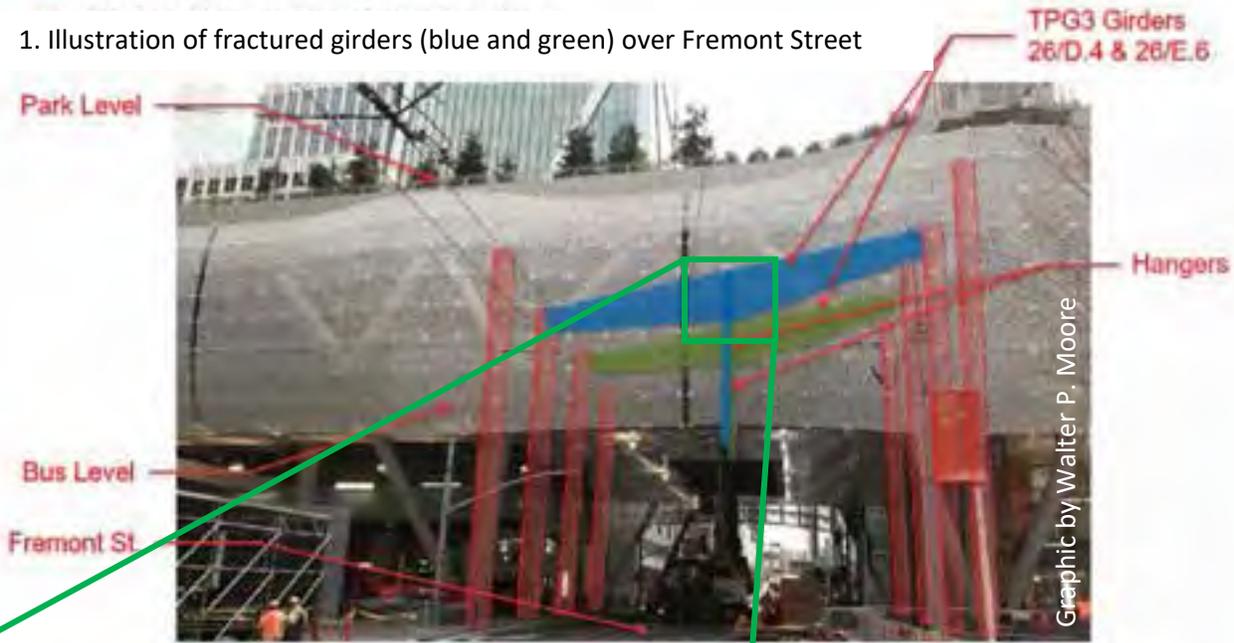
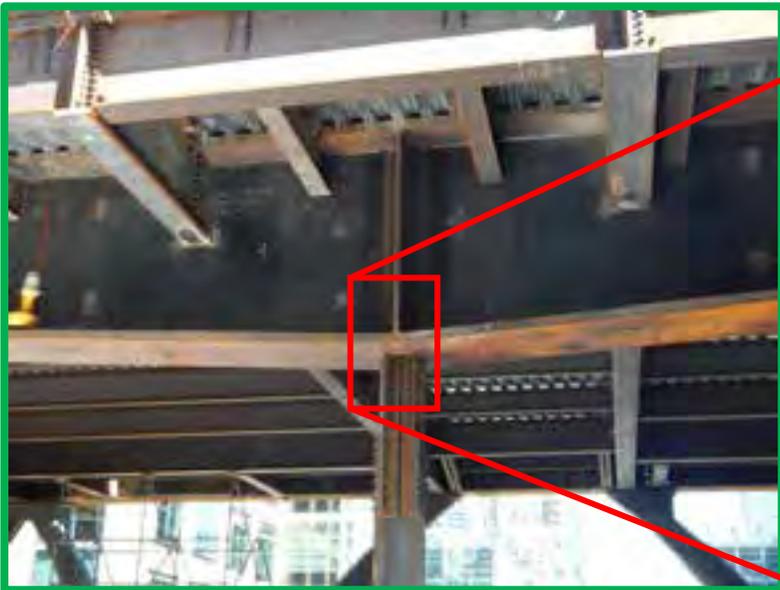
1. Illustration of fractured girders (blue and green) over Fremont Street

- August 12, 2018: Transit Center opens for bus operations.
- September 25, 2018: Workers installing ceiling panels discover a fracture in the bottom flange of a girder over Fremont (see Images 1-3 on page 3). TJPA closes the Transit Center. In the following days, TJPA discovers a fracture in a second similarly designed girder over Fremont Street. Two other girders over First Street share the design of the fractured girders but remain intact. TJPA installs shoring at Fremont and First Street.

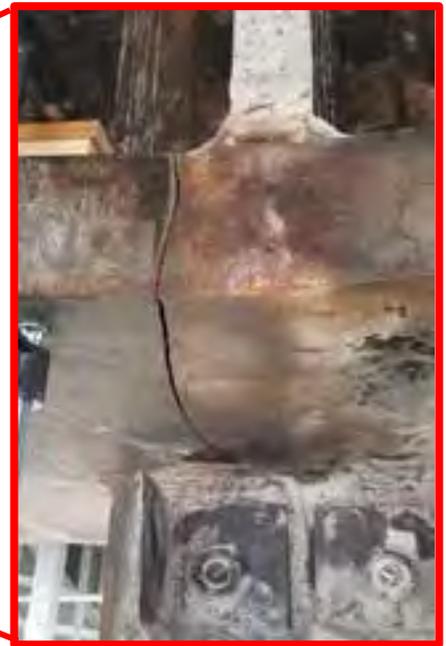
2. Hanger-to-girder connection at site of fracture (before fracture)

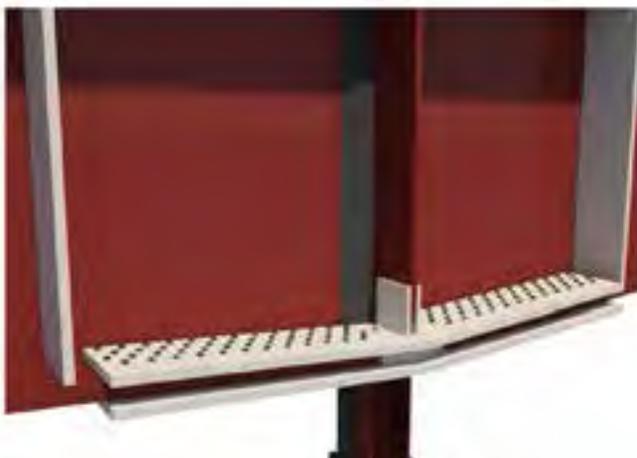
3. Fracture through bottom flange

In December 2018, the results of the material testing pointed to a preliminary hypothesis that the cause of failure was a result of: material properties (low fracture toughness at the mid-thickness of four-inch-thick steel plates); the presence of initiating defects (micro-cracks introduced by the flame cutting of slots); and stress across the fracture plane (residual stress due to adjacent welding, and applied stress from loads on the girders after erection).

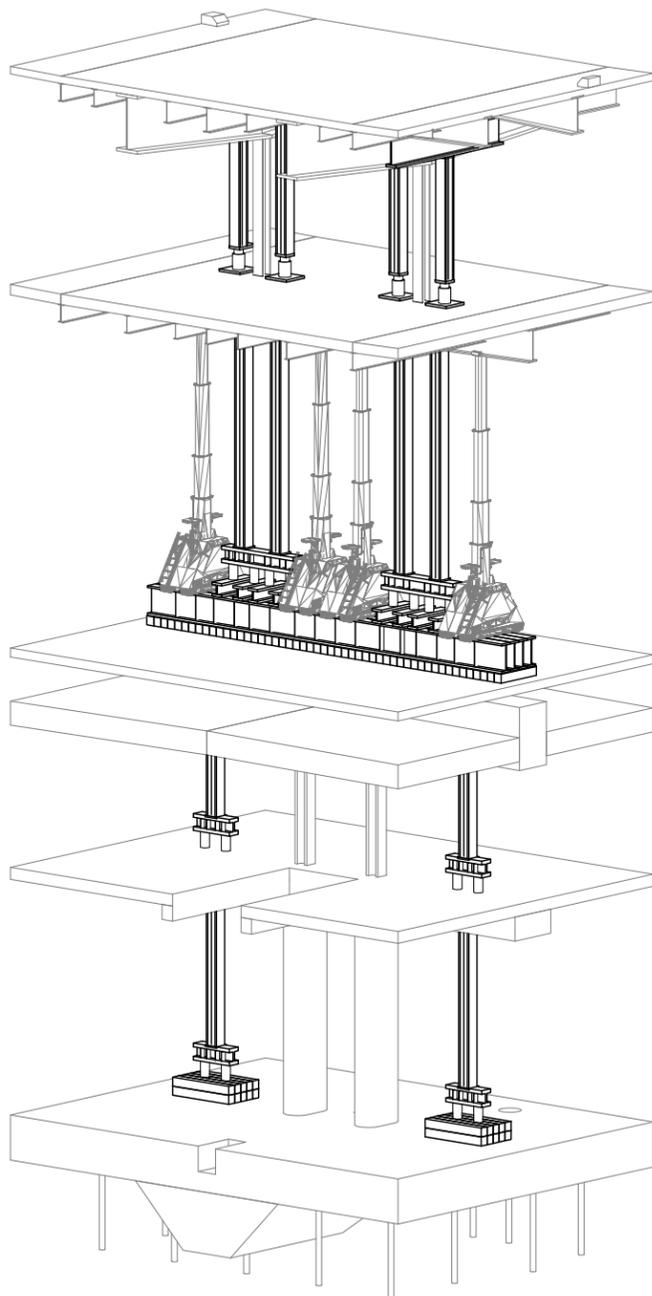
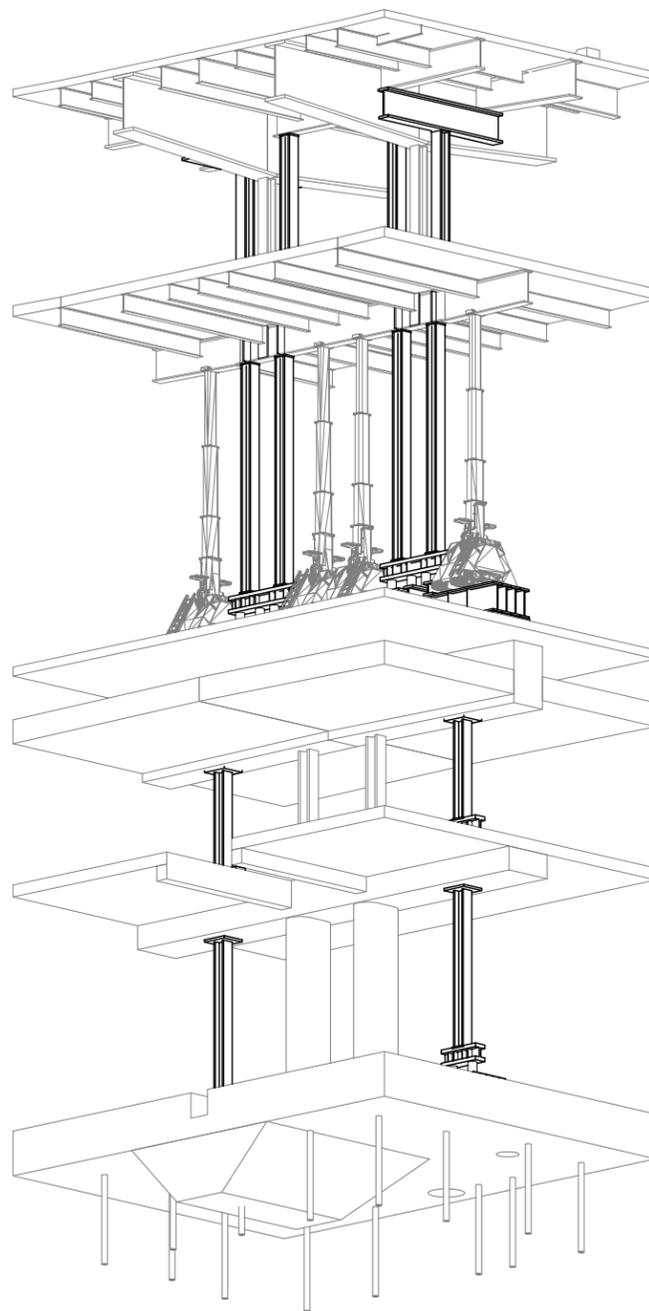
**S1-8105**

**1 OVERALL 3D**  
NOT TO SCALE

**2 OVERALL 3D FROM BELOW**  
NOT TO SCALE

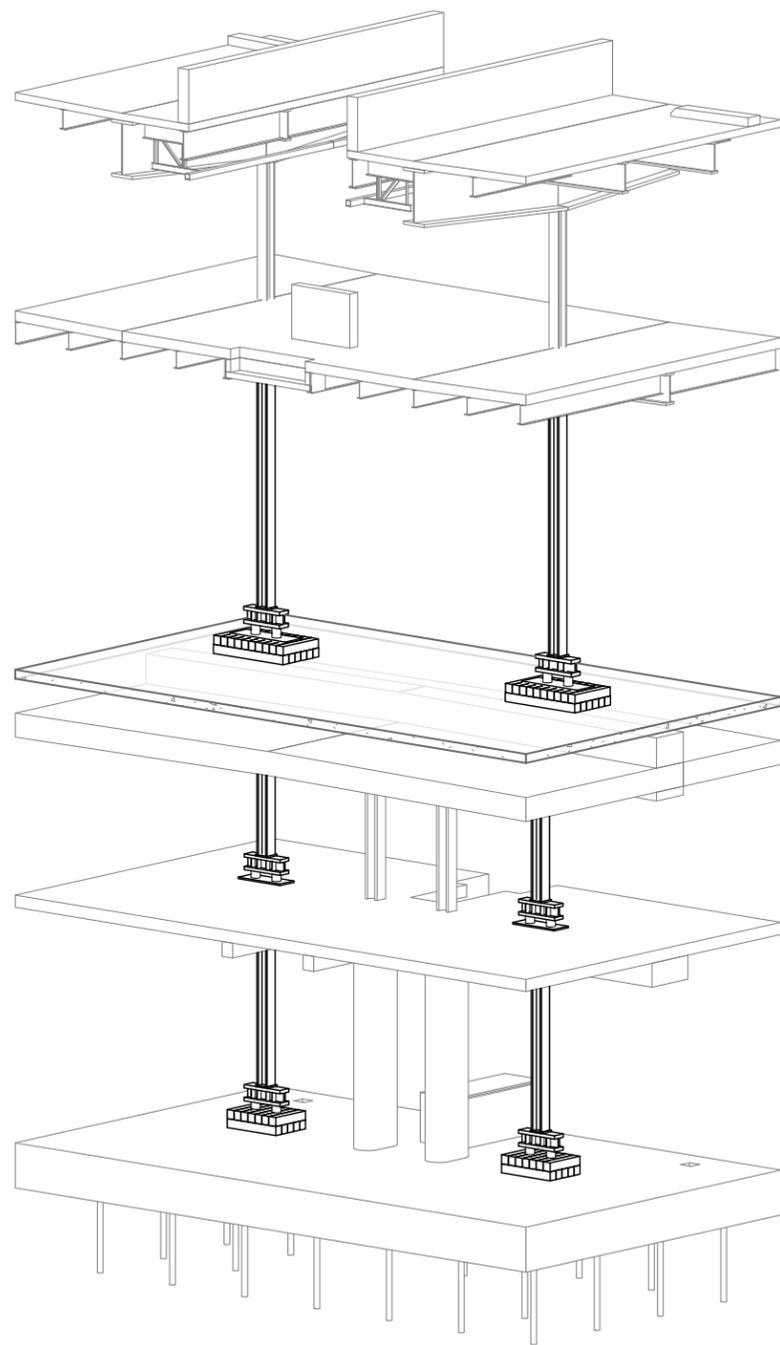
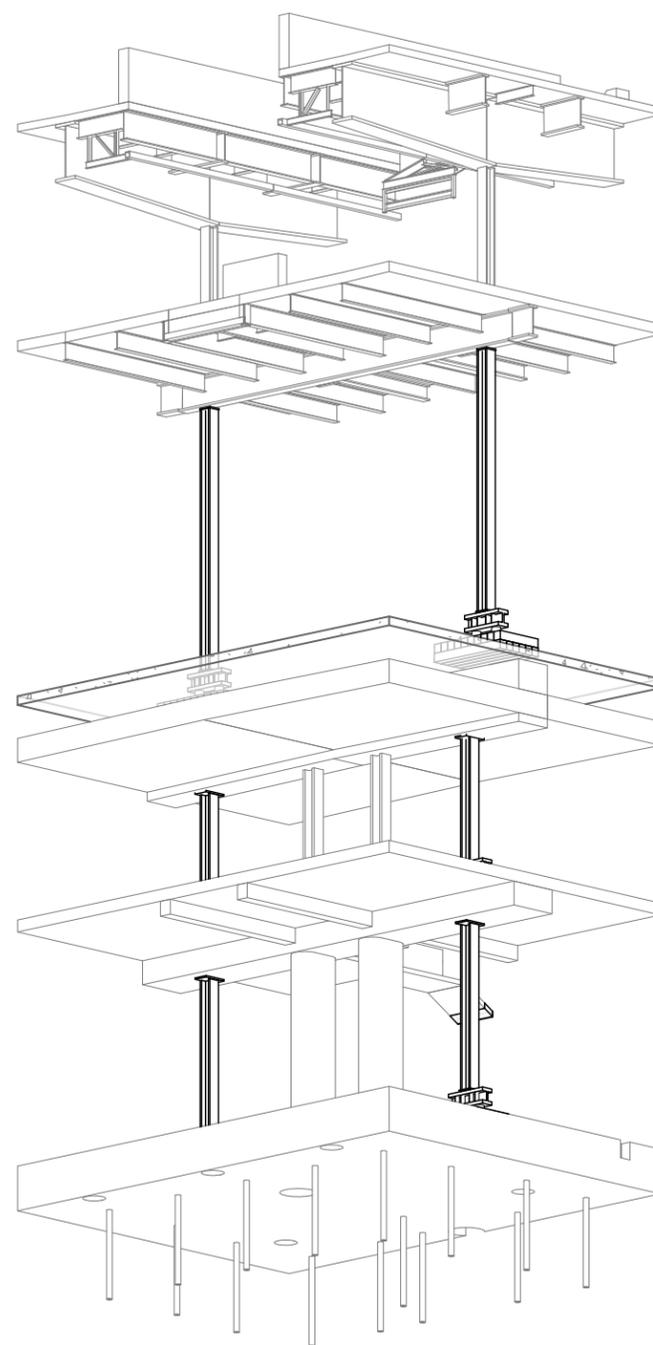
**ISOMETRIC VIEW AT FIRST STREET (GL 18)**

**1 ISOMETRIC AT FIRST STREET**  
NOT TO SCALE

**2 ISOMETRIC FROM BELOW**  
NOT TO SCALE

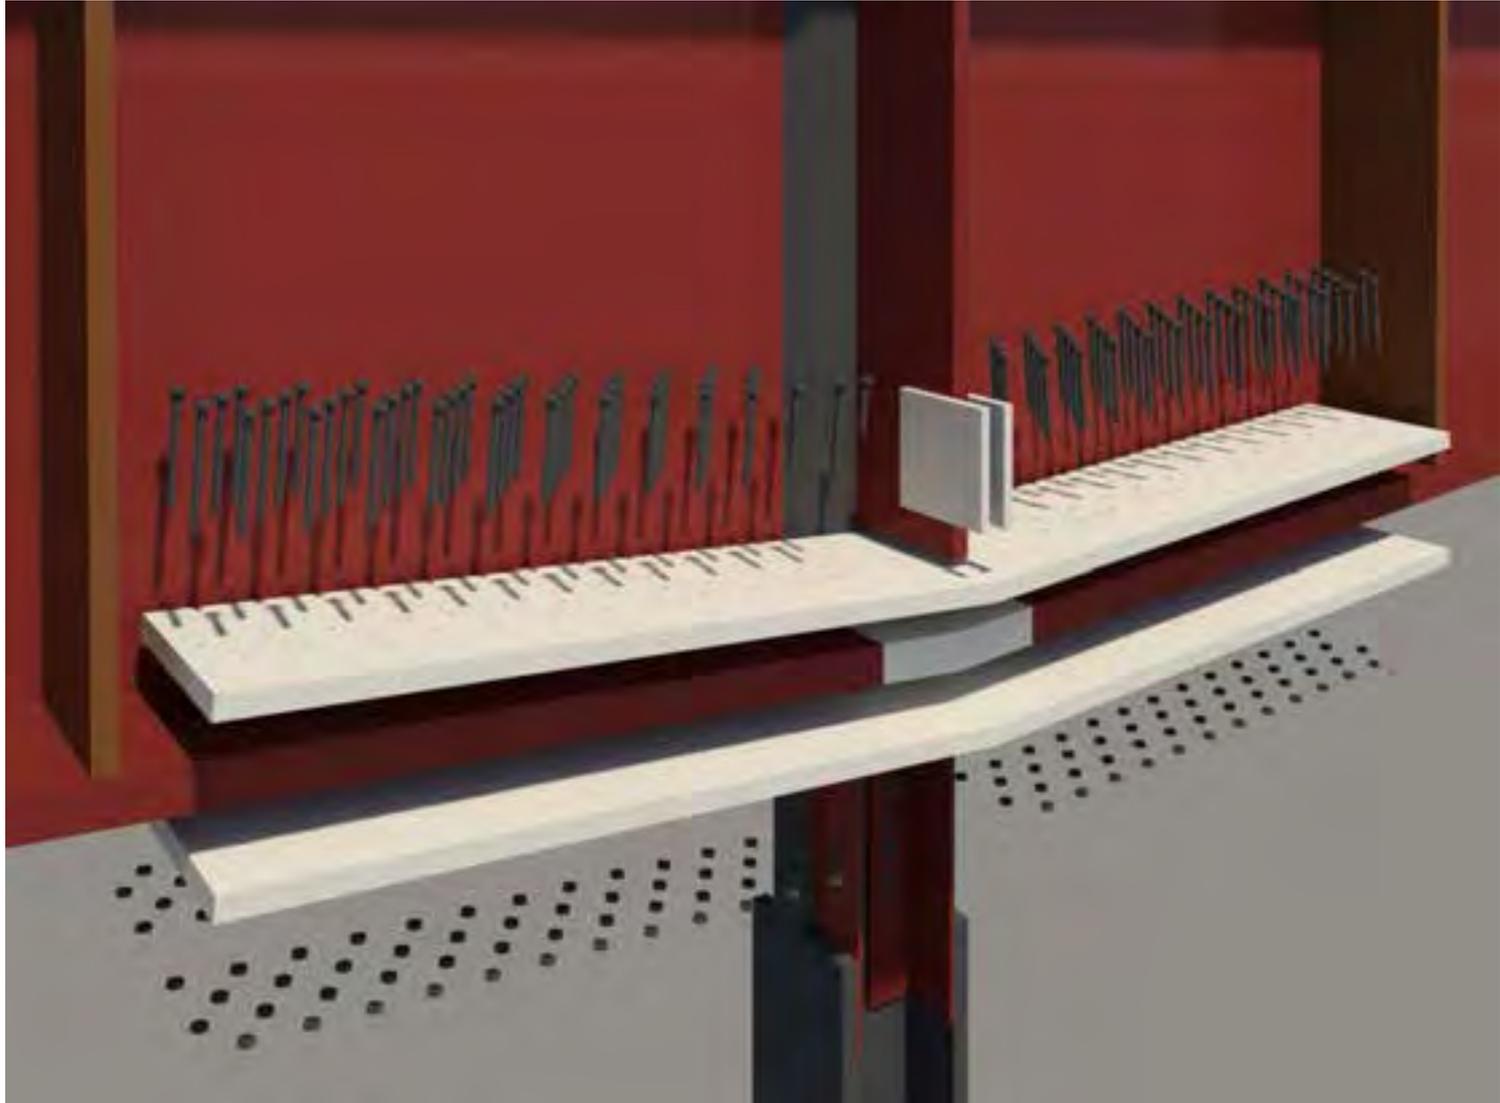
# Girder Remediation Detail

This graphic has details specific to Fremont street girders

The preliminary hypothesis from material testing provided enough knowledge of the cause of failure to allow Thornton Tomasetti to design a repair. The repair is a sandwich of steel plates bolted across the fractures (See Image 4 on page 3). The design of the girders at Fremont Street is replicated at First Street. Differences in fabrication reduced the risk of fracture at First Street, but TJPA will implement a retrofit to the First Street girders similar to the repair of the Fremont Street girders as a precautionary measure.

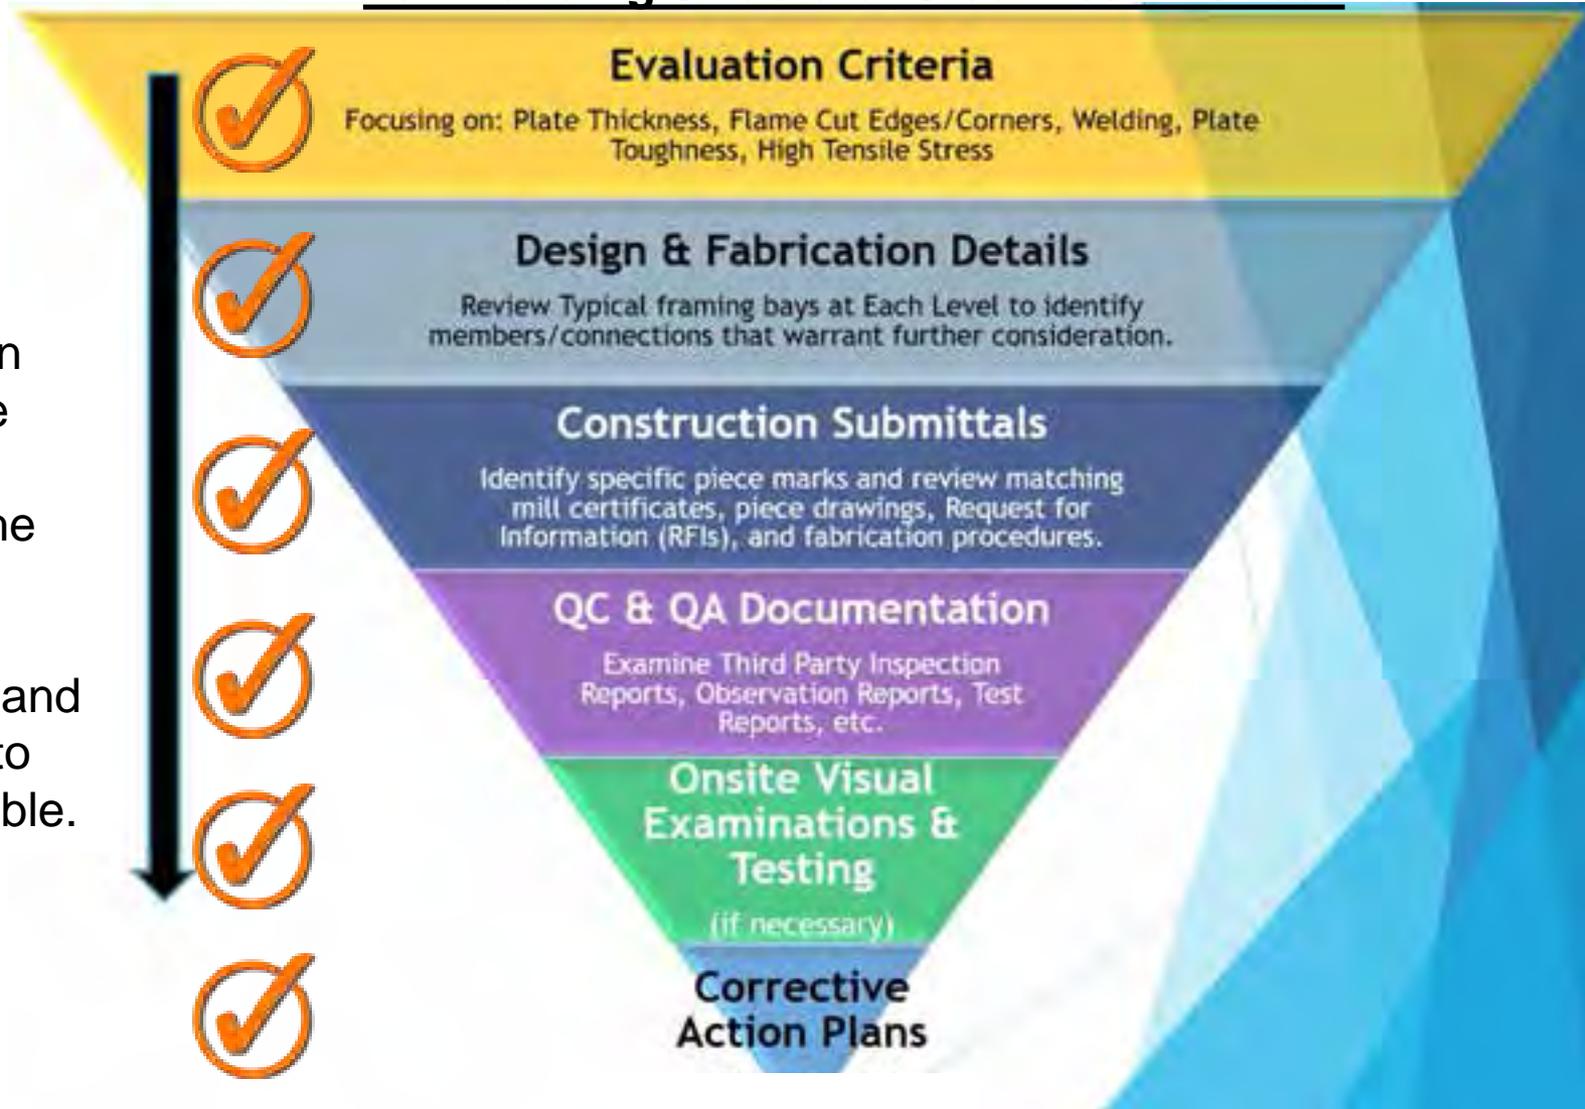
## Full Building Structural Steel Health Check

Progression through the successive sieves of the funnel has been completed and confirmed to be acceptable.
