TRANSBAY JOINT POWERS AUTHORITY

PRESS RELEASE

**TRANSBAY JOINT POWERS AUTHORITY ANNOUNCES
INITIAL INSPECTION RESULTS FOR SALESFORCE
TRANSIT CENTER**

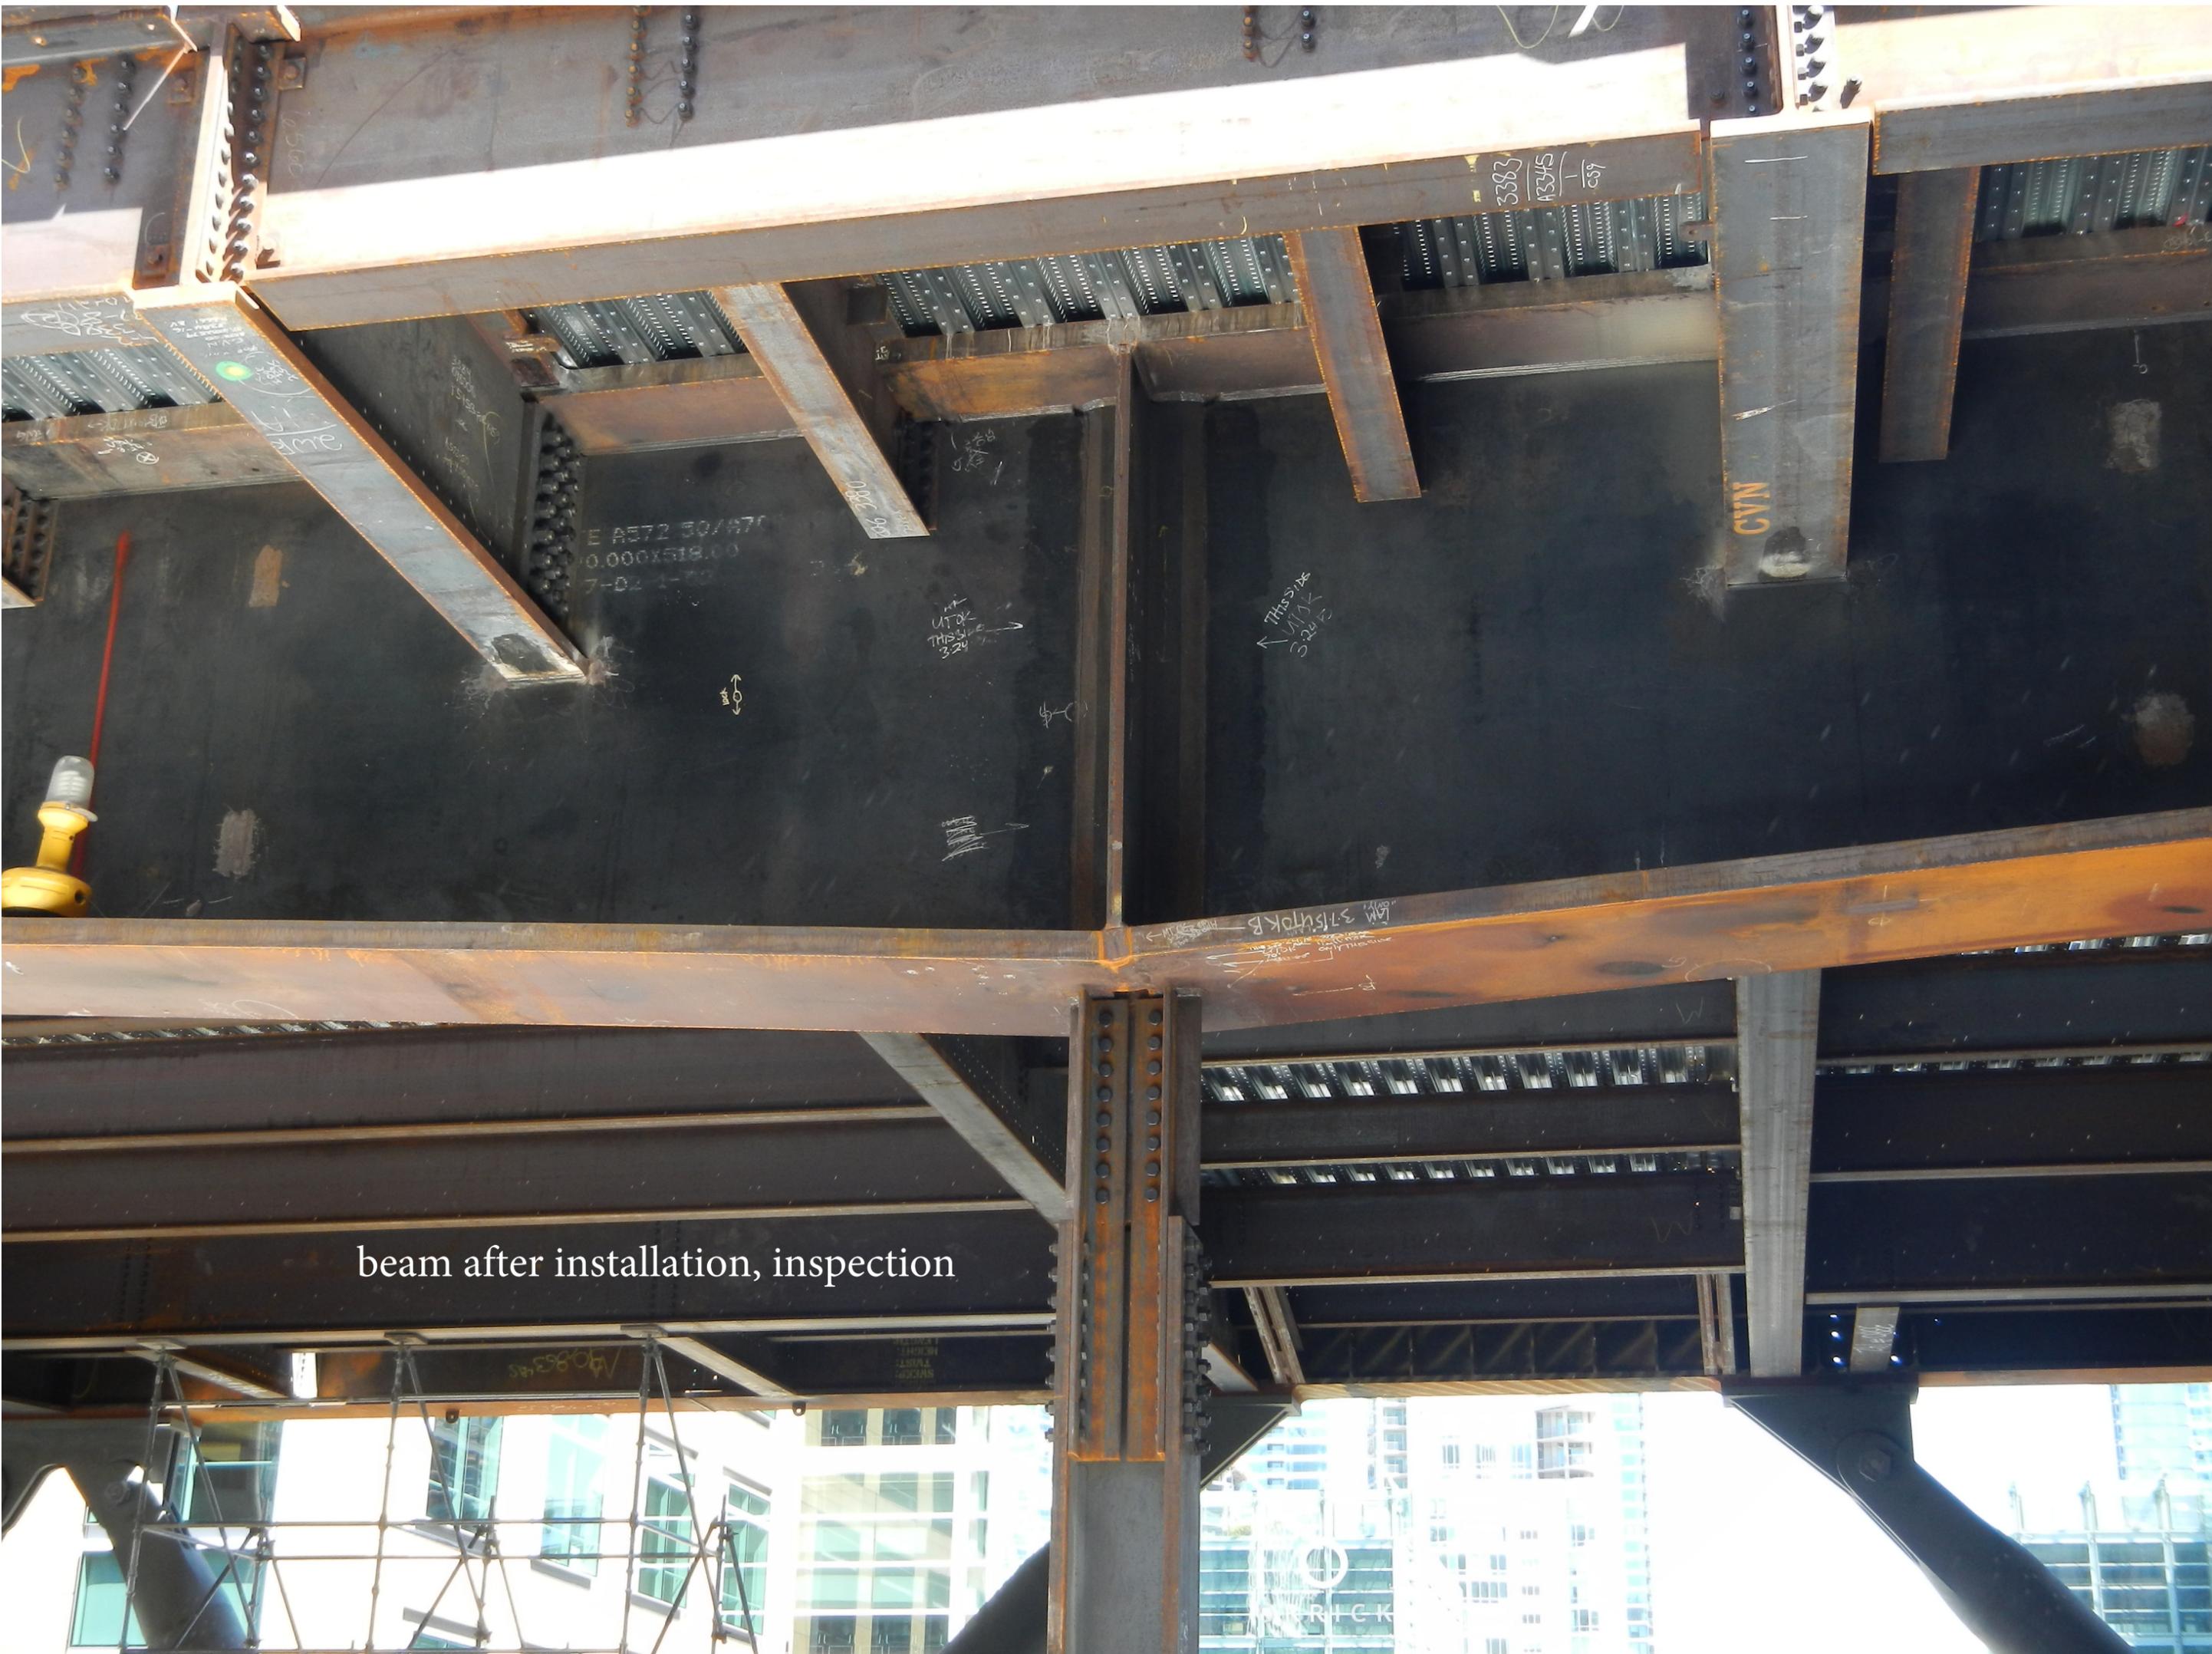
beam after installation, inspection

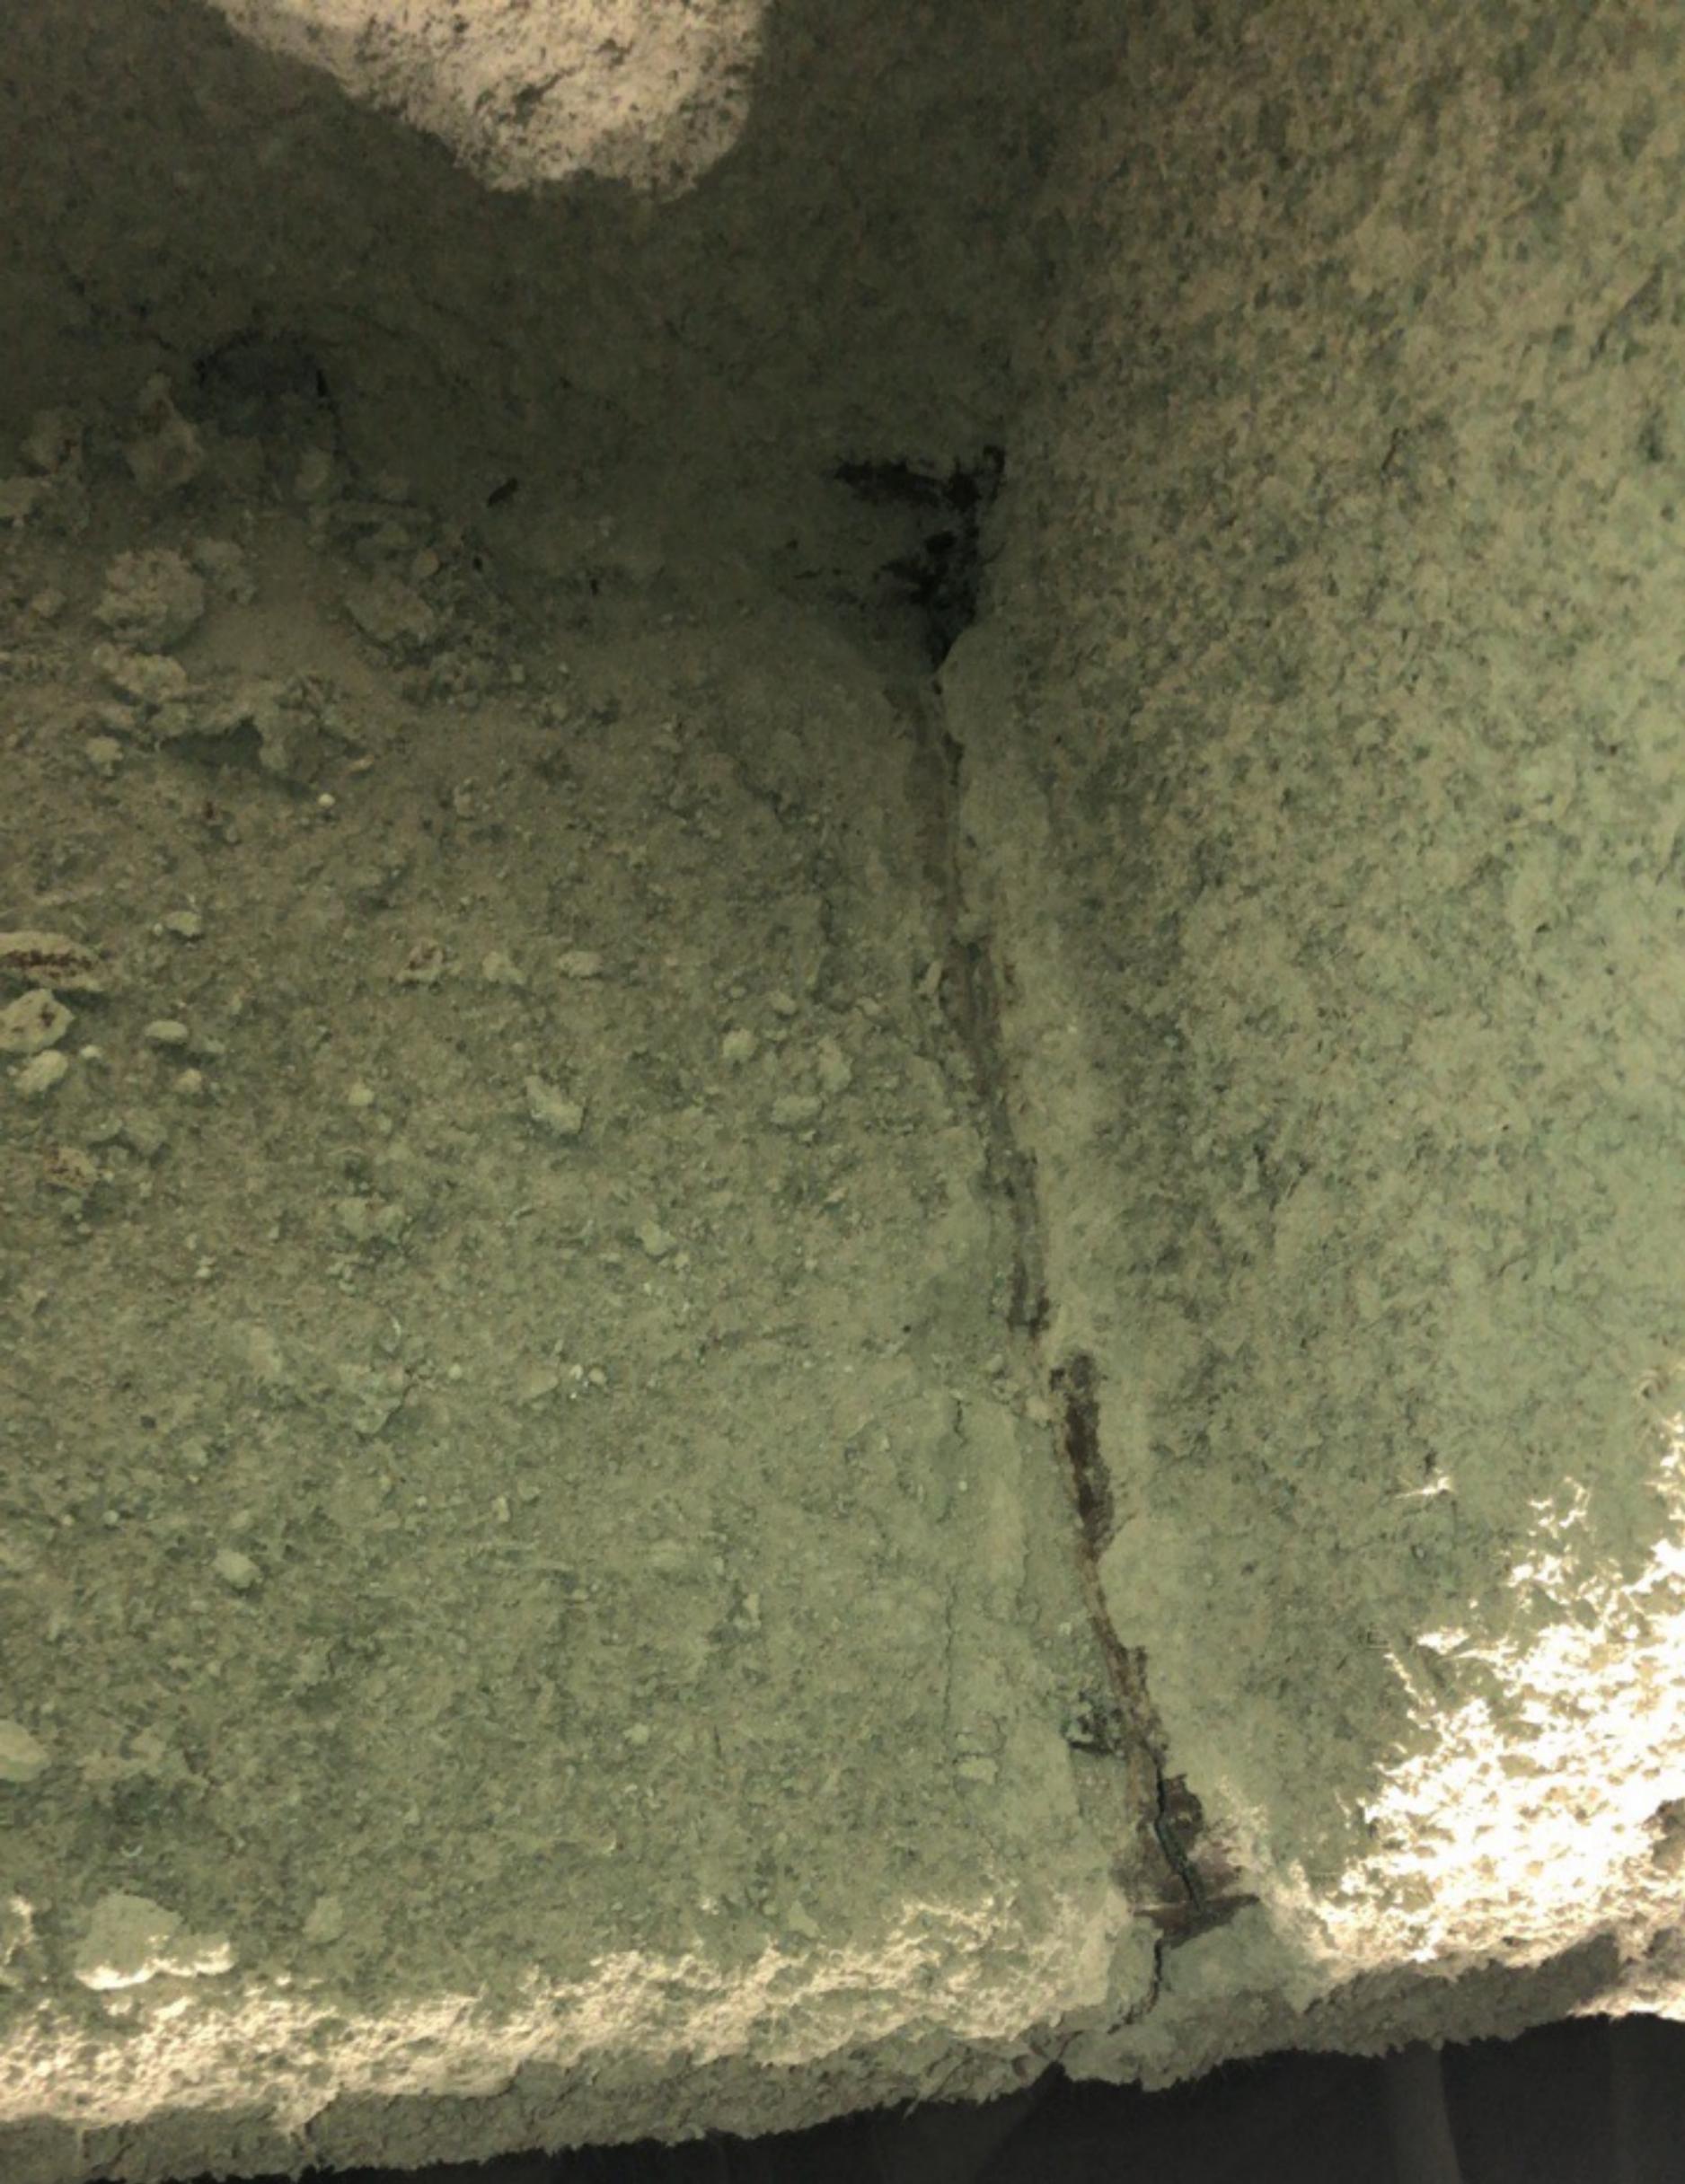
Sep 25, 2018 at 7:30:29 PM

Salesforce Transit Center was temporarily closed yesterday after a fissure in one of the steel beams in the ceiling of the third level Bus Deck near Fremont Street was discovered. Out of an abundance of caution, the TJPA, after conferring with design engineers and contractors, temporarily closed the transit center as the agency worked with Webcor/Obayashi and structural engineers Thornton Tomasetti to investigate and conduct an exhaustive inspection of all similarly designed locations throughout the center.

fissure located on flange on the bottom portion of
the beam that spans over Fremont Street.
(fireproofing intact)

TJPA engineers and contractors are developing a shoring plan for the Fremont Street location to relieve loading on the beams in question to prevent further damage. The team will first address opening Fremont Street as soon as safely possible and then bus operations will follow. The TJPA will then design a permanent repair and schedule construction to make those repairs.

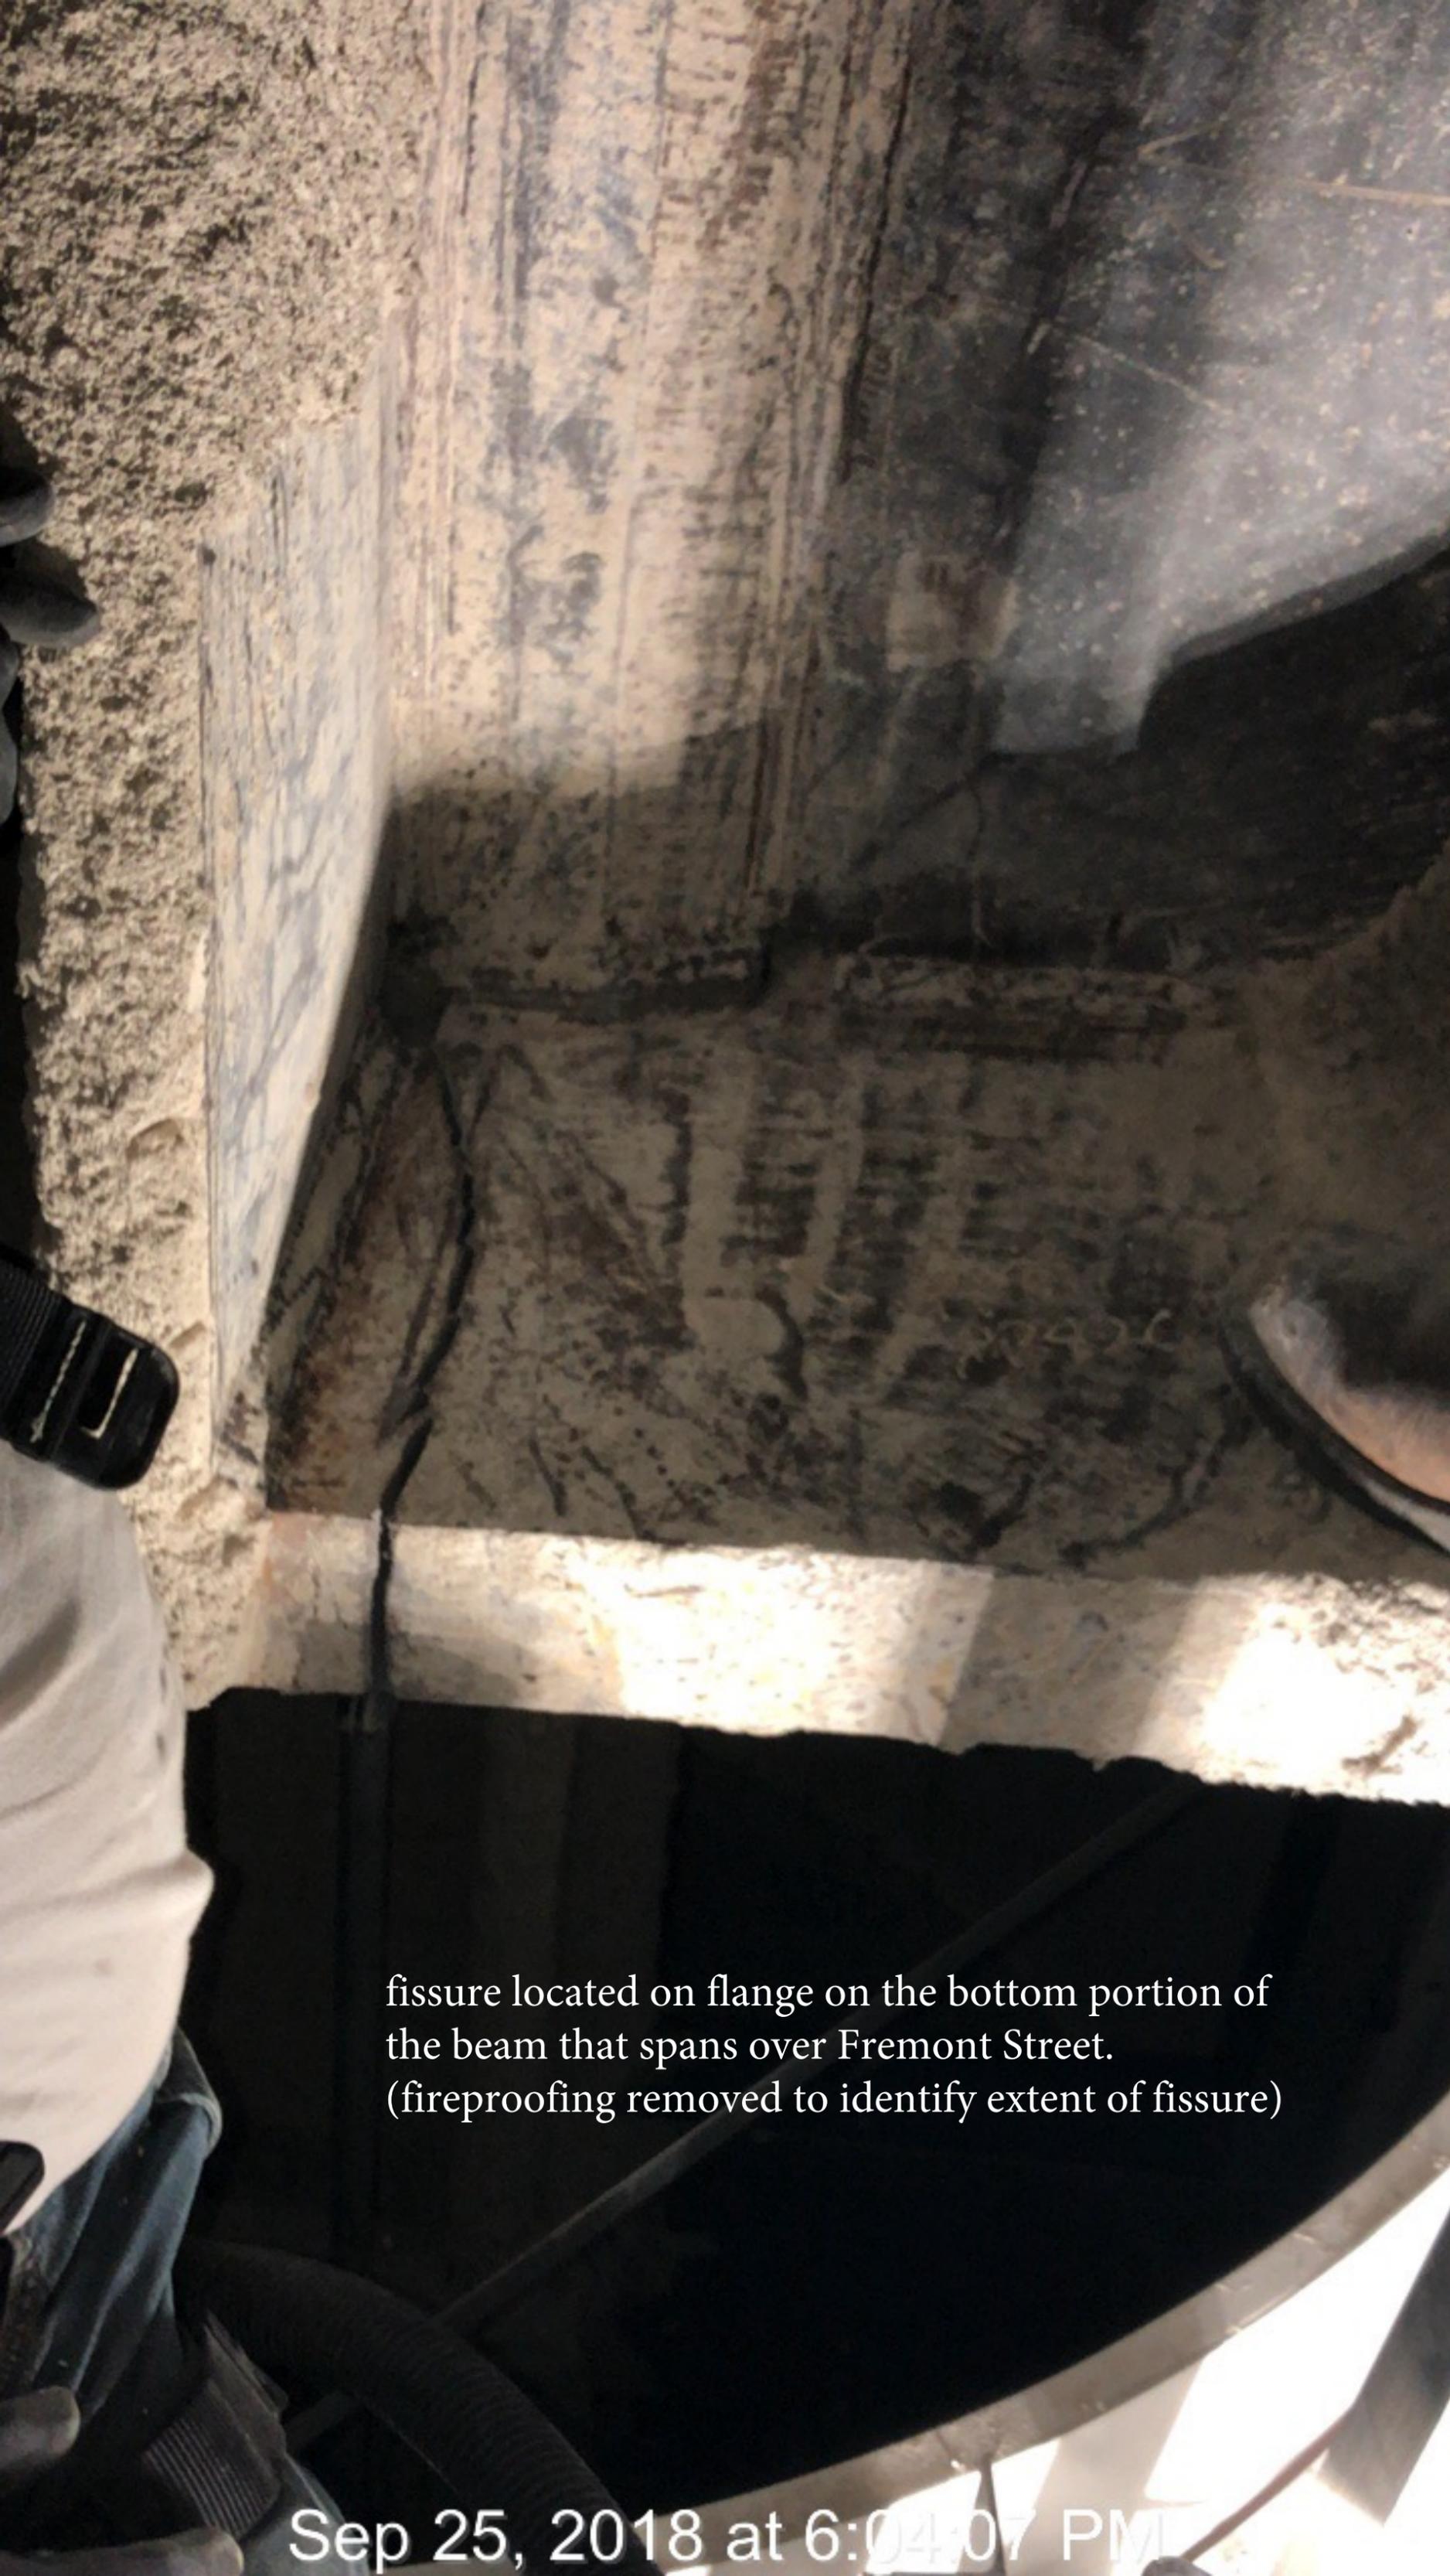
Sep 25, 2018 at 6:04:07 PM

Inspections show an additional fissure on an adjacent beam at the Fremont Street location. The TJPA will conduct additional ultrasonic testing at this location to determine the extent of the damage. Inspections on First Street where similar designs exist, show no similar issues, but the TJPA will continue to monitor and test this location.

fissure located on flange on the bottom portion of the beam that spans over Fremont Street.
(fireproofing removed to identify extent of fissure)
